Yass Soldiers Memorial Hall Community Meeting

STRUCTURAL ENGINEERING REPORT ON CRACKING & SETTLEMENT

YASS MEMORIAL HALL & LIBRARY

88 COMUR ST, YASS N.S.W.

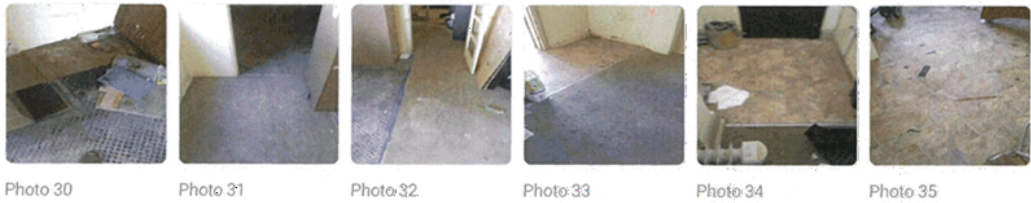
Ground Floor - Youth Centre

Floor

Poor

Stained

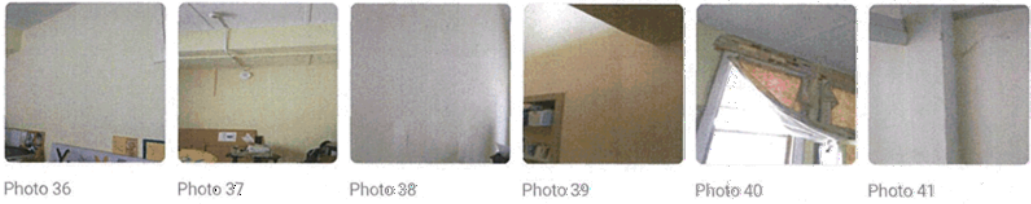
Ground Floor - Youth Centre

Walls

Poor

Need render patched
Repaint

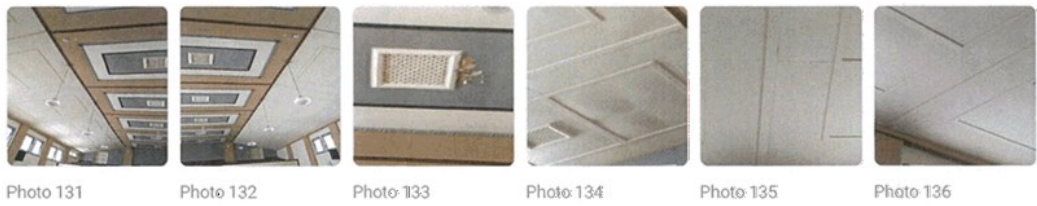
Ground Floor - Main Hall

Celing

Sagging
Paint peeling
Stained, water damage

Poor

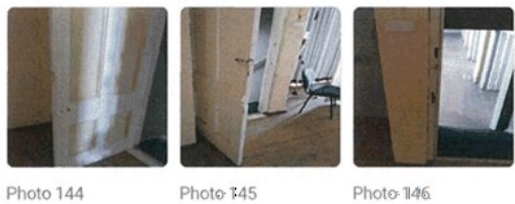
Ground Floor - Stage

Doors

Missing doors handles
Repaint

Poor

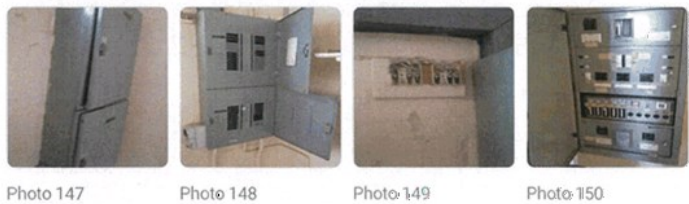
Ground Floor - Stage

Electrical

Need to get a qualified electrician whole building

Poor

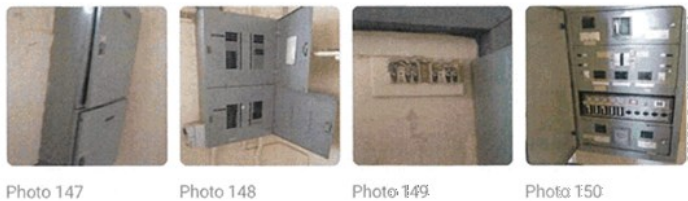
Poor

Need to get a qualified electrician whole building

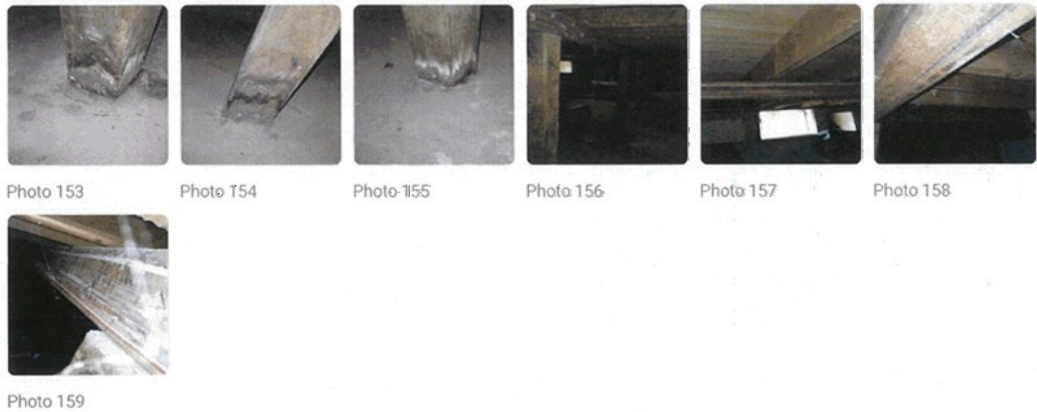
Under Stage

Lights not working
Water damage and rot in bottom of 4 timber posts holding up center stage

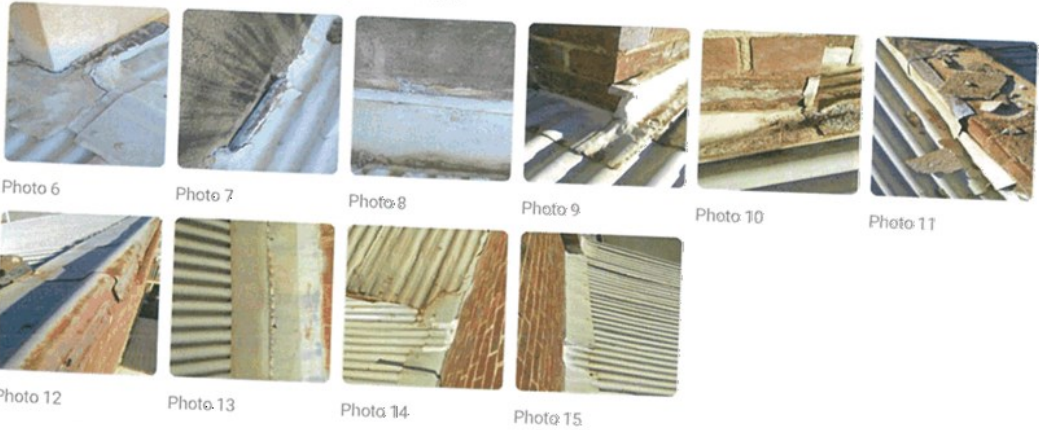
A lot in poor condition
Some lifting up off roof or pull away from walls

Poor

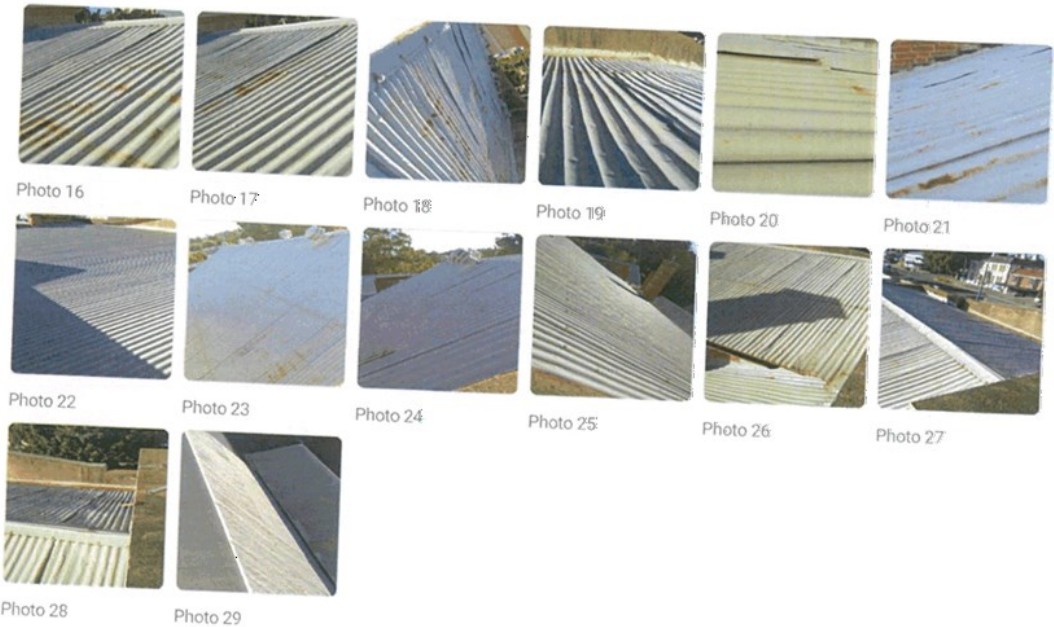
Roof Sheets

All sheets need replaced screwed down at the very least
Front 3 of memorial hall roof need new sheets
All sheets showing signs of rust

Poor

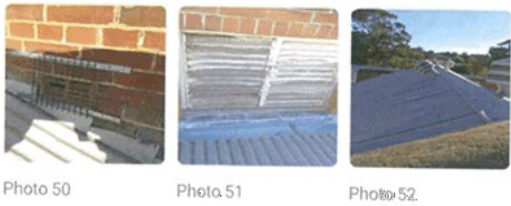
Timber one rotten
Clay brick vents broken

Poor

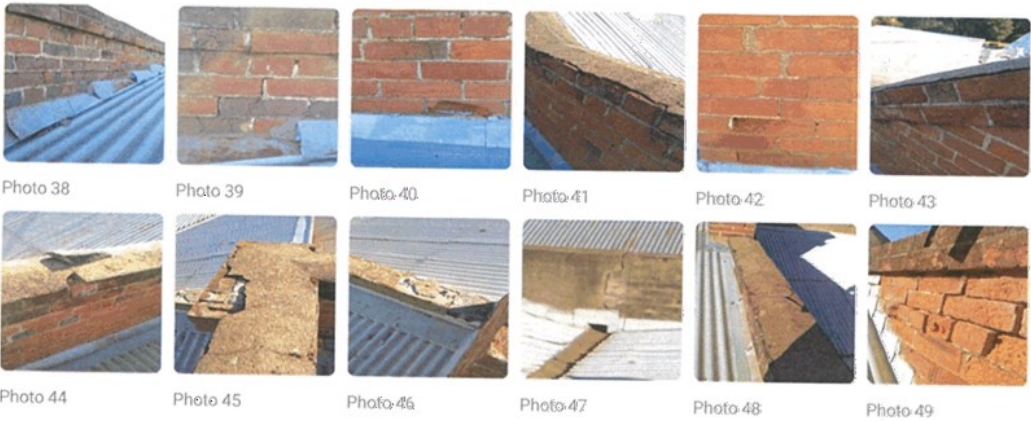
Bricks missing parts
Cracking throughout brick work
Lose cement on top of parapets

Poor

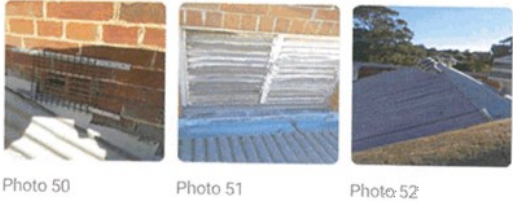
Vents

Timber one rotten
Clay brick vents broken

Poor

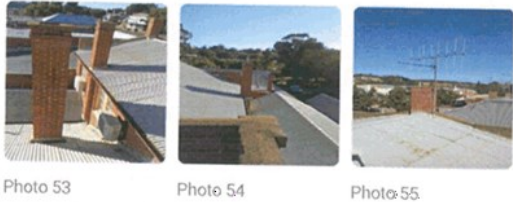
Chimney

Appear to be in good shape

Fair
