Ordinary Meeting of Council

GULLY REHABILITATION PLAN

66 BROOKLANDS ROAD
WALLAROO NSW 2618

Version 1
03 June 2020

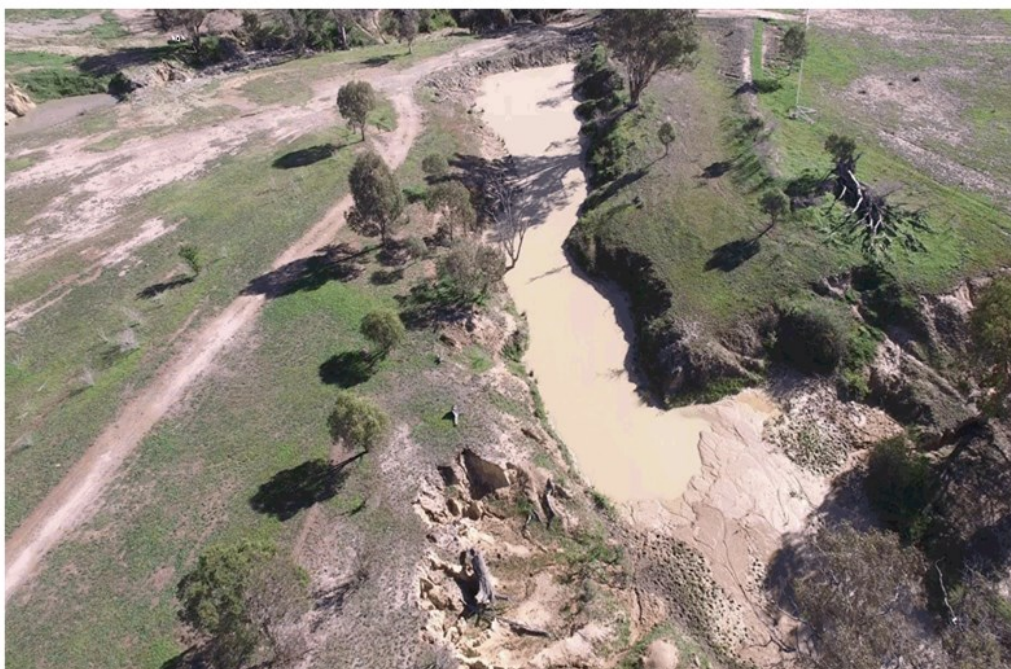
Photo 1: Downstream dam with high suspended sediment load

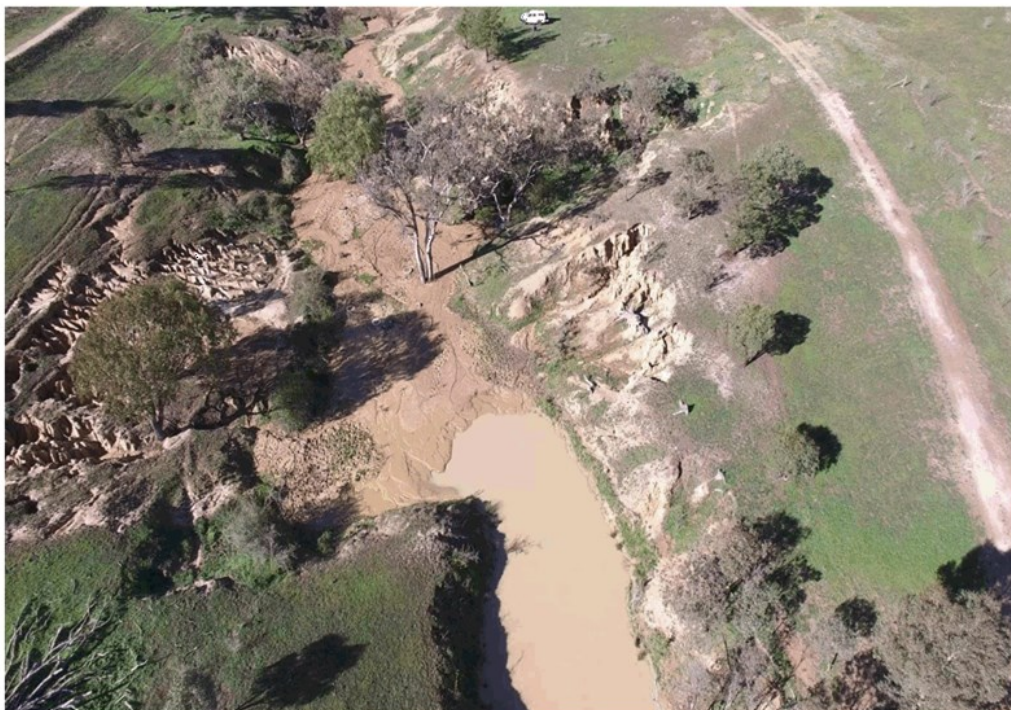
Photo 2: Deposited sediment in dam backwaters

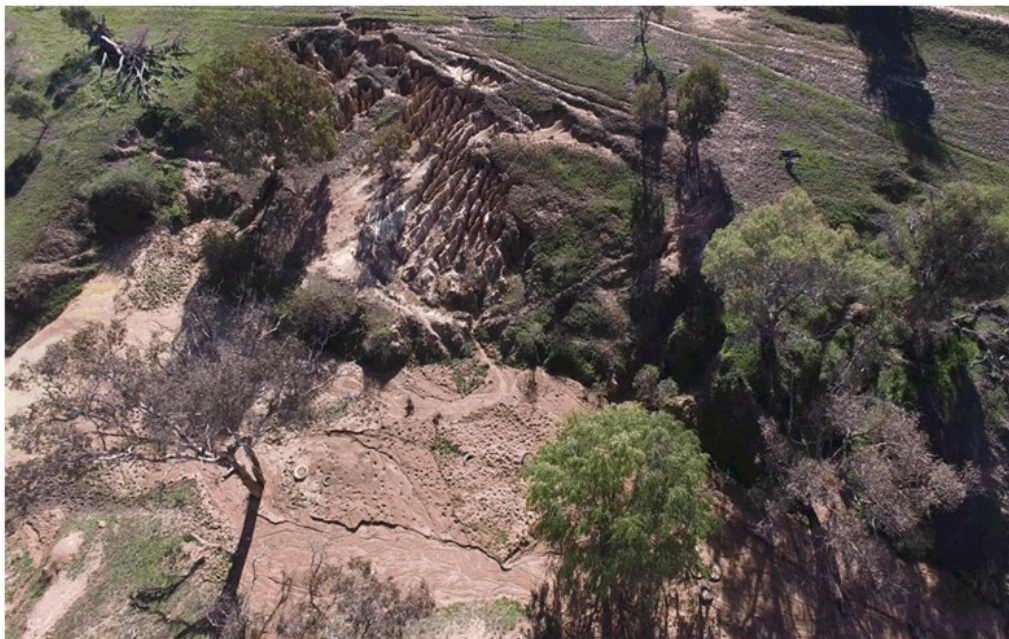
The gully sidewalls are actively eroding and present a significant risk to downstream water quality and habitats.

Photo 3: Severely eroding gully sidewalls - sediment deposited in channel from upslope erosion

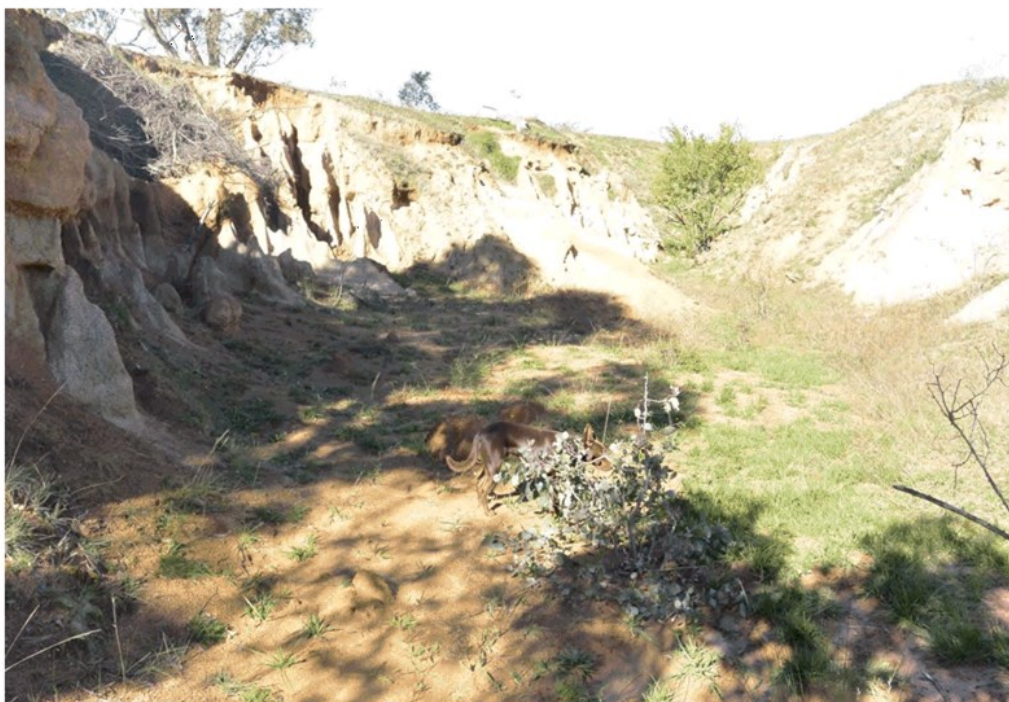
Photo 4: Lateral gully erosion – to be filled to restore gully profile

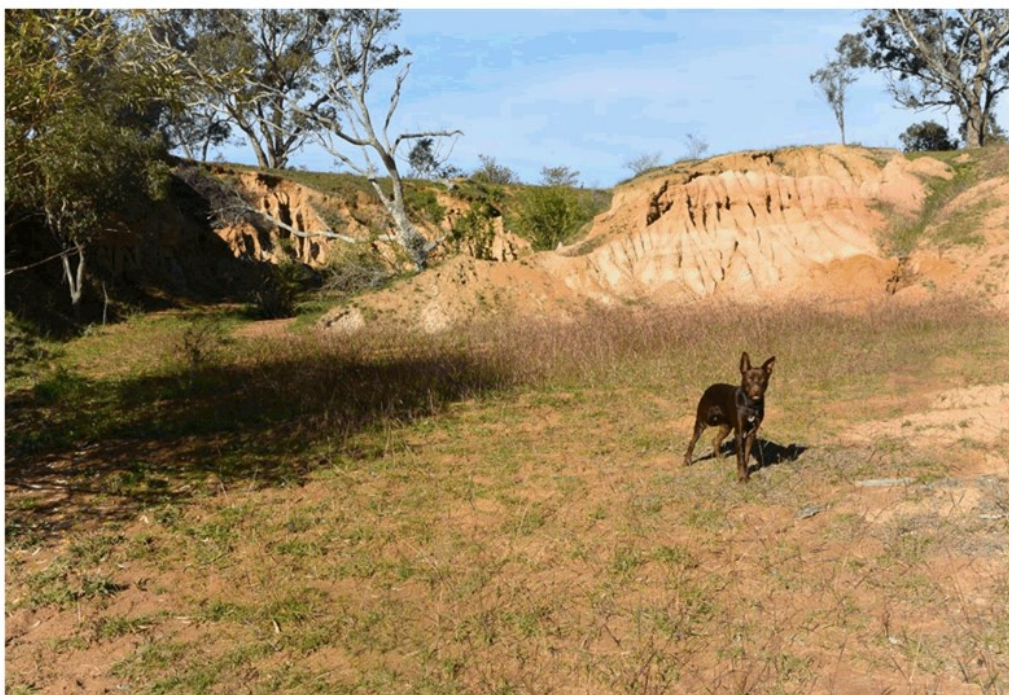
Photo 5: Lateral gully erosion – to be filled to restore gully profile

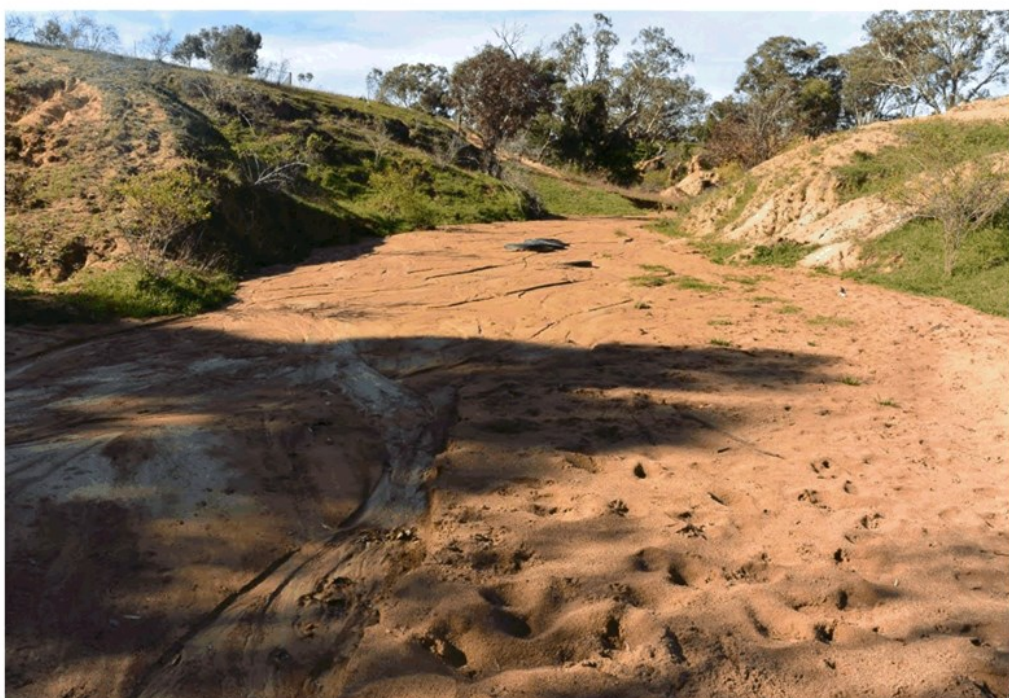
Photo 6: Stable vegetated gully sides – deposited sediment from upstream erosion

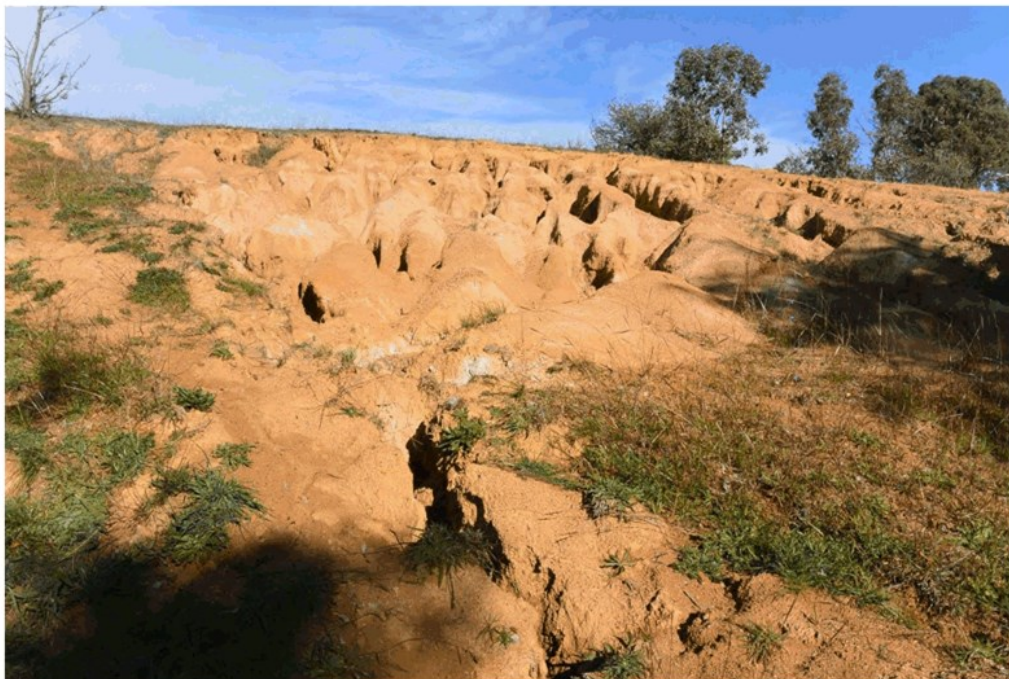
Photo 7: Moderate gully sidewall erosion – minor fill prior to shape, topsoil and revegetation

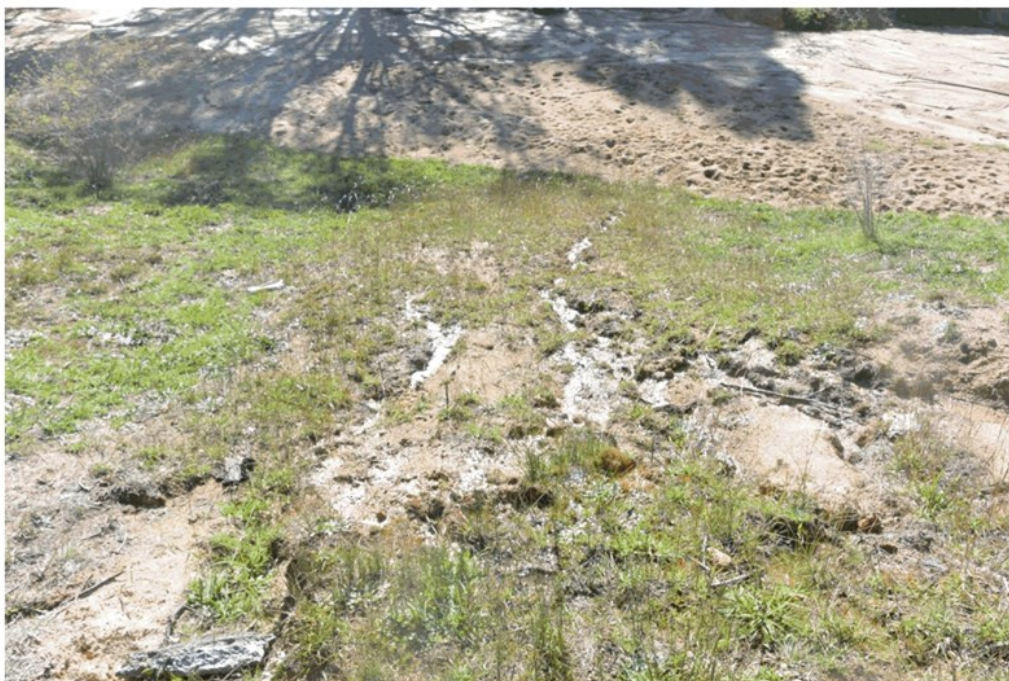
Photo 8: Lateral subsurface flows - intersecting gully sidewall and driving erosion

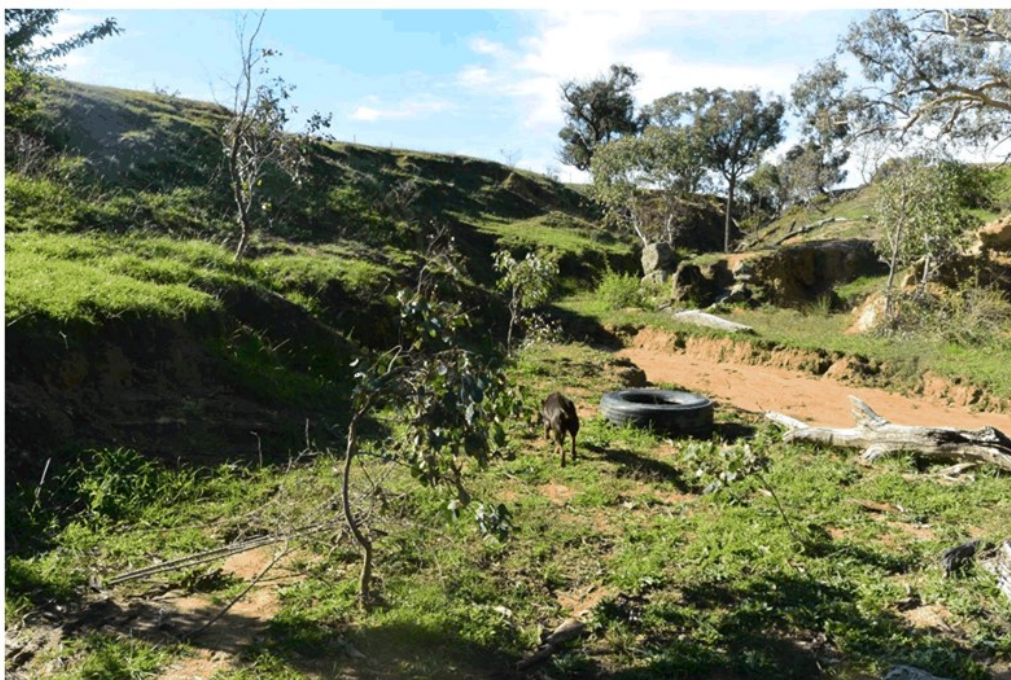
Photo 9: Stable vegetated gully sidewalls – natural regeneration of native trees and shrubs

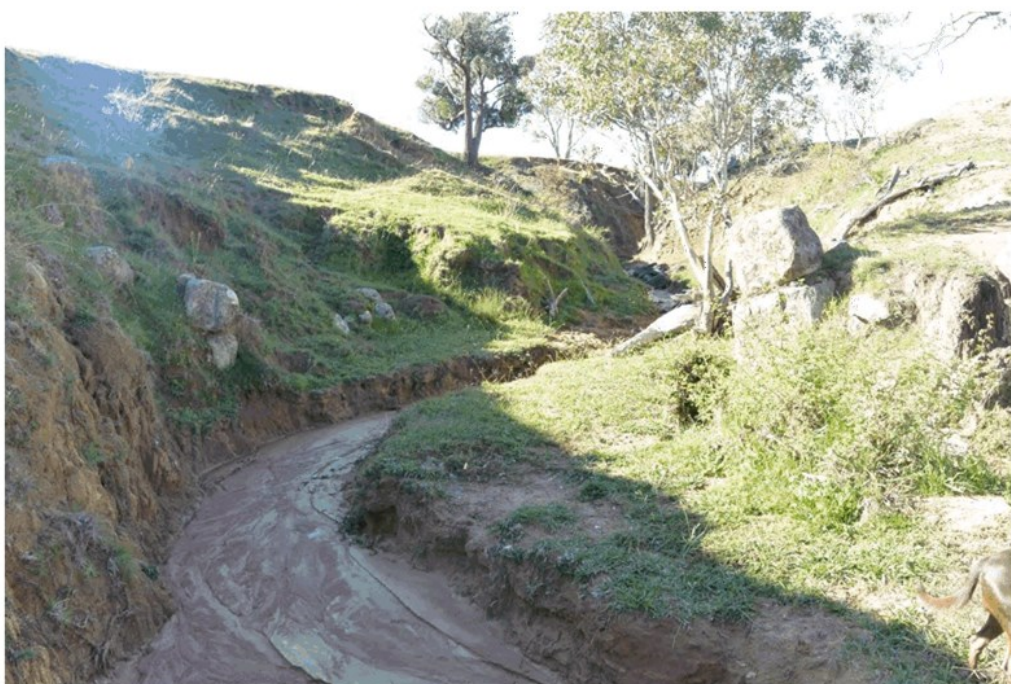
Photo 10: Stable gully sidewalls – minor bed lowering (erosion)

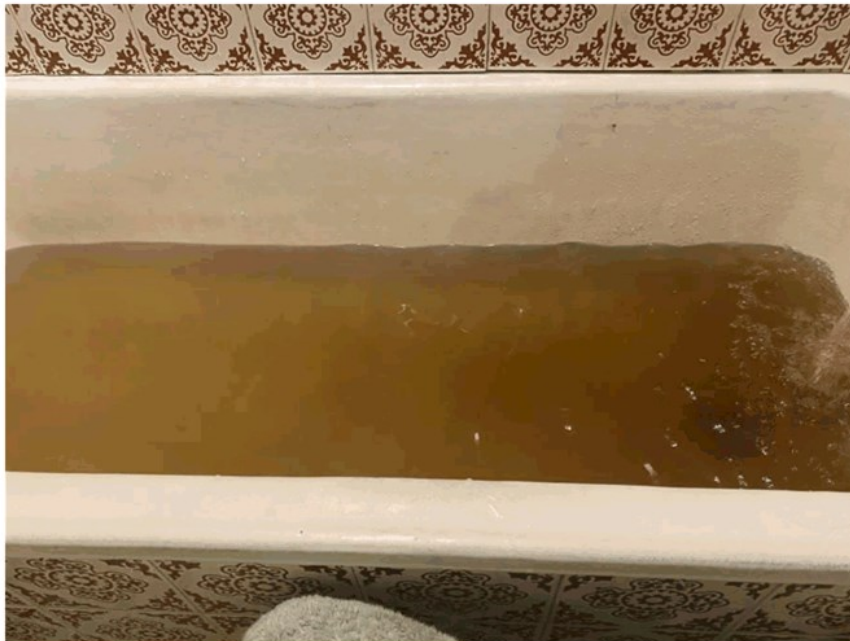
Council receives numerous customer complaints about colour, taste, and odour resulting from shortcomings in the existing treatment process. Poor performance during storm events coupled with limited ability to buffer changes in raw water quality has also led to several boil water notices being issued by NSW Health for breaches of treated water turbidity targets following significant rainfall. As a result, the media has been calling for Council to invest in a robust WTP capable of dealing with the varied influent water quality typically experienced at Yass WTP.

Figure 1-2 Orange-brown water in Yass resident's home (Published in Canberra Times, 25th January 2021)

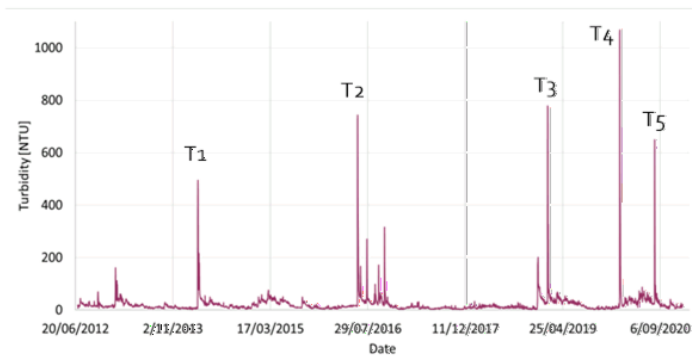
In addition to having limited treatment effectiveness at or above the design capacity of 100 NTU, WTP performance is further impacted when these conditions persist for extended periods or reoccur within weeks. The maximum turbidity that a WTP utilising a DAF clarification process followed by single media filtration could treat is anecdotally in the order of 200 NTU, with an influent turbidity of <50 NTU being preferred for optimum DAF performance. To successfully treat water with high turbidity, the WTP in its current state would need to be downrated significantly to increase air/water interface for effective flotation.

Figure 4-1 Turbidity fluctuations over July 2012-December 2020 period
