Yass Soldiers Memorial Hall Committee Meeting

5.1 Memorial Hall Dilapidation Report

SPECIAL PURPOSE INSPECTION DILAPIDATION REPORT

ADDRESS:	Yass Memorial Hall 82-94 Comur Street YASS NSW 2582
REPORT PREPARED FOR:	Yass Valley Council 209 Comur Street YASS NSW 2582
PHONE:	(02) 6226 1477
EMAIL:	Seamus.McGurk@yass.nsw.gov.au
DATE ATTENDED:	27 – 29 April 2021

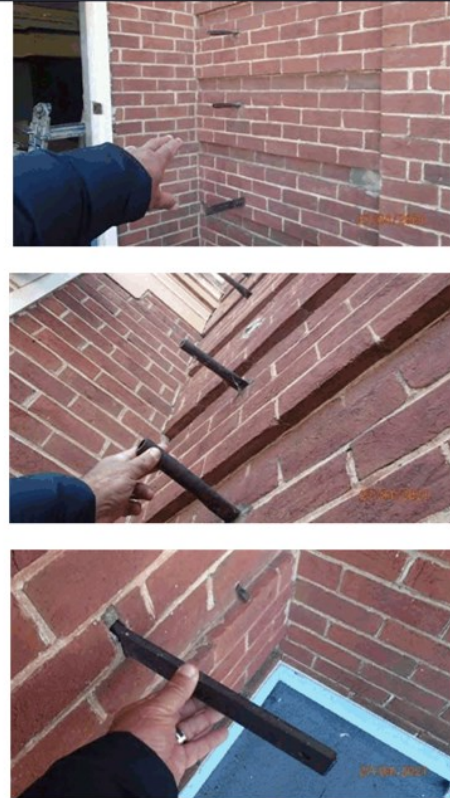
ITEM	LOCATION	DESCRIPTION / OVERVIEW / FINDINGS	IMAGE REFERENCE
FRONT EXTERIOR FAÇADE – BALCONY LEVEL			
3	Ends of first floor balcony.	<p>There are redundant embedded steel fixtures projecting from the brick façade at either end of the first floor balcony which appear to be remnants from previous roof access ladders.</p> <p><u>Consideration should be given to removal of these items which currently present as a potential safety hazard to anyone trafficking or working on the balcony.</u></p>

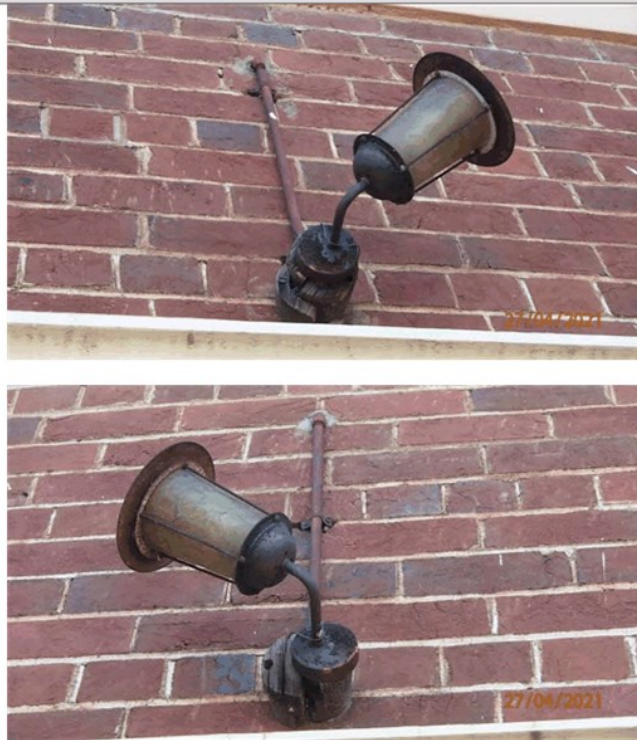
ITEM	LOCATION	DESCRIPTION / OVERVIEW / FINDINGS	IMAGE REFERENCE
5	Front façade, first floor balcony.	<u>The original light fixtures on the front façade show evidence of deterioration to the original timber mounting blocks and consideration should be given to salvaging the fixtures while sealing and upgrading the electrical wiring and mounting blocks.</u>

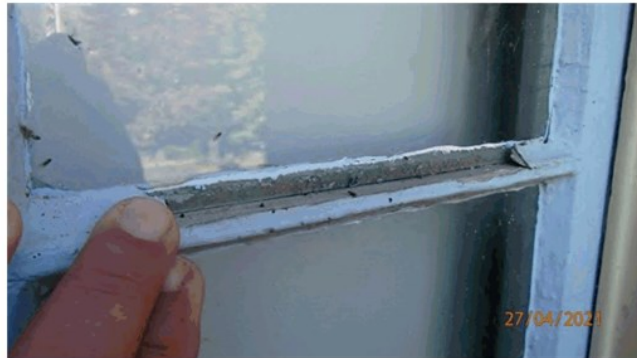
ITEM	LOCATION	DESCRIPTION / OVERVIEW / FINDINGS	IMAGE REFERENCE
6	Windows and doors facing first floor balcony.	<p><u>The external timber windows and doors facing the first-floor balcony present with weathering and deterioration to the paint finish and glazing party.</u></p> <p><u>These external timber elements could be treated holistically by stripping back old paint, conducting repairs and/or replacement of damaged timber elements and repainting for long-term protection.</u></p>

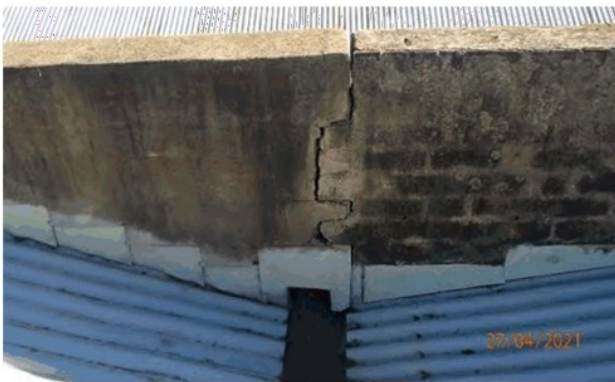
ITEM	LOCATION	DESCRIPTION / OVERVIEW / FINDINGS	IMAGE REFERENCE
10	Masonry parapet walls either side of valley gutter of the corrugated roofs at the front left corner of the building .	<p><u>There is evidence of cracking to the masonry parapet walls at either end of the valley gutter.</u></p> <p><u>This cracking extends the full height of the wall on the left side elevation and consideration should be given to providing an articulation joint in these areas.</u></p> <p>The crack width indicates the cracking is classified as Category 3. The NSW Guide to Standards and Tolerances, Part 3.2 Damage to masonry walls (Refer to Table 3.02 On Page 24) states the following;</p> <p><i>"Category 3 or greater damage to walls is defective and requires investigation, stabilisation, monitoring and rectification work, which may include breaking out and replacing sections of the wall."</i></p>

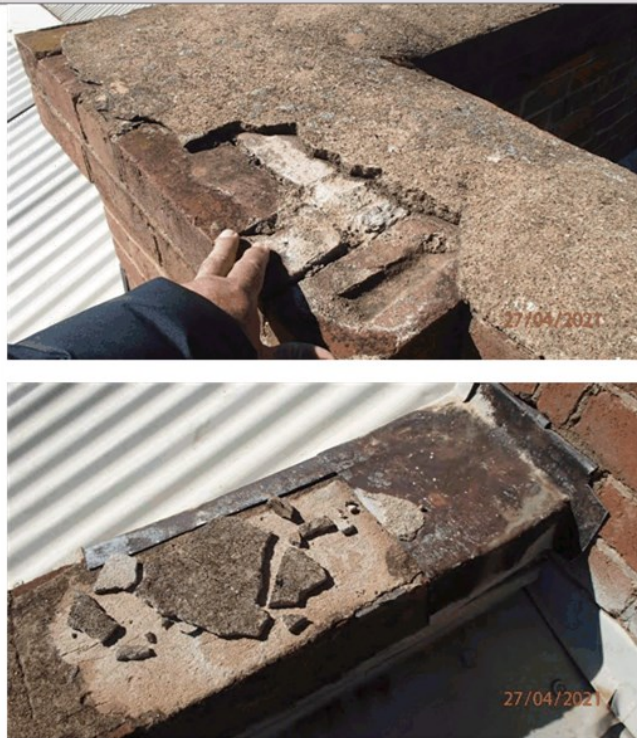
ITEM	LOCATION	DESCRIPTION / OVERVIEW / FINDINGS	IMAGE REFERENCE
11	Original cement into the parapet walls either side of valley gutter at the front left corner of the building .	<p>The original cement into the parapet walls has deteriorated and cracked in most areas leaving previously embedded flashings exposed and now present with gaps and potential bypass leaks.</p> <p>Without the cement into the parapet walls, water is then absorbed into the brickwork creating further deterioration.</p>

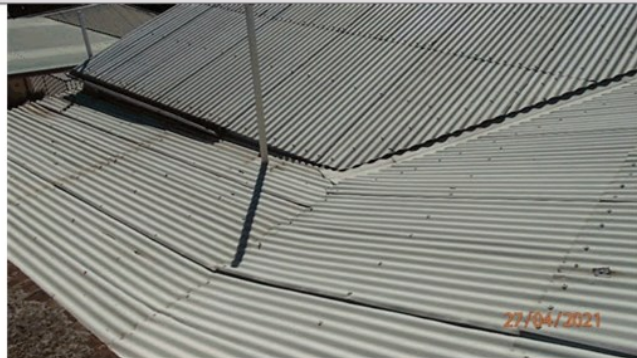
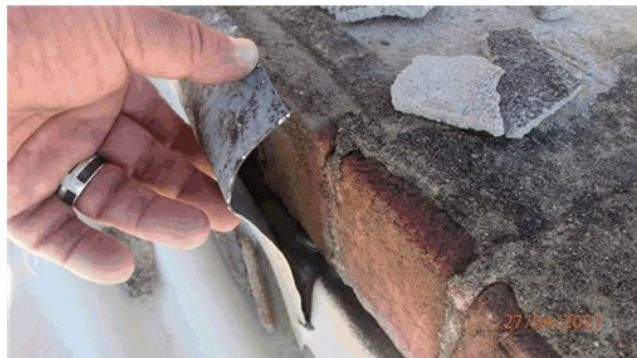
ITEM	LOCATION	DESCRIPTION / OVERVIEW / FINDINGS	IMAGE REFERENCE
12	Small roof, left side of building.	<u>The small roof on the left side of the building behind the meeting room also presents with similar defects are noted to the roof sheeting and flashing, with gaps, indentation and loose screws.</u>

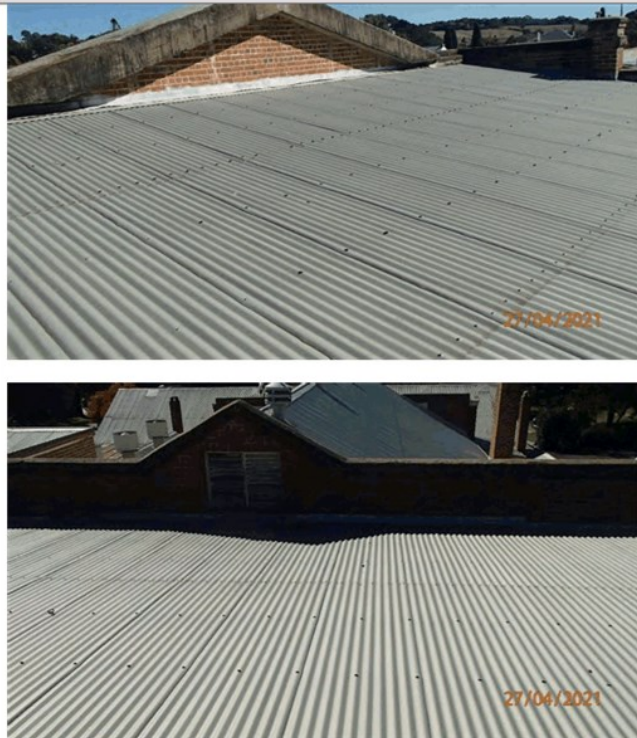
ITEM	LOCATION	DESCRIPTION / OVERVIEW / FINDINGS	IMAGE REFERENCE
13	Corrugated roof over the archives and Memorial Hall mezzanine seating level.	<p>These images are an overview of the corrugated roof over the archive and Memorial Hall mezzanine seating level.</p> <p><u>This roof also presents with roofing screw issues and sagging in the roof due to damaged roof batten below and flashing issues around the roof and box gutter.</u></p> <p>See below for further images.</p>

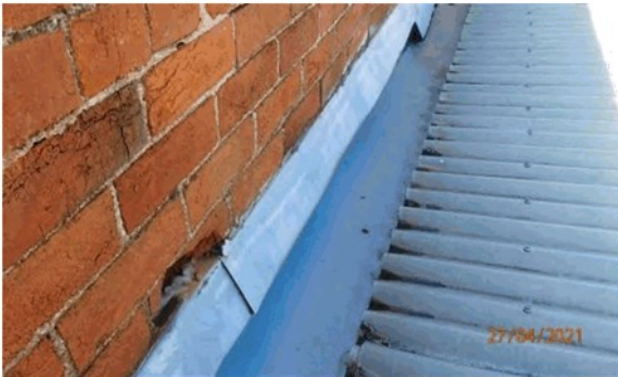
ITEM	LOCATION	DESCRIPTION / OVERVIEW / FINDINGS	IMAGE REFERENCE
14	Box guttering, corrugated roof over the archives and Memorial Hall mezzanine seating level.	<p>The box gutter servicing this roof has been replaced in the past, although there are still visible defects, gaps and fixing issues with the adjoining parapet flashing near the box gutter and around the perimeter of the roof.</p>

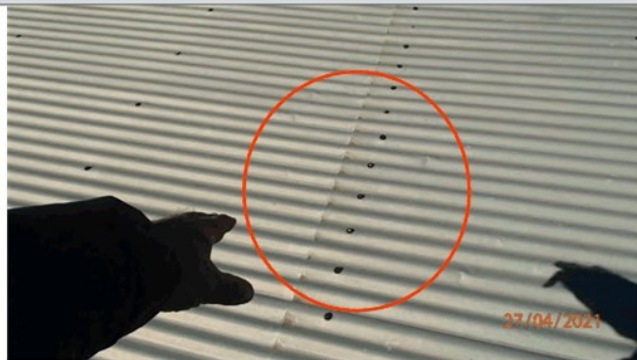
ITEM	LOCATION	DESCRIPTION / OVERVIEW / FINDINGS	IMAGE REFERENCE
15	Corrugated roof over the archives and Memorial Hall mezzanine seating level.	<p><u>A section of the roof presents with movement underfoot, suggesting there may be cracking to the structure below.</u></p> <p><u>This area requires maintenance, repairs and stiffening.</u></p>

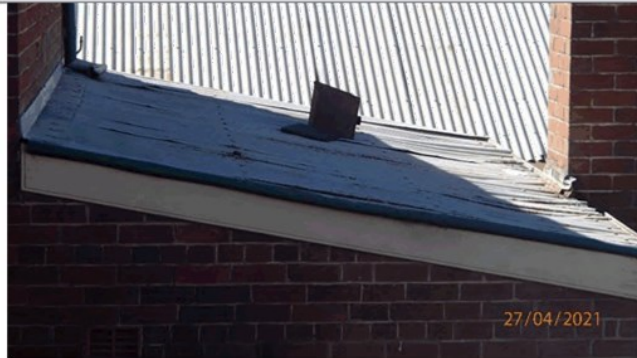
ITEM	LOCATION	DESCRIPTION / OVERVIEW / FINDINGS	IMAGE REFERENCE
25	Small skillion roof over male toilets right of the stage in the memorial hall.	<u>The small skillion roof over the male toilets on the right-hand side of the Memorial Hall building, presents with loose screw fixing, indentation to sheeting and gaps between sheeting.</u> (See also Item # 32, page 45 of this report).

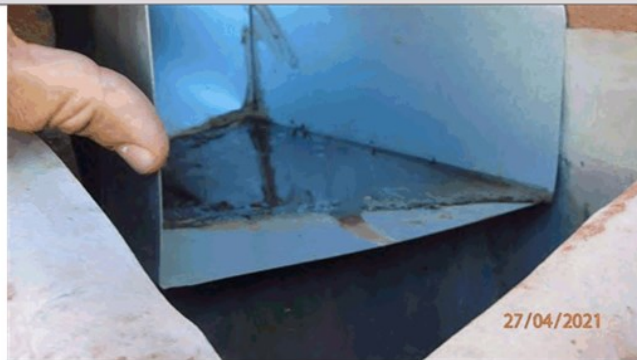
ITEM	LOCATION	DESCRIPTION / OVERVIEW / FINDINGS	IMAGE REFERENCE
27	Roof over the archive and mezzanine floor level of Memorial Hall.	<p>The roof gutter discharge into the rainwater head from the roof over the archive and mezzanine floor level of Memorial hall does not have adequate fall and allows moisture to build up creating a leak past the underside of the gutter via capillary action.</p> <p>This, along with most other box gutters require reconfiguration to improve falls, provide additional overflows and improve the main discharge points along with the receiving rainwater heads.</p>

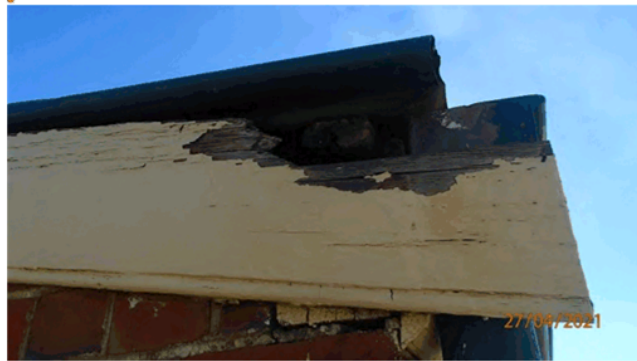
ITEM	LOCATION	DESCRIPTION / OVERVIEW / FINDINGS	IMAGE REFERENCE
33	Skillion roof between Memorial Hall roof and library.	<p><u>The timber fascia for the skillion roof between the main Memorial Hall roof and the library roof presents with weathering and deterioration.</u></p> <p><u>This has exposed roof framing, suffering weathering and has created holes for entry by birds, possums and rodents.</u></p>

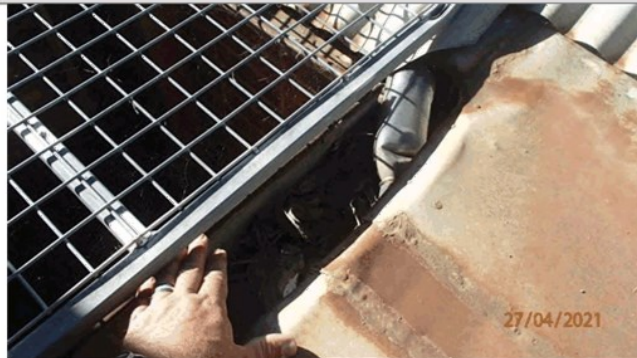
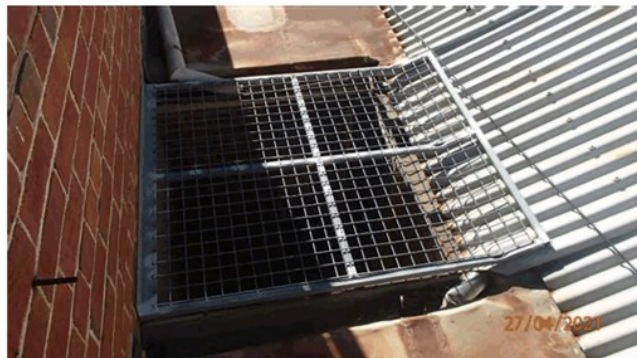
ITEM	LOCATION	DESCRIPTION / OVERVIEW / FINDINGS	IMAGE REFERENCE
38	Skillion roof, rear end of main Memorial Hall.	<p>The square penetrations in the metal deck roof are fitted with quad gutters around the perimeter which show evidence of debris buildup, absent joints and other minor alignment and sagging defects.</p> <p>Consideration should be given to removal and replacement of these gutters with new gutters with slotted overflow to the front to prevent potential overflowing of the gutter back into the building and roof areas.</p> <p>These penetrations extend down to subfloor level, where they are accessible through openings in the base brickwork. Moisture accumulating at the base of these shafts is affecting sections of masonry wall in the library.</p>

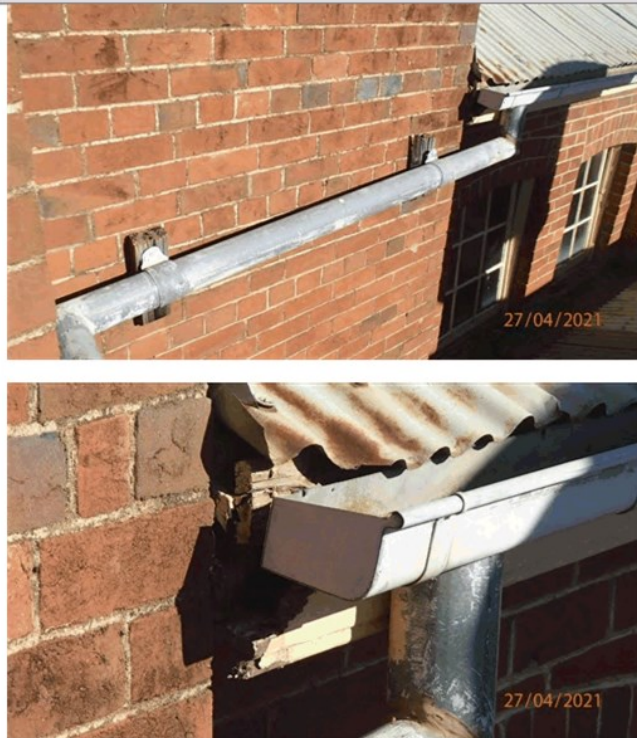
ITEM	LOCATION	DESCRIPTION / OVERVIEW / FINDINGS	IMAGE REFERENCE
39	Left rear corner of the main Memorial Hall roof.	<p>The downpipe at the left rear corner of the main Memorial Hall roof shows evidence of deterioration to the downpipe timber fixing blocks along with damage and deterioration to the timber fascia corner allowing weathering of roof elements.</p> <p>Maintenance is required to the roof flashing, timber fascia and downpipe support in this area.</p>

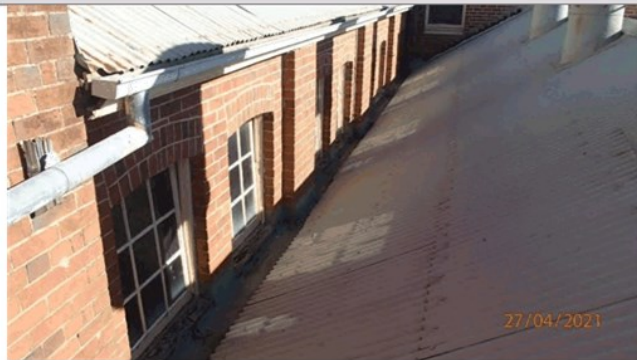
ITEM	LOCATION	DESCRIPTION / OVERVIEW / FINDINGS	IMAGE REFERENCE
40	Junction between pitched corrugated roof and left-hand side of the main Memorial Hall roof.	<p><u>The junction between the pitched corrugated roof and on the left-hand side of the main Memorial Hall roof serviced by a box gutter with perimeter flashing to the windowsills and walls displays cracking and deterioration in several areas.</u></p> <p><u>The windows joining the roof and gutter in this area also show evidence of weathering and deterioration.</u></p> <p><u>Maintenance and repairs along with painting is required for long-term protection.</u></p>

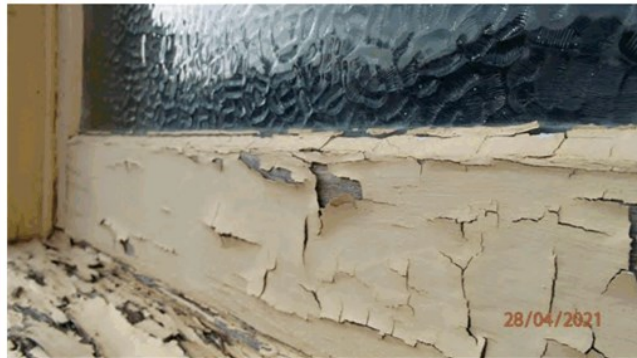
ITEM	LOCATION	DESCRIPTION / OVERVIEW / FINDINGS	IMAGE REFERENCE
44	Timber windows servicing Annex 2, left-hand side of building Memorial Hall.	<p>The timber windows servicing the Annex 2 to the left side of the building presents with weathering and deterioration and additional patching, repairs and painting are required for long-term protection.</p> <p>The same weathering deterioration can also be observed to the windows servicing the male toilet facilities adjacent to Annex 2.</p>

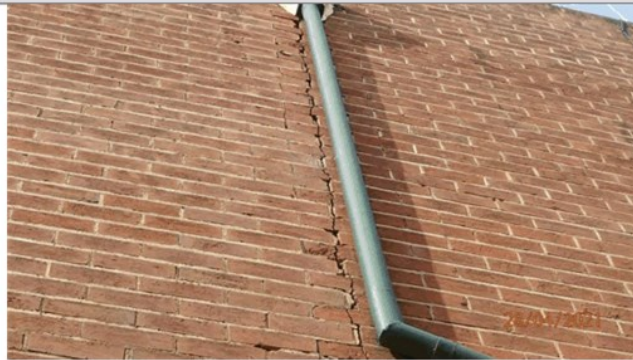
ITEM	LOCATION	DESCRIPTION / OVERVIEW / FINDINGS	IMAGE REFERENCE
46	Masonry wall, left-hand side of Youth Centre offices.	Cracking to masonry wall on the left-hand side of the Youth Centre offices (above used centre offices) which extends from the parapet to the full height of the first floor level in line with the rainwater head and downpipe. <u>An articulation joints in this location is advisable, to be filled with a foam backing rod and colour matched caulking.</u>

A photograph showing a vertical crack in a red brick masonry wall. A green downpipe runs vertically along the crack. The crack extends from the parapet down to the first floor level. A date stamp '28/04/2021' is visible in the bottom right corner.
47	Masonry wall, top left corner window servicing the Youth Centre offices.	Cracking to the masonry wall at the top left corner of the windows servicing the Youth Centre offices extends from the concrete lintel through six courses of brickwork below. The crack appears to be approximately 8mm or less and is as a result of differential movement between the masonry work and the concrete lintel above. <u>This cracking should be sealed with colour matched caulking.</u>

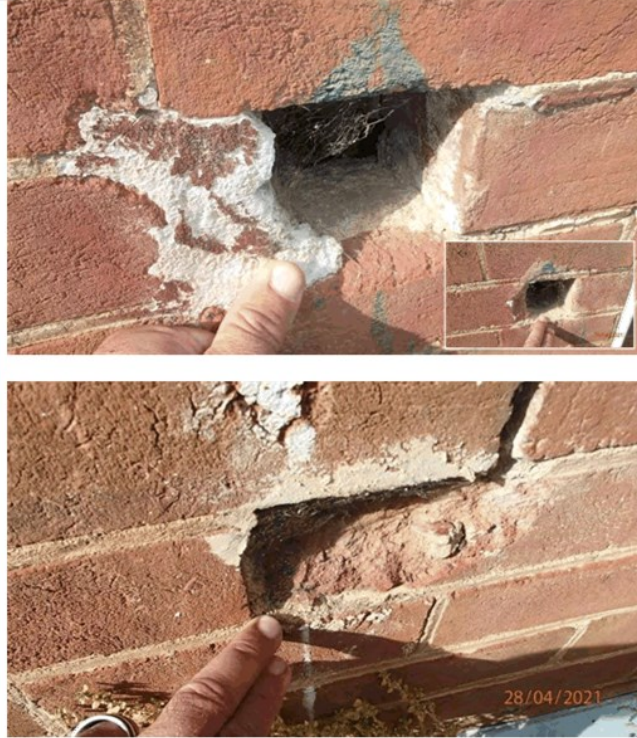
ITEM	LOCATION	DESCRIPTION / OVERVIEW / FINDINGS	IMAGE REFERENCE
48	Masonry wall, left-hand side of Youth Centre offices.	<p>These images illustrate holes in the masonry wall on the left-hand side of the Youth Centre offices which should be sealed to prevent moisture entry and pest entry.</p> <p><u>There was also isolated evidence of brick fret observed which should be filled and patched.</u></p>

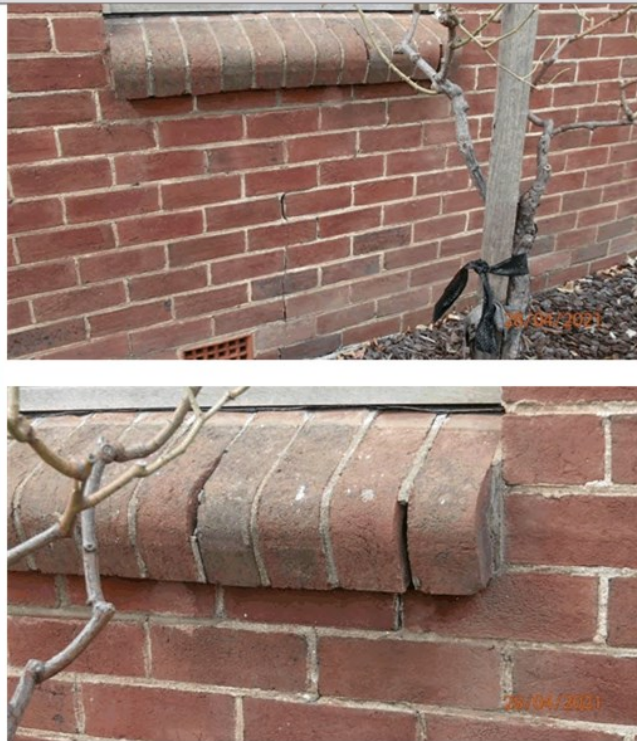
ITEM	LOCATION	DESCRIPTION / OVERVIEW / FINDINGS	IMAGE REFERENCE
52	Masonry brickwork, window at front of Memorial Hall.	<p>There is evidence of cracking to the masonry brickwork below the window at the front of the building, servicing the Youth Centre offices which extends from the windowsill down to DPC level.</p> <p><u>There is also evidence of gaps and deterioration to the mortar around the brick sill, both which requires patching with colour matched caulking and cement.</u></p>

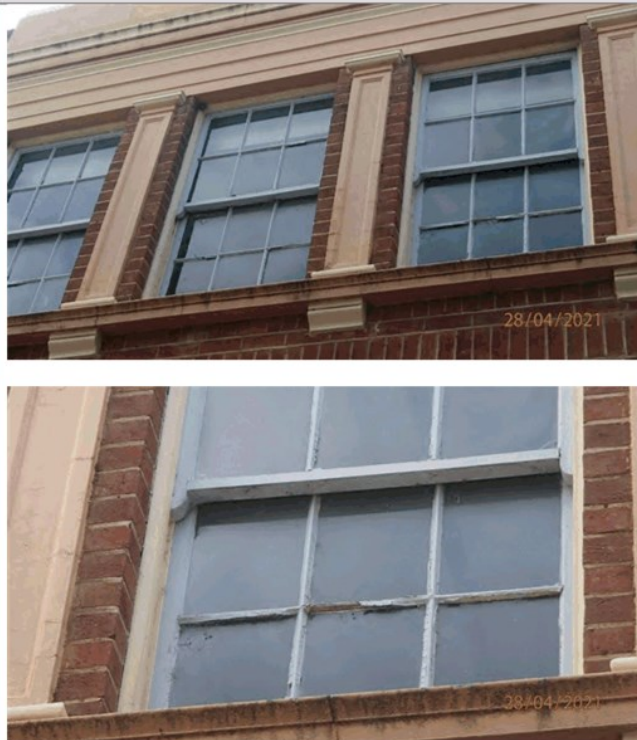
ITEM	LOCATION	DESCRIPTION / OVERVIEW / FINDINGS	IMAGE REFERENCE
53	Upper level windows, front left corner of Memorial Hall.	The upper-level windows at the front left corner of the building display evidence of weathering and deterioration, <u>which requires patching and repairs along with painting for long-term protection.</u>

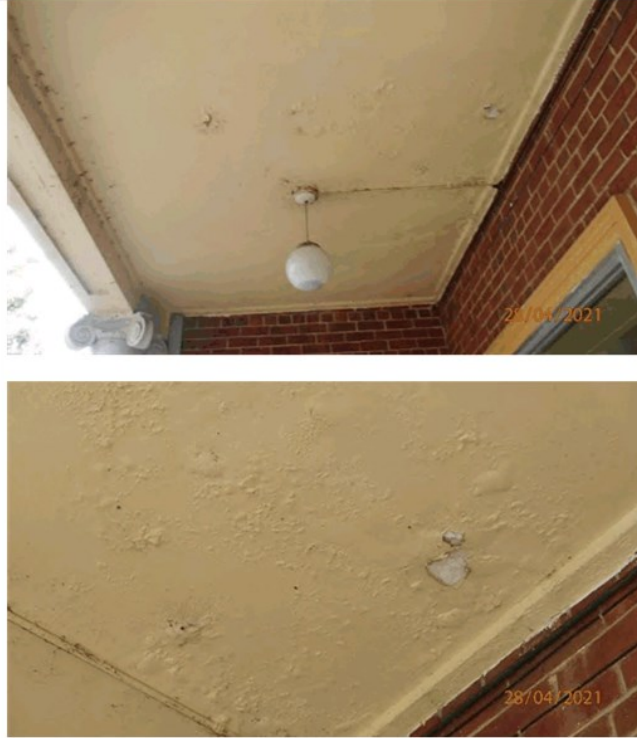
ITEM	LOCATION	DESCRIPTION / OVERVIEW / FINDINGS	IMAGE REFERENCE
56	First-floor balcony soffit, Memorial Hall.	<p>The soffit to the underside of the first-floor balcony displays evidence of water damage to the third left panel of the soffit, which suggests failure of the waterproofing membrane in this area.</p> <p><u>A full refurbishment of the balcony waterproofing is recommended along with the required patching and repairs to the soffit lining, along with additional painting.</u></p>

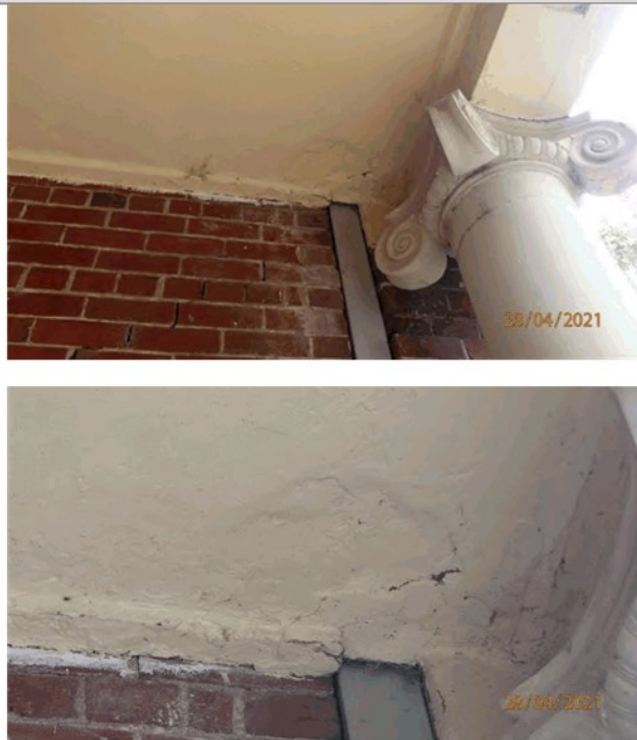
ITEM	LOCATION	DESCRIPTION / OVERVIEW / FINDINGS	IMAGE REFERENCE
57	First-floor balcony soffit, Memorial Hall.	<p>The soffit lining around the right-hand side downpipe servicing the first-floor balcony displays evidence of water damage, suggesting failure of the waterproofing in this area.</p> <p><u>A full refurbishment of the balcony waterproofing along with necessary repairs and painting to the soffit is recommended.</u></p>

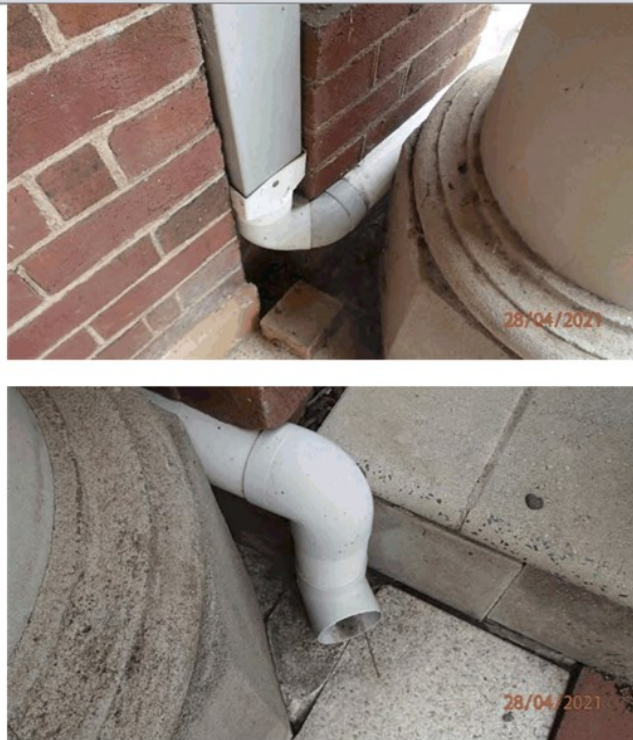
ITEM	LOCATION	DESCRIPTION / OVERVIEW / FINDINGS	IMAGE REFERENCE
58	First-floor balcony downpipe, Memorial Hall.	<p>The downpipe servicing the balcony on the right-hand side has been modified and redirected to discharge onto the pavement at the front entry to the Memorial Hall.</p> <p><u>Consideration should be given to clearing of the original stormwater line and reconnection of the downpipe to the stormwater line to prevent potential winter slip hazards being created to the public common areas at the front of the building.</u></p>

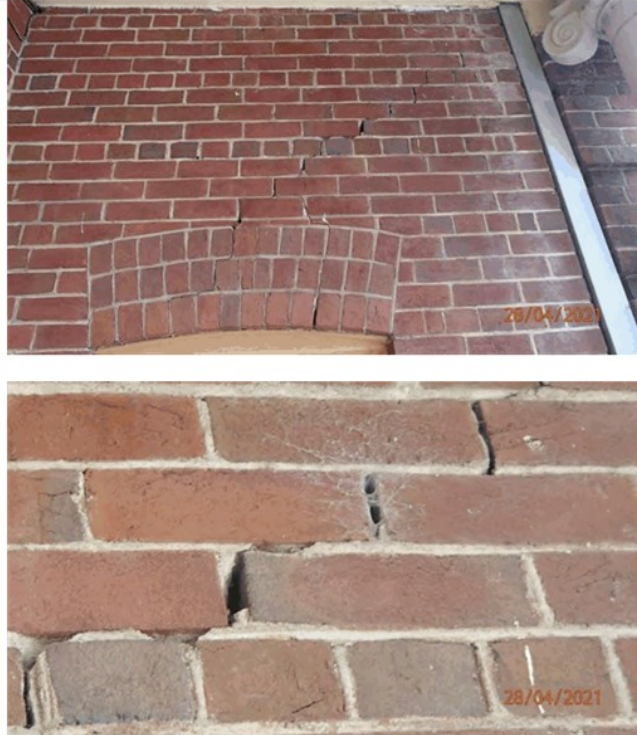
ITEM	LOCATION	DESCRIPTION / OVERVIEW / FINDINGS	IMAGE REFERENCE
59	Masonry wall above doorway, Memorial Hall.	<p>There is visible cracking to the brick masonry above the doorway</p> <p>The crack emanates from the right-hand side of the main entry and then extends from the brick lintel diagonally towards the downpipe on the right-hand side.</p> <p><u>Cracking appears to be approximately 8mm or less and requires patching with colour matched mortar and caulking.</u></p>

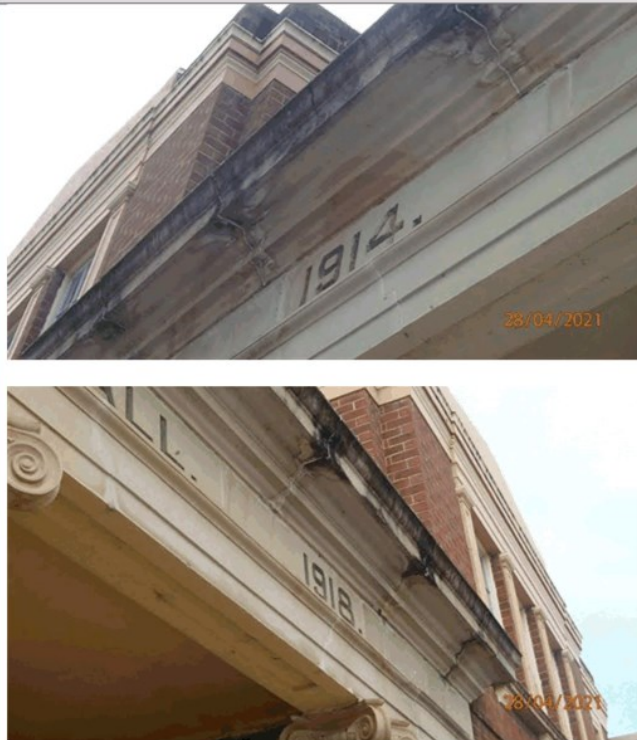
ITEM	LOCATION	DESCRIPTION / OVERVIEW / FINDINGS	IMAGE REFERENCE
61	Main entry, Memorial Hall.	<p>The sandstone wall corbelling above the main entry to the Memorial Hall displays evidence of watermark staining, cracking and chipping across the full length of the main entry.</p> <p><u>Consideration should be given to cleaning, patching and sealing of the sandstone, which may require application of a unifying finish across the surface for a consistent presentation and long-term protection.</u></p>

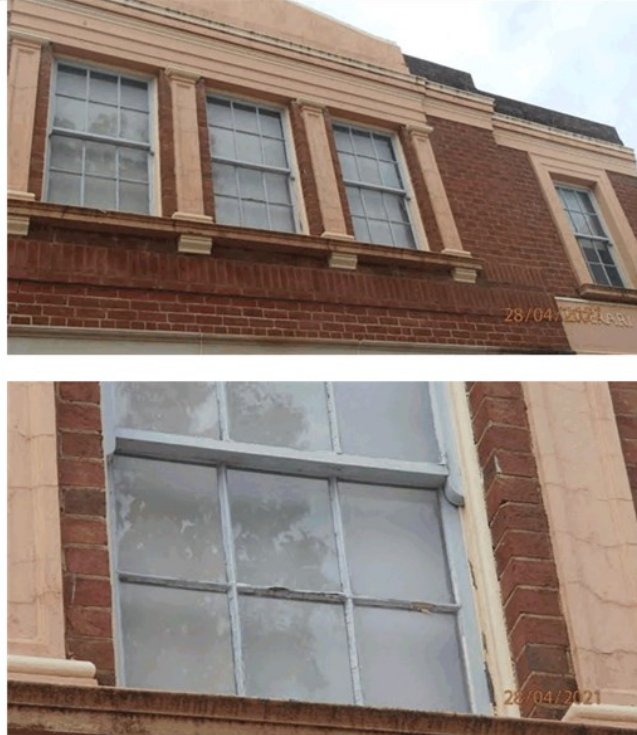
ITEM	LOCATION	DESCRIPTION / OVERVIEW / FINDINGS	IMAGE REFERENCE
62	Upper-level windows, right front façade, Memorial Hall.	<p>The upper-level windows on the right-hand side of the front façade, servicing the archive area presents with weathering and deterioration, which requires patching, repair and painting for long-term protection.</p> <p><u>Visible cracking to the cement wall corbelling decorative columns between the windows also requires patching and repainting.</u></p>

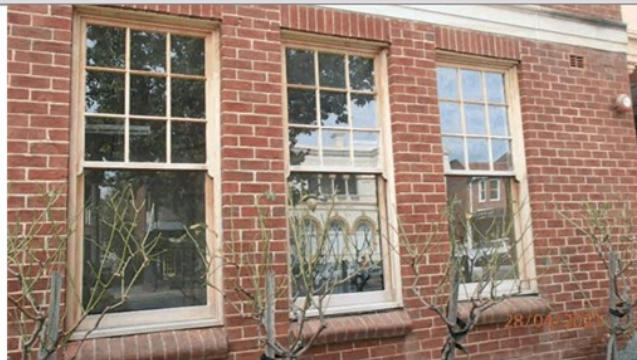
ITEM	LOCATION	DESCRIPTION / OVERVIEW / FINDINGS	IMAGE REFERENCE
63	Front right façade, double hung windows.	<u>The timber double hung windows at the bottom level right-hand side of the front façade appear to have been replaced, although additional refinishing or repainting is required for long-term protection and to provide a uniform appearance with other original windows.</u>

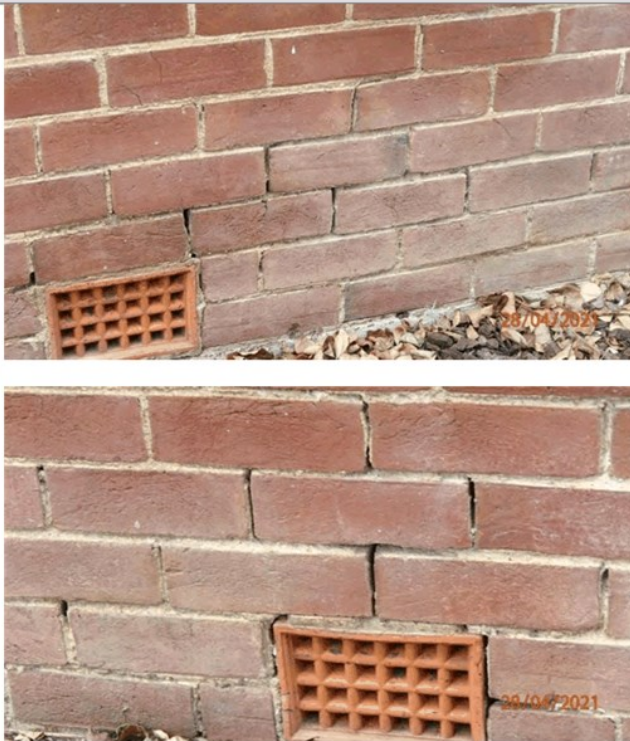
ITEM	LOCATION	DESCRIPTION / OVERVIEW / FINDINGS	IMAGE REFERENCE
64	Base brickwork, front right, Memorial Hall.	<p>The base brickwork at the front right corner of the building presents with deterioration to the mortar across the façade in this area. It is generally caused by moisture absorption along with the freeze and thaw effect of the molecules causing expansion of the water molecule and deterioration of the mortar.</p> <p><u>Repointing with colour matched mortar is recommended.</u></p>

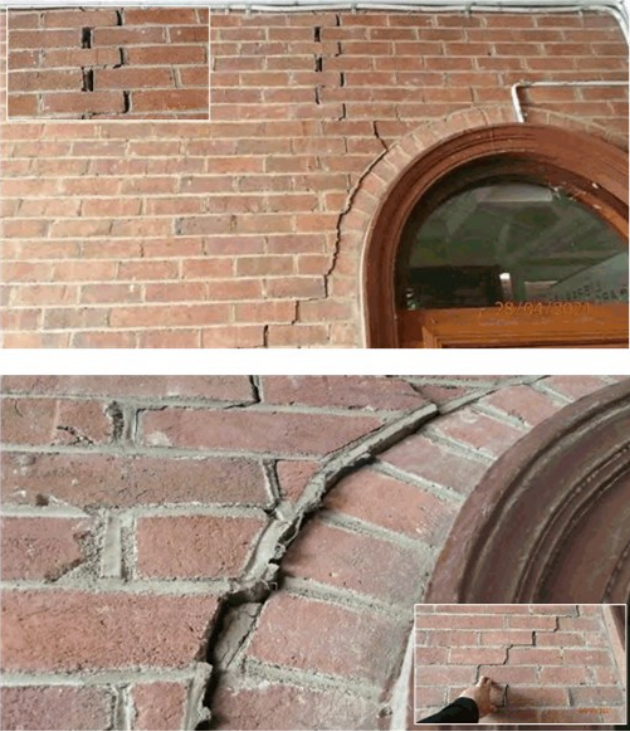
ITEM	LOCATION	DESCRIPTION / OVERVIEW / FINDINGS	IMAGE REFERENCE
68	Entry door, archive rooms, ground level.	<p>There is evidence of cracking to the masonry wall arch around the entry door to the archive rooms at ground level.</p> <p>The cracking appears to be approximately 10mm or less, starting from the soffit lining extending around the brick arch then radiating through 14 courses of brickwork below the arch into a diminishing fashion.</p> <p><u>Engineering advice is required as to the best method of repair which may entail partial demolition and rebuilding of the brickwork in this area.</u></p>

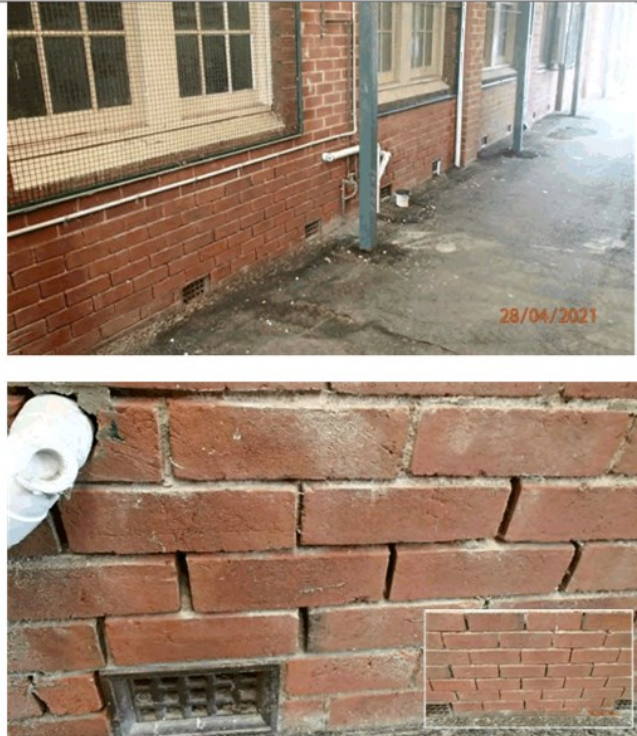
ITEM	LOCATION	DESCRIPTION / OVERVIEW / FINDINGS	IMAGE REFERENCE
69	Right of Memorial Hall, adjoining public walkways and library.	<p>The external brickwork on the right-hand side of the Memorial Hall, adjoining the public walkway and library, displays evidence of deterioration to the mortar joints along the full length of the wall. Deterioration is caused by moisture absorption being exacerbated by the freeze and thaw effect causing molecules to expand and deteriorate the mortar.</p> <p><u>Repointing of the mortar in a colour matched cement is recommended.</u></p>

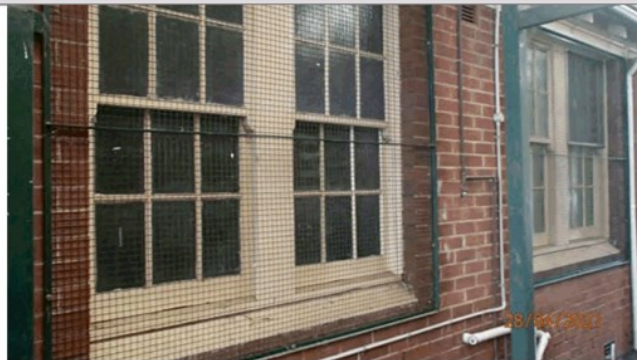
ITEM	LOCATION	DESCRIPTION / OVERVIEW / FINDINGS	IMAGE REFERENCE
71	Timber windows, right of Memorial Hall adjoining public walkway and library.	<p>The timber windows along the right-hand side of the building, adjoining the public walkway towards the library, appear to be in reasonably good condition, as they are not exposed to significant weathering.</p> <p><u>These windows are covered with security screens, which makes access to periodic maintenance painting difficult.</u></p>

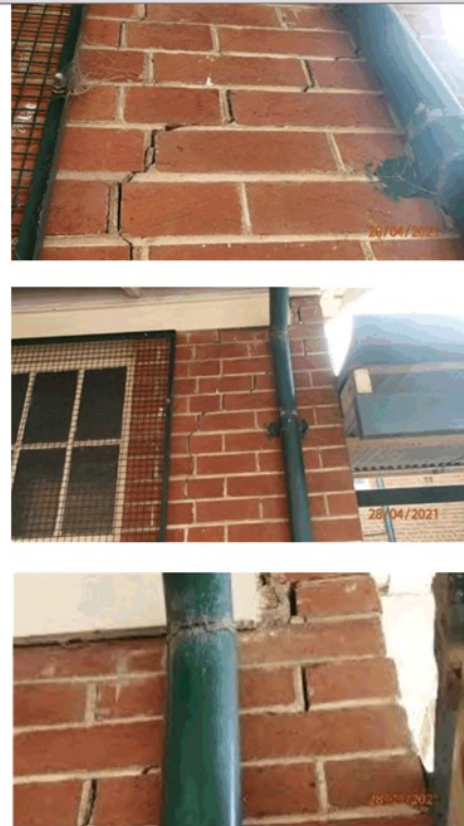
ITEM	LOCATION	DESCRIPTION / OVERVIEW / FINDINGS	IMAGE REFERENCE
72	Masonry wall, rear right corner, Memorial Hall adjoining public walkway and library.	<p>These images illustrate cracking to the masonry wall at the right rear corner of the Memorial Hall, adjoining the public walkway towards the library.</p> <p>This cracking appears to be approximately 8mm or less and extends from the top through 12 courses of brickwork to the walkway below.</p> <p><u>Additional repointing of colour matched mortar and caulking to cracked bricks is recommended.</u></p>

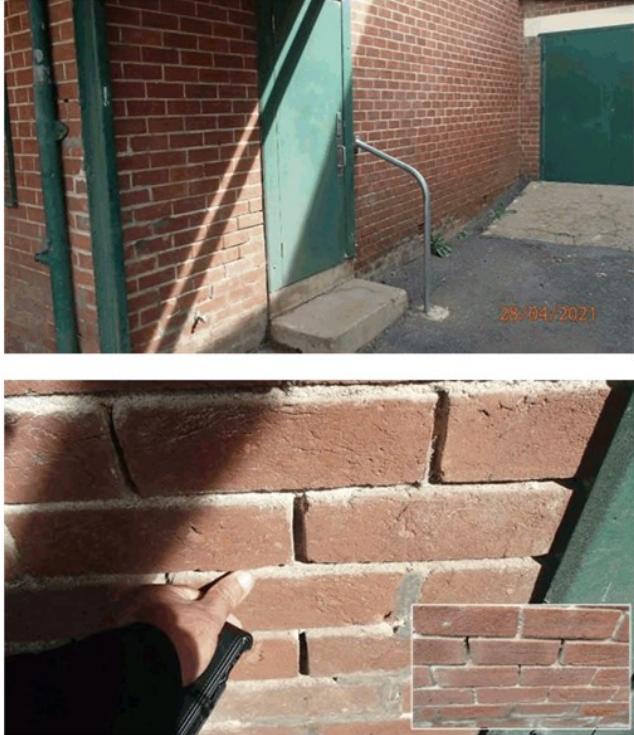
ITEM	LOCATION	DESCRIPTION / OVERVIEW / FINDINGS	IMAGE REFERENCE
73	Kitchen rear, right of Memorial Hall.	<p>These images illustrate the brickwork of the wall at the rear of the kitchen on the right-hand side of the Memorial Hall.</p> <p><u>There is visible deterioration to the brickwork mortar in this area and repointing in colour matched mortar is recommended.</u></p>

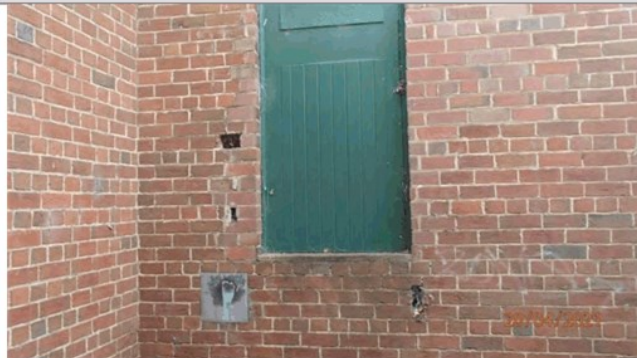
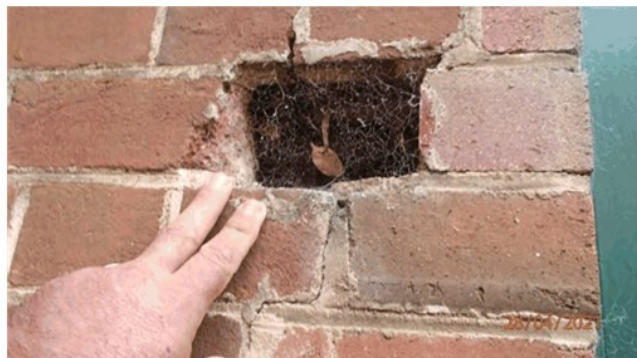
ITEM	LOCATION	DESCRIPTION / OVERVIEW / FINDINGS	IMAGE REFERENCE
76	Original external door, male toilets, right of Memorial Hall.	<p>These images illustrate an original external door to the male toilets on the right-hand side of the Memorial Hall stage, which has had the landing removed, resulting in penetrations in the brickwork.</p> <p>Consideration should be given to patching all penetrations in the brickwork to prevent moisture, and pest entry.</p> <p><u>Since there is no landing on the outside of the door the door should be locked permanently or removal of the door and bricking up of the opening is recommended.</u></p>

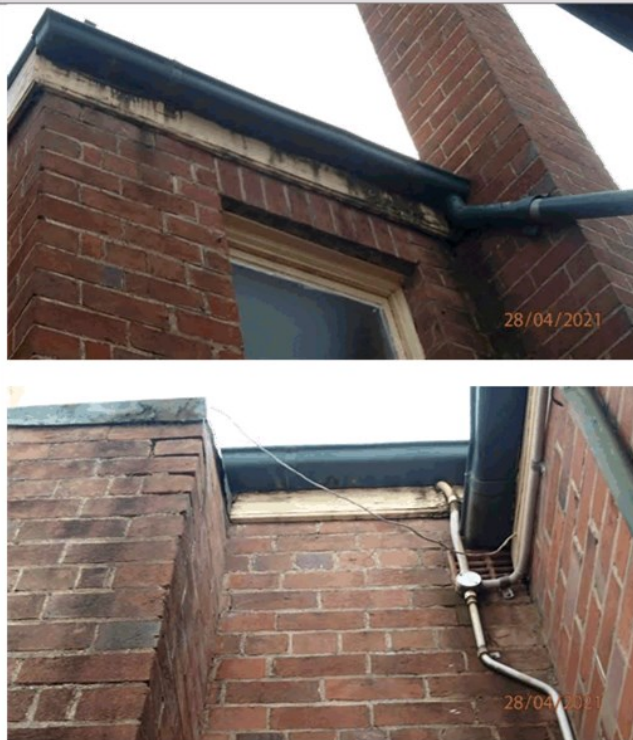
ITEM	LOCATION	DESCRIPTION / OVERVIEW / FINDINGS	IMAGE REFERENCE
77	Above, male toilets, right of Memorial Hall.	<p>These images illustrate water damage to the timber fascia with watermarks and staining to the adjoining brickwork resulting from leakage from the roof gutter over the male toilets facilities on the right-hand side of the Memorial Hall stage.</p> <p>The roof in this area was noted to have significant defects and consideration should be given to replacement of the entire roof sheeting along with timber fascia and new guttering.</p> <p><u>Additional cleaning to the brickwork is recommended.</u></p>

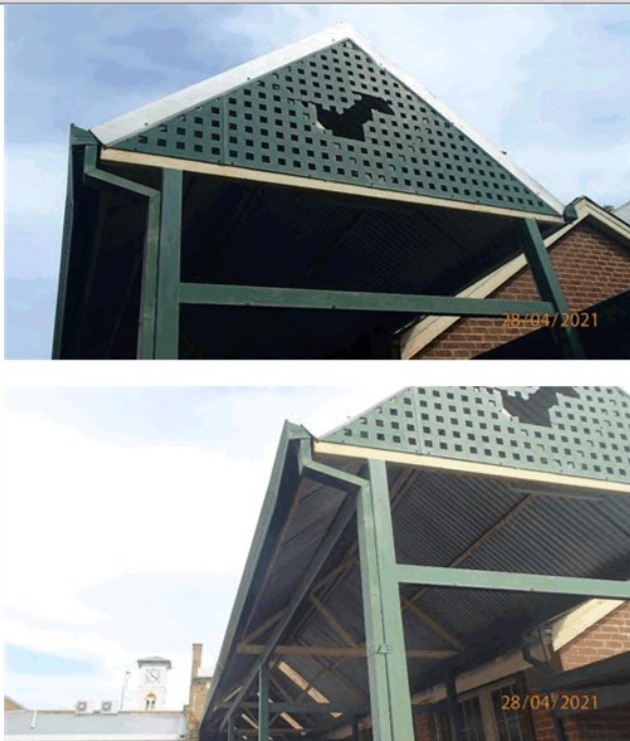
ITEM	LOCATION	DESCRIPTION / OVERVIEW / FINDINGS	IMAGE REFERENCE
78	Covered walkway, right of Memorial Hall leading to Library.	<p><u>There is visible damage to the gable and lattice screening of the covered walkway linked to the right-hand side of the Memorial Hall leading to the library.</u></p> <p><u>There is also evidence that the roof gutter on the right-hand side of the covered link has sagged.</u></p> <p><u>Adjustment to the roof gutter and support brackets is required.</u></p>

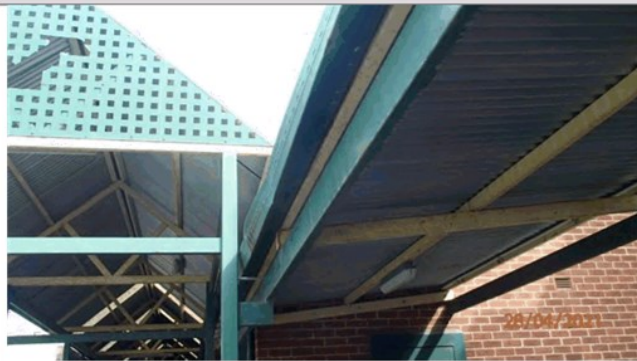
ITEM	LOCATION	DESCRIPTION / OVERVIEW / FINDINGS	IMAGE REFERENCE
79	Roof extending from Library to kitchen annex.	<p>The roof guttering servicing the roof extending from the public library to the kitchen annex displays evidence of deformation and damage.</p> <p><u>Consideration should be given to replacement of that section of guttering, along with improvements to the support brackets.</u></p>

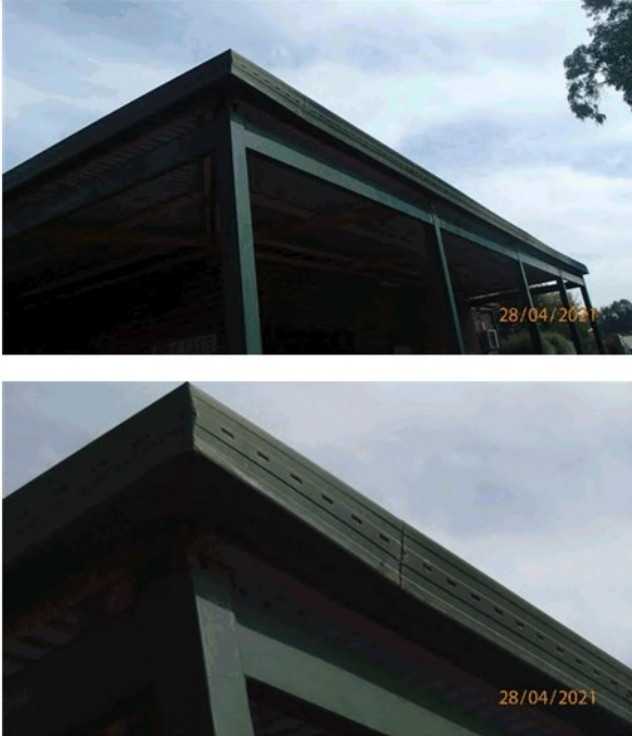
ITEM	LOCATION	DESCRIPTION / OVERVIEW / FINDINGS	IMAGE REFERENCE
80	Roof guttering, front public toilet facilities.	<p>The roof gutter at the front of the public toilet facility displays evidence of misalignment and leakage at the gutter joints, with excessive debris within the gutter itself.</p> <p><u>Consideration should be given to realignment of the gutter and support brackets along with periodic cleaning to remove debris and the potential for overflowing.</u></p>

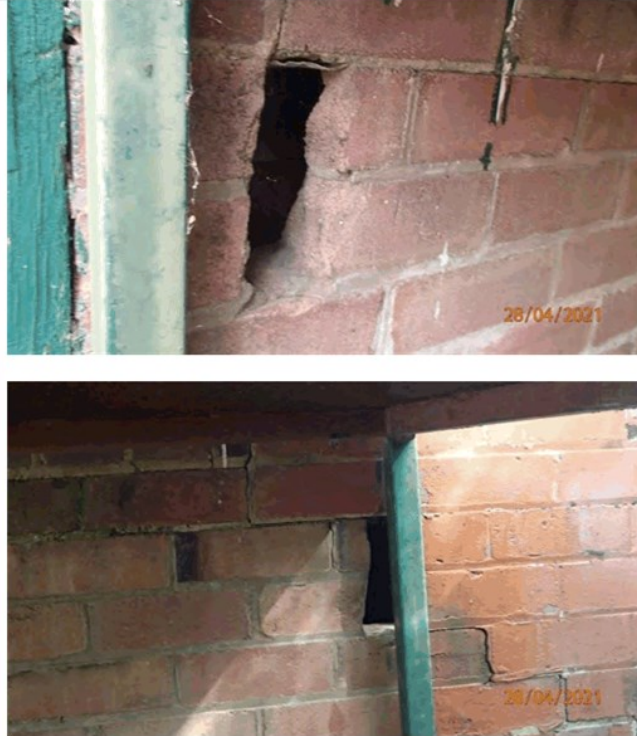
ITEM	LOCATION	DESCRIPTION / OVERVIEW / FINDINGS	IMAGE REFERENCE
87	Brickwork below steel landing, second service door, rear left of Library.	<p>There are holes in the brickwork below the steel landing servicing the second service door at the left rear corner of the library.</p> <p><u>Additional patching to the brick wall is required to prevent moisture, and pest entry.</u></p>

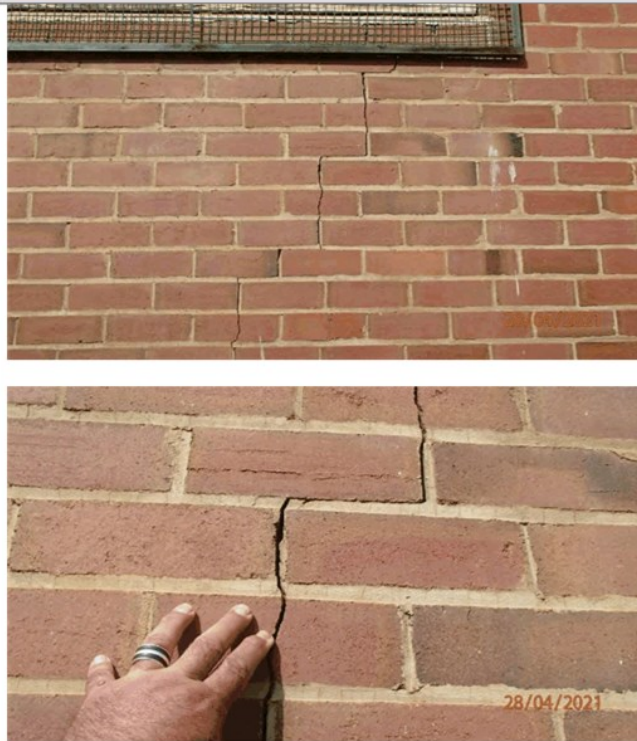
ITEM	LOCATION	DESCRIPTION / OVERVIEW / FINDINGS	IMAGE REFERENCE
89	Masonry wall below window, rear left corner of Library.	<p>These images illustrate cracking below the window of the library at the left rear corner of the building which emanates from the windowsill and radiates downwards through 17 courses of brickwork and presents with cracks of approximately 4mm or less in width.</p> <p><u>Additional patching of the mortar and sealing of the cracked bricks with colour matched caulking is recommended.</u></p>

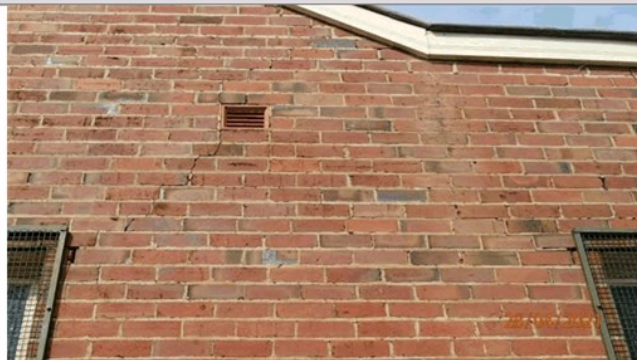
ITEM	LOCATION	DESCRIPTION / OVERVIEW / FINDINGS	IMAGE REFERENCE
91	Masonry wall, left side façade.	<u>This image illustrates cracking to the masonry wall radiating from the top corners of the library windows on the left-hand side façade. The cracks appear to be approximately 3 mm or less and additional patching of the mortar and sealing of the cracked bricks with colour matched caulking is recommended.</u>

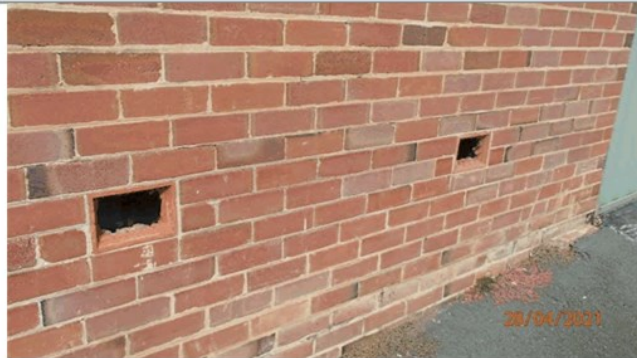
ITEM	LOCATION	DESCRIPTION / OVERVIEW / FINDINGS	IMAGE REFERENCE
92	Subfloor vents, rear of Library.	<u>This image illustrates damaged subfloor vents and consideration should be given to removal and replacement with new matching vents.</u>

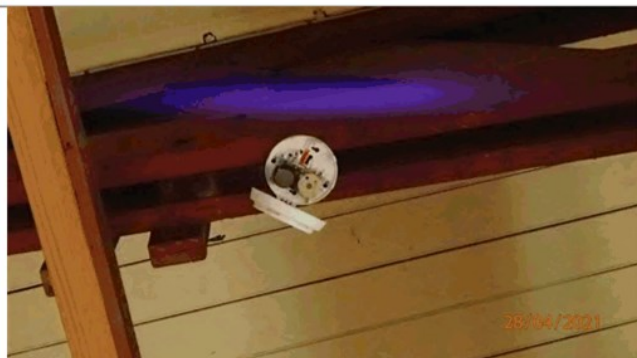
103	Stage.	<p><u>The smoke detector mounted on the timber truss located centrally within the stage requires servicing or replacement.</u></p>
