Aboriginal Consultative Committee Meeting

February 2009

5.1 Inclusions on the State Heritage Register relating to Yass Gorge
Attachment B Report on raising the Yass Dam wall

Yass Dam Raising

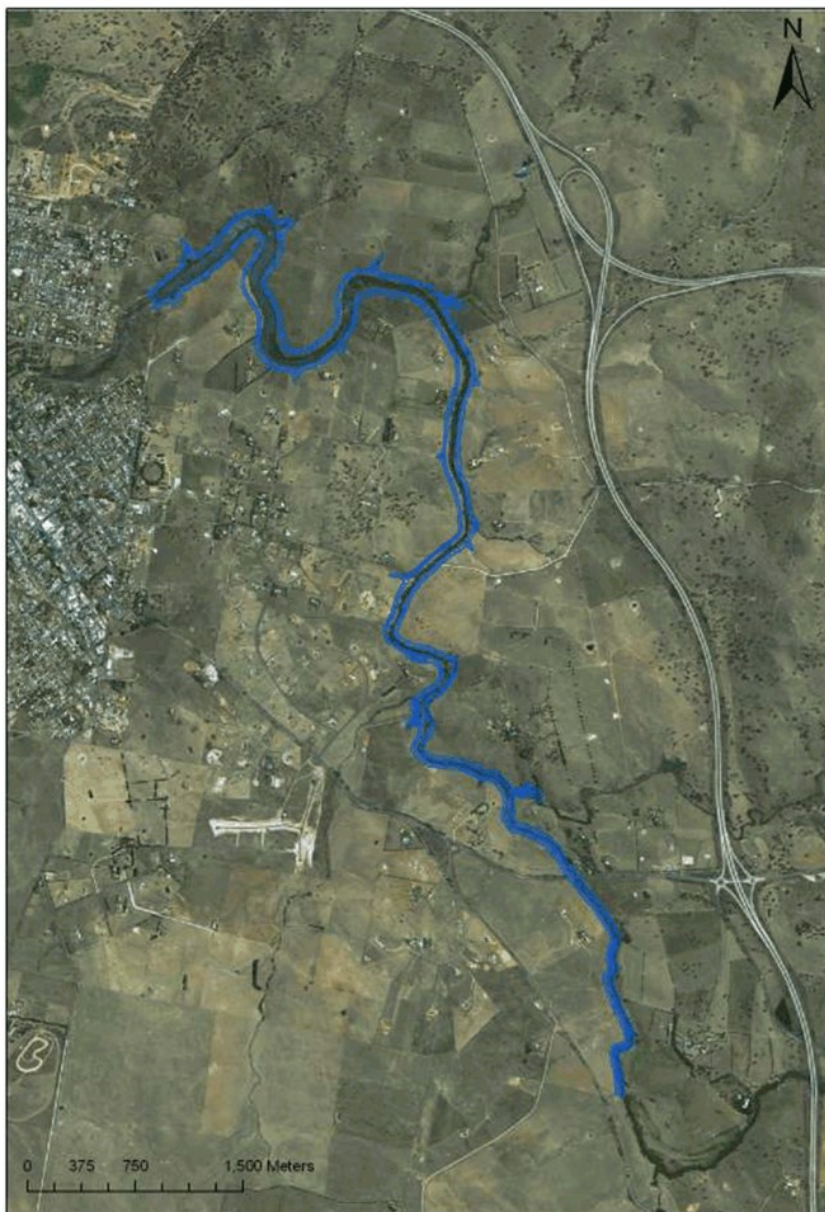
Figure 2. Location of proposed inundation area (supplied by Department of Commerce).

The lateral extent of the increased inundation is determined by the nature of the topography; where the landforms adjacent to the river are low lying and of low gradient the lateral inundation is greatest, while on the other hand where the landforms are elevated and of steeper gradients the lateral extent of the proposed inundation is minimal to negligible. It is noted that the majority of the terrain adjacent to the river is elevated and steep and accordingly increased lateral inundation will be minimal along the majority of the river affected by the proposal.

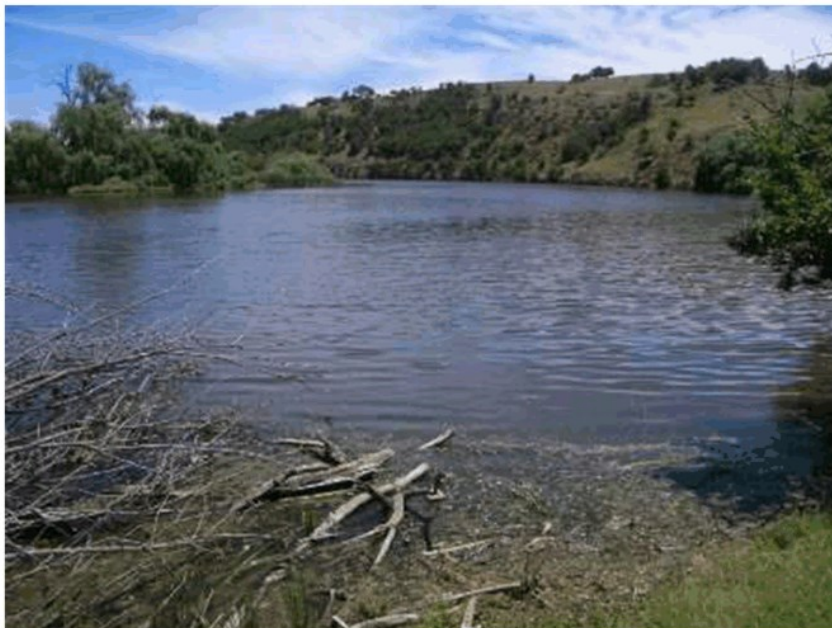
Plate 1. Northwest side of Yass River at c. 0.8 km upstream from dam wall; looking west. Note the steep, cliff like slope to river. The area of inundation at this location is in the order of c. 3m however on the northwest side the lateral extent of inundation in this area will be minimal.

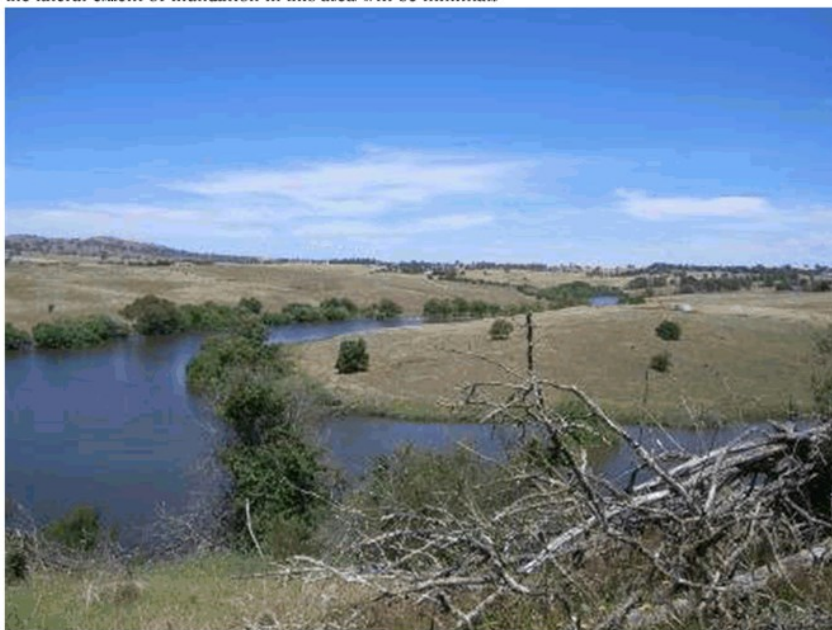
Plate 2. South side of Yass River at c. 0.8 – 1 km upstream from dam wall looking east. Note the gentler slope to river. The area of inundation at this location is in the order of c. 3m and according the lateral extent of inundation in this area will be in the order of c. 10-15 metres.

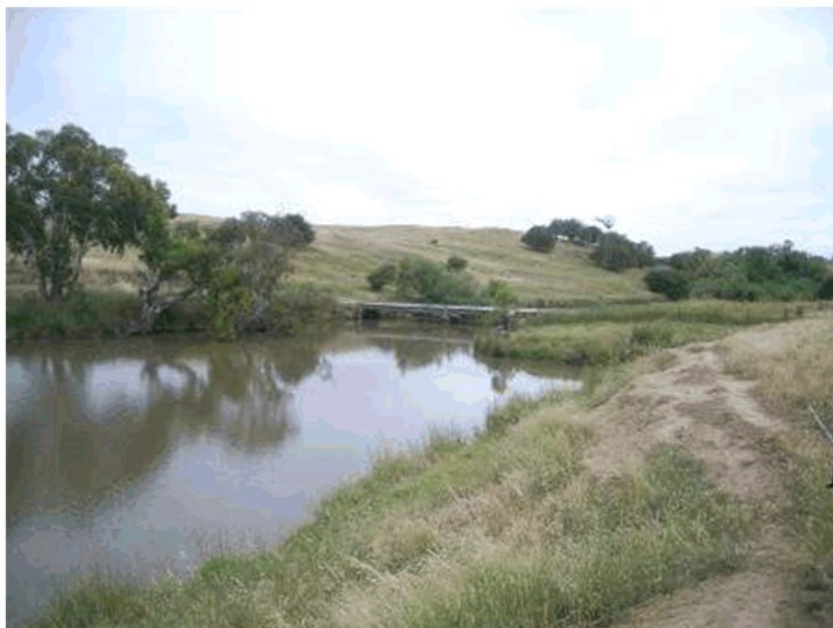
Plate 3. North side of Yass River at c. 5 km upstream from dam wall. Note slope to river. The area of inundation at this location is in the order of c. 1m and accordingly lateral extent of inundation, after water breaches the c. 1m high river bank, will be minimal.

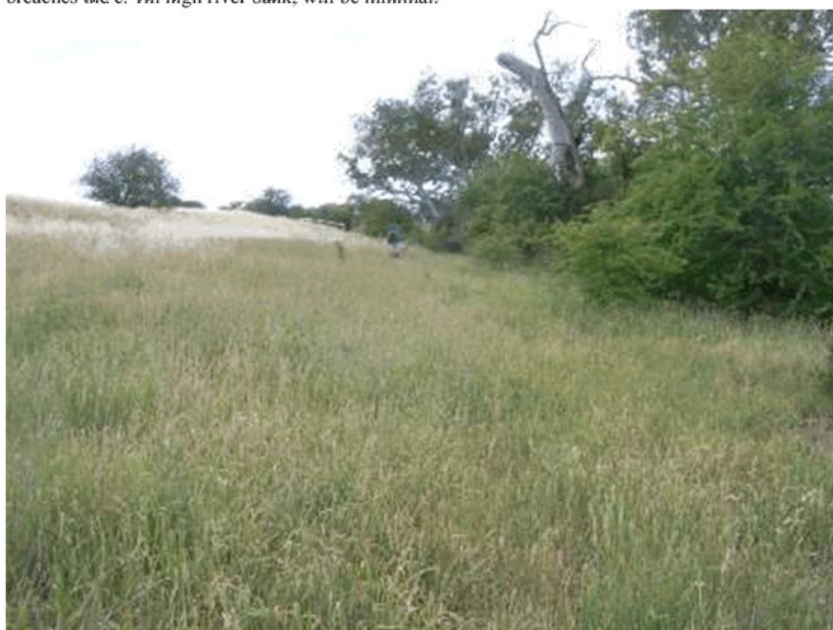
Plate 4. South side of Yass River at c. 8 km upstream from dam wall near Pearses Bridge. Note slope to river. The area of inundation at this location is in the order of c. 0.2m and accordingly lateral extent of inundation, after water breaches the c. 1m high river bank, will be negligible.

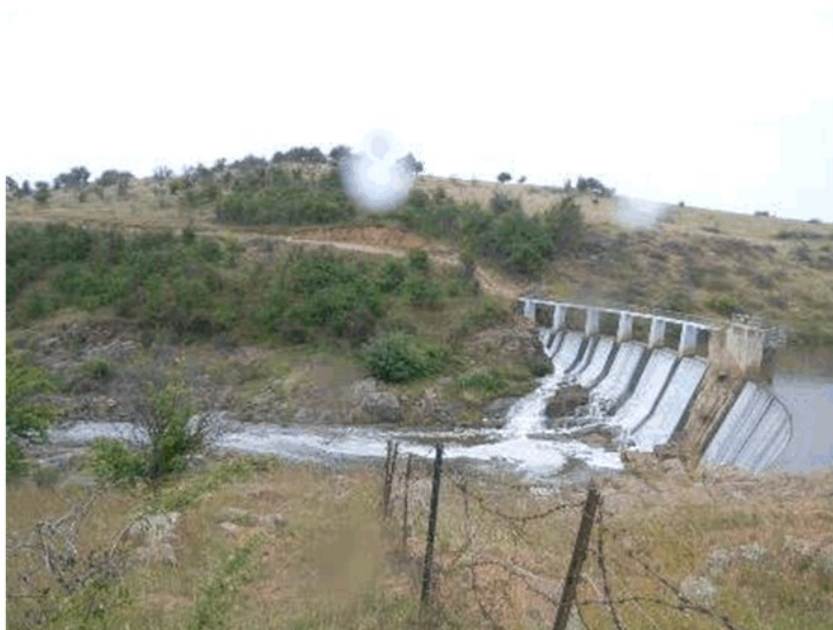
Plate 5. West side of dam wall showing existing cutting for track and vehicle parking.

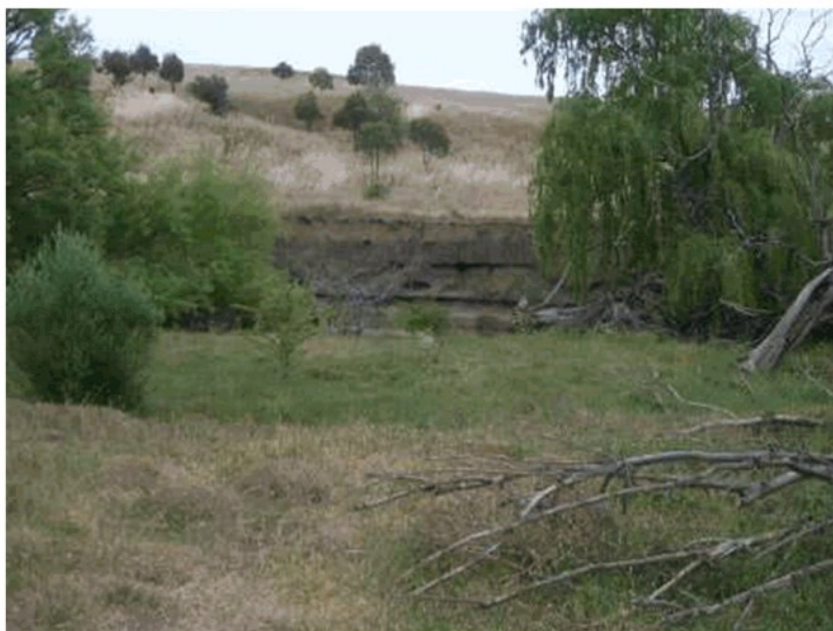
Plate 10. Active entrenchment of the Yass River c. 4 km upstream of the dam wall. Photo shows the sharp contact c. 60 cm below the ground surface between a recent deposit of Post Settlement Alluvium and a truncated B horizon.

Post Settlement Alluvium (PSA) is widely reported as covering the floodplains of creeks and streams in the region (Wasson *et. al* 1998). It is found to measure up to 1 - 3 metres in thickness and has been incised by modern channels rather than deposited overbank by these channels (see Plate 10).

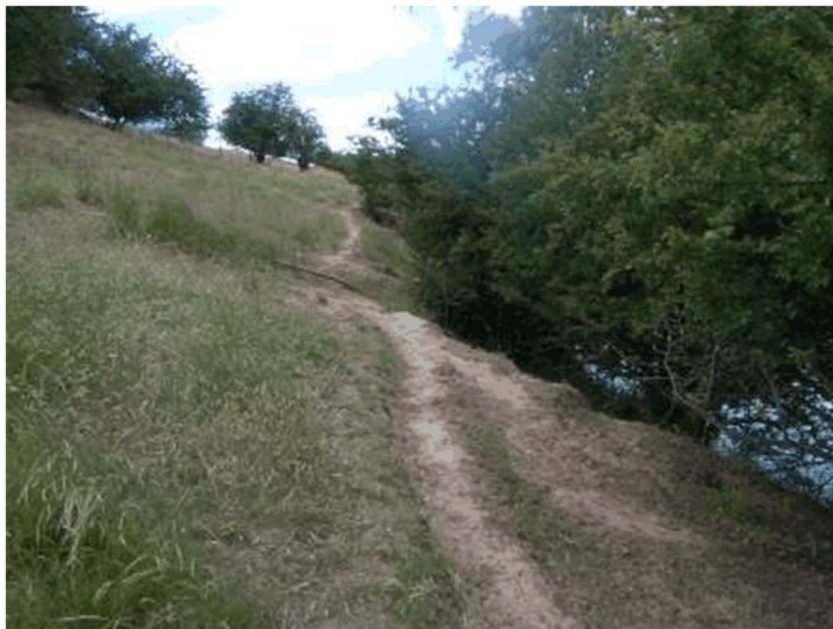
Plate 11. Stock trampling along river bank.

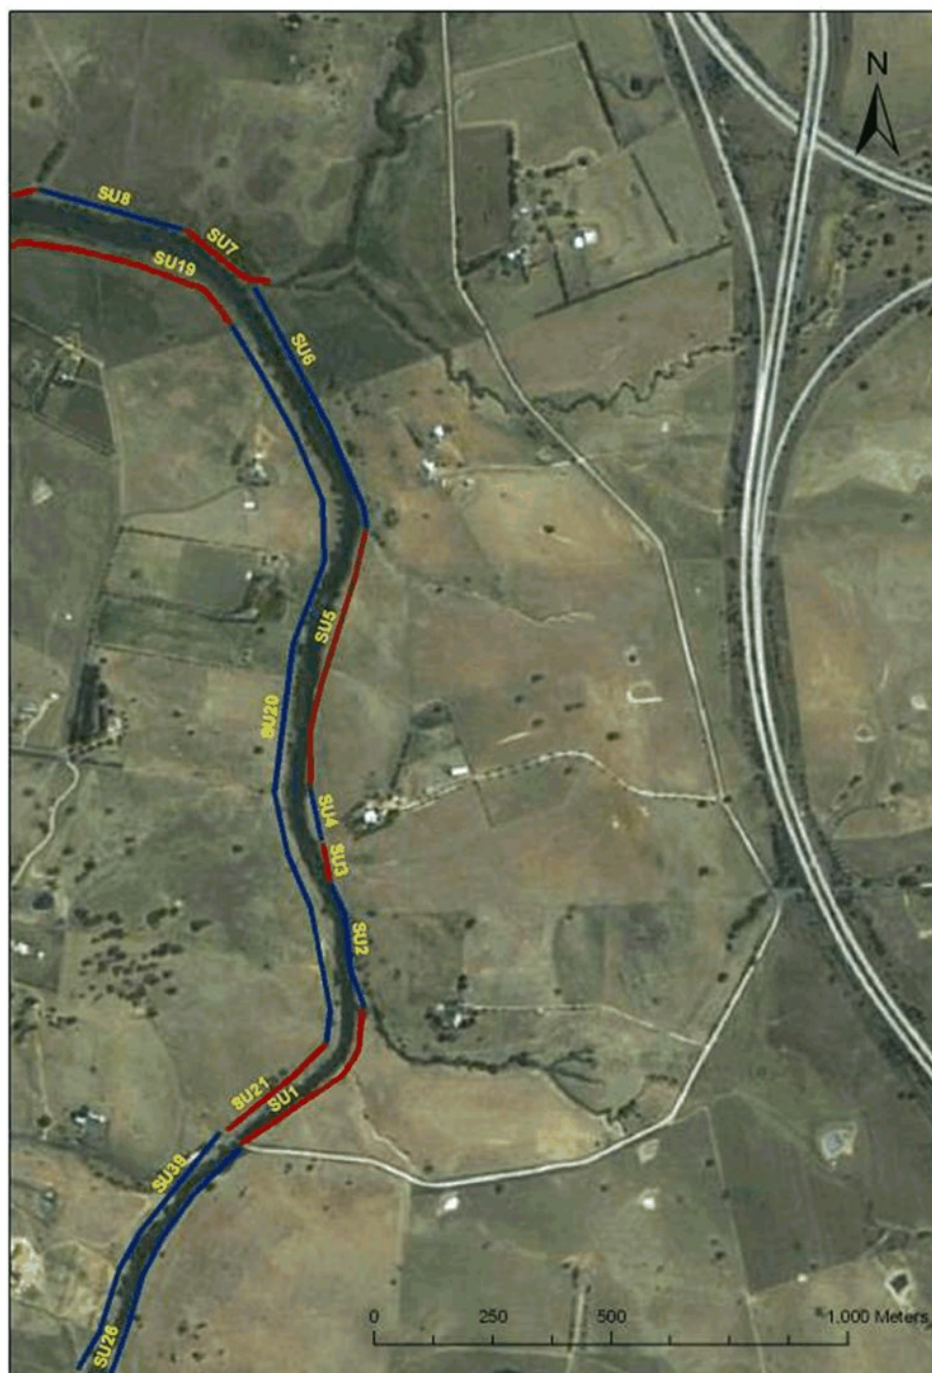
Figure 6. Survey Units and recorded locales in middle of inundation area.
