Yass Soldiers Memorial Hall Community Meeting

STRUCTURAL ENGINEERING REPORT ON CRACKING & SETTLEMENT

YASS MEMORIAL HALL & LIBRARY

88 COMUR ST, YASS N.S.W.

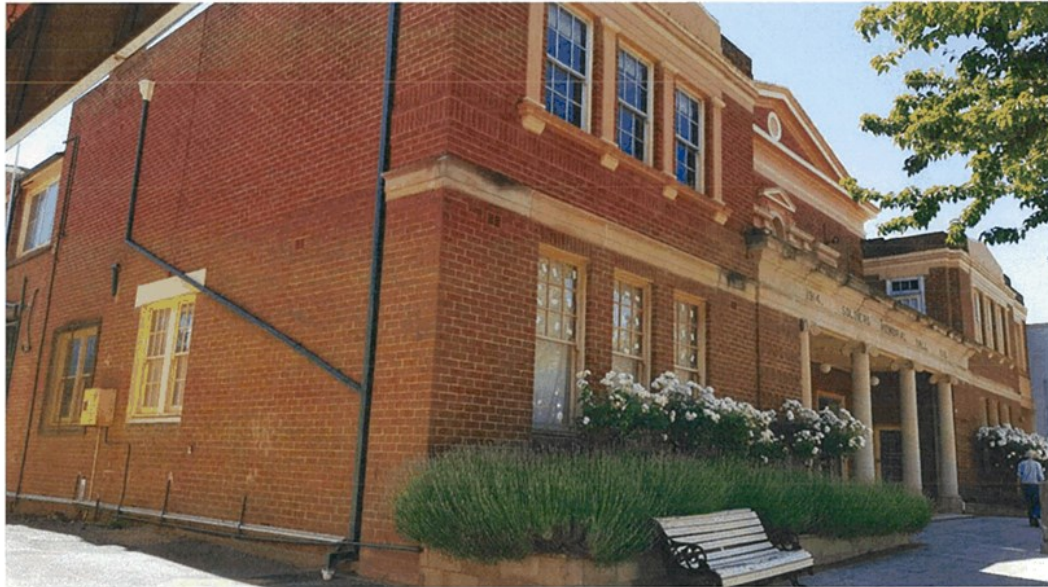
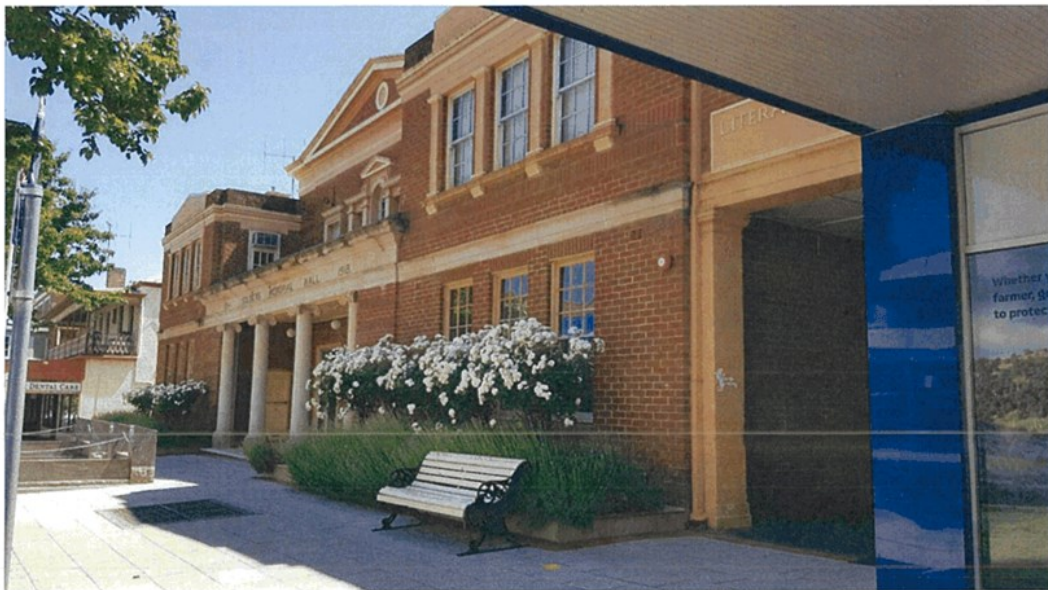
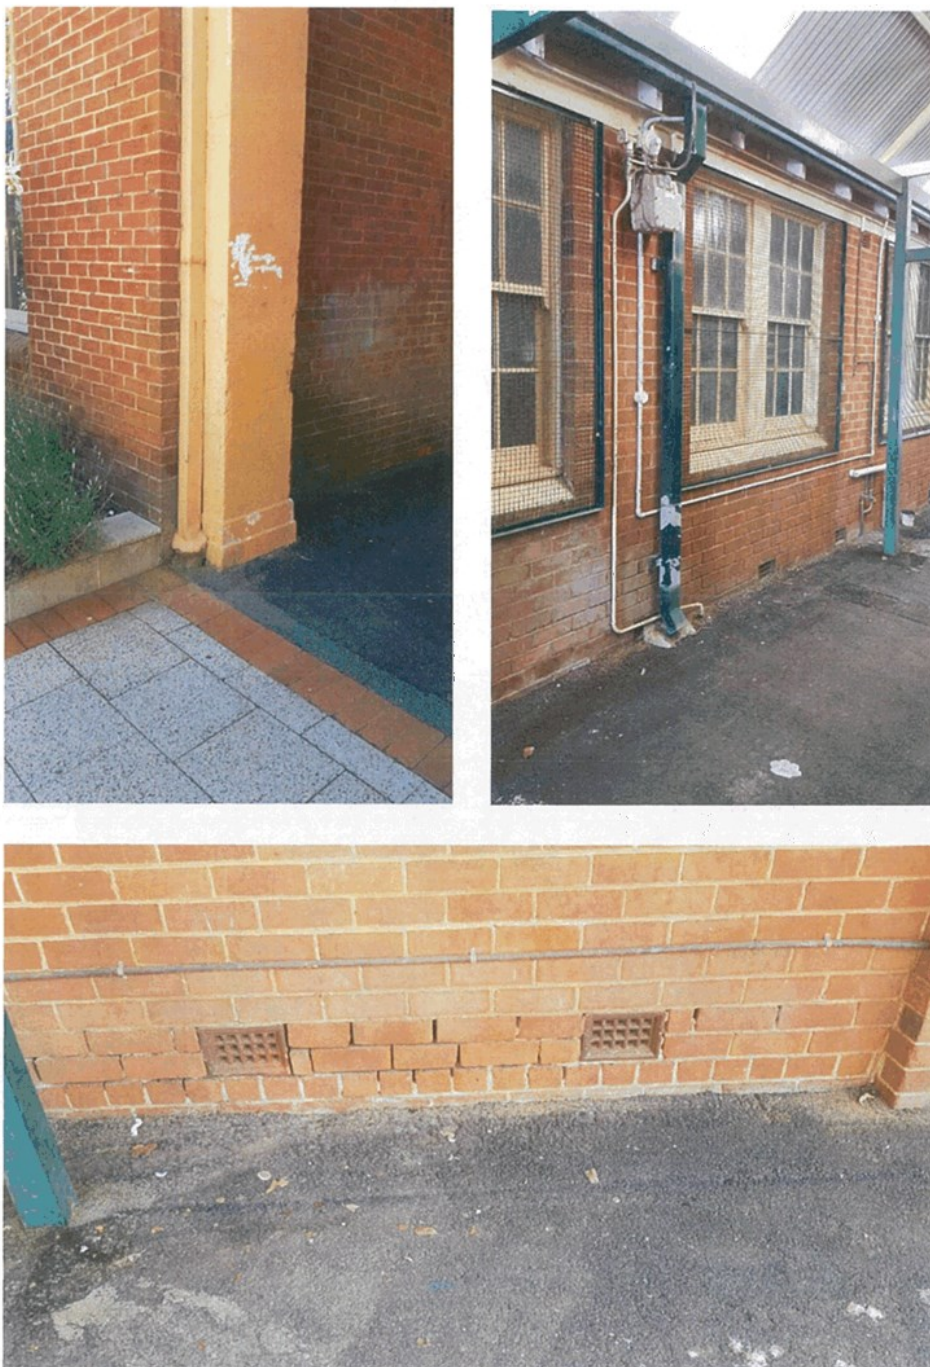
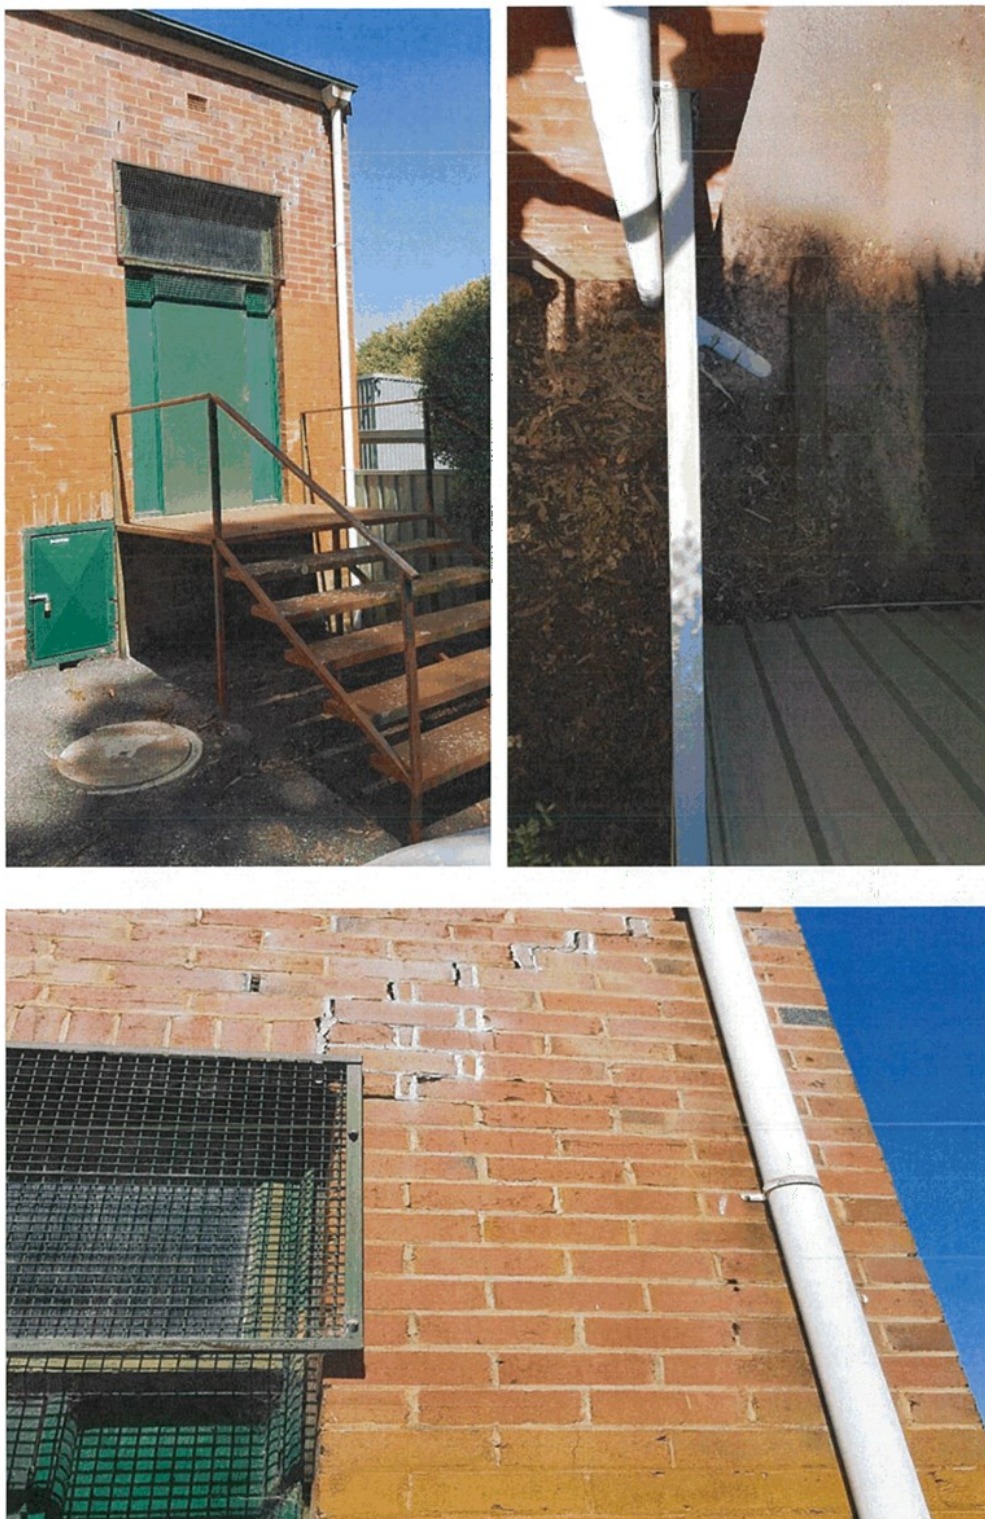
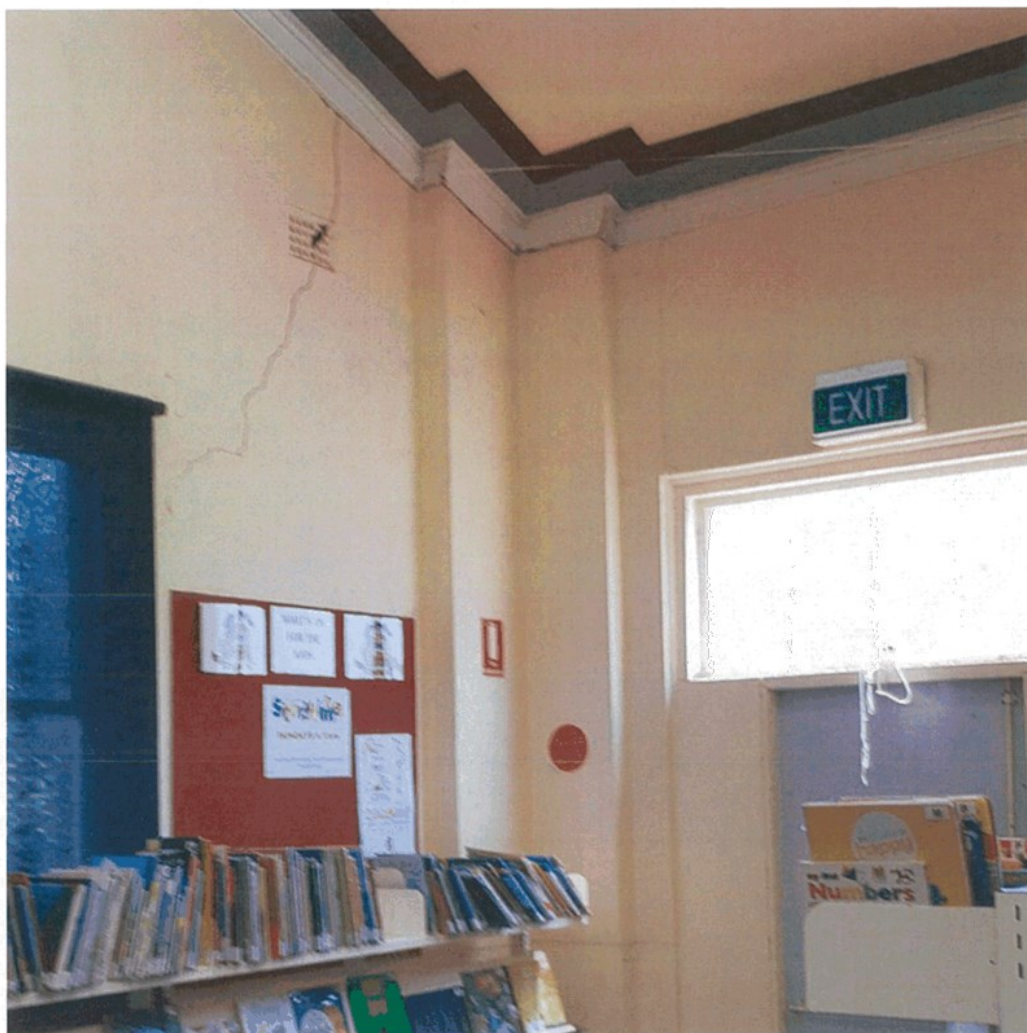
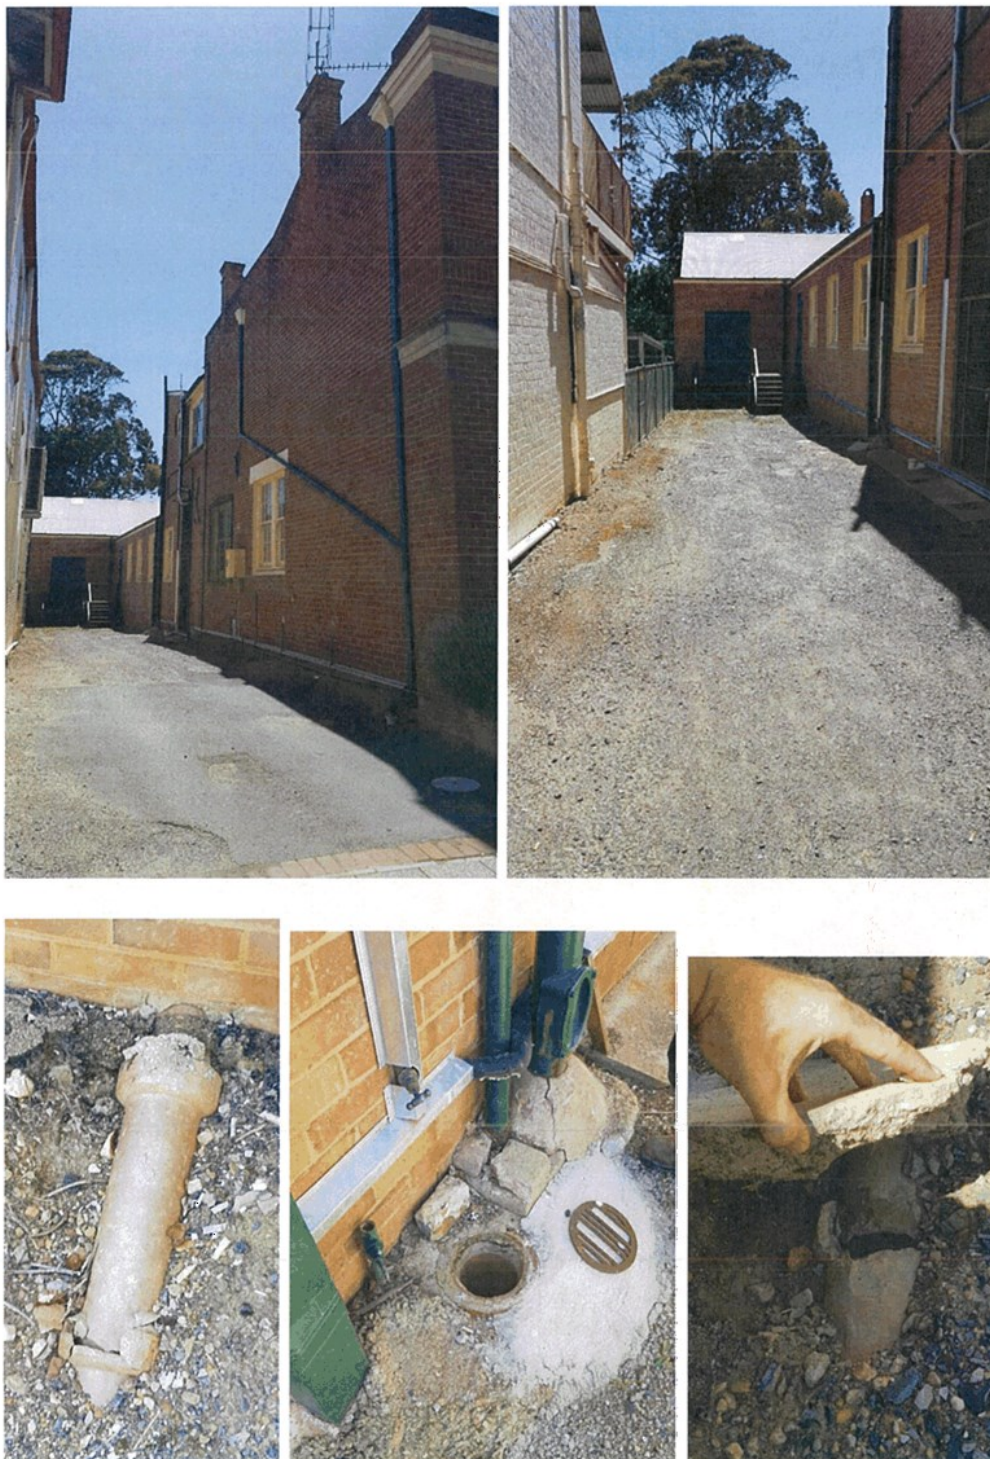
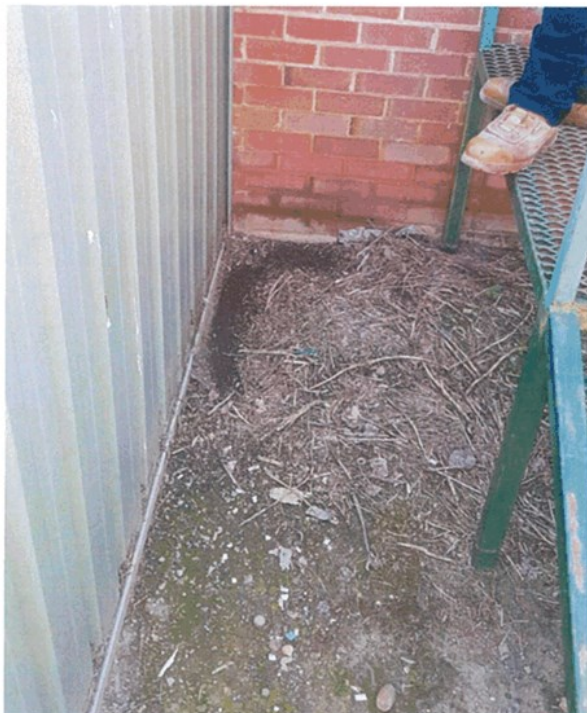
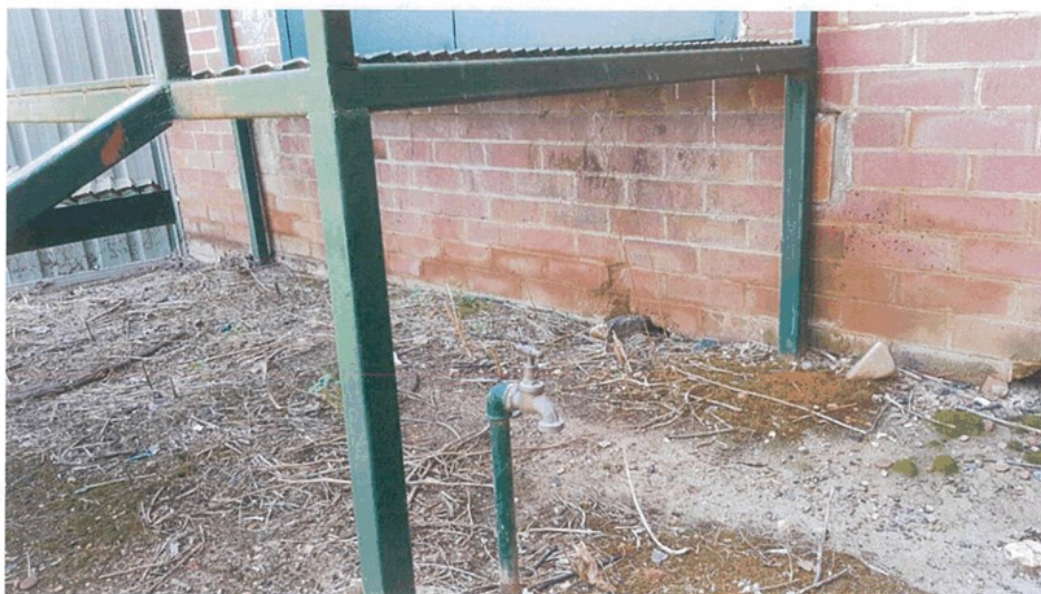
APPENDIX A – Photographs

- d. Minor cracking in the internal masonry walls can be seen throughout the entire interior of the building in order of 1mm width and up to approx. 2mm in some places. Such cracks are defined as Damage Category, *Very Slight* and *Slight* respectively in accordance with AS2870-2011 *Residential Slabs and Footings*.

- e. The external wall of *Annex 1* can be seen leaning outward approximately 40mm over its height. The timber roof structure is not showing evidence of distress and appears to be adequately restraining the wall at the top. Long term deflection and settlement of the timber roof structure is suspected to be the cause of the leaning wall. Previously repaired cracks are evident to the internal render of the external wall. Externally, the lime mortar is deteriorating and soft at the lower parts of the wall up to the level of the DPC, to depth of up to approx. 20mm. The clay masonry units are in sound condition.

- f. The North Eastern corner of the *Library* also has noticeable cracking in the wall. Externally, the current crack width on the Eastern elevation is in order of 10mm and previous repairs indicate a total movement since construction of approximately 30-40mm. Internally, cracking is evident of approximately 6mm on the Northern elevation. Internal cracking on the Eastern elevation is suspected to be concealed behind the vertical trim adjacent the door. Cracks being 5mm – 15mm wide are defined as *Moderate*, whilst cracks over 15mm are defined as *Severe* in accordance with AS2870-2011 *Residential Slabs and Footings*.

- g. The ground adjacent the North Eastern corner of the *Library* can be seen to have newly replaced stormwater as evident by the “new” UPVC pipework. The time on installation of this pipework is not well known but it an indication that the previous pipework was ineffective and likely leaking rain water into the ground. Additionally, a concrete manhole is seen adjacent the corner, which indicates a suspected deep network drainage pipeline for Stormwater or Sewer.

- h. The driveway area at the norther side of the building is seen to fall Westward towards the *Library*. Ponding of surface water is evident against the building. Much of the Stormwater and Sewer drainage in the area is seen to be repaired, altered or in some places damaged
