Ordinary Meeting of Council

GULLY REHABILITATION PLAN

66 BROOKLANDS ROAD
WALLAROO NSW 2618

Version 1
03 June 2020

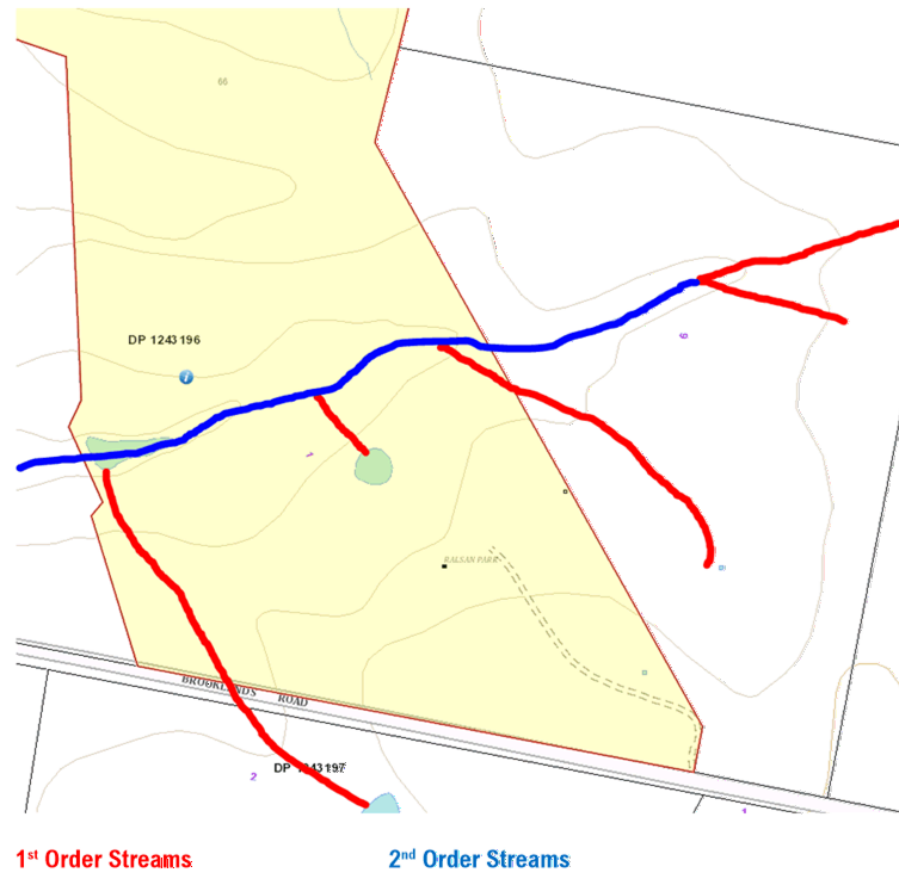
Figure 5: Stream Order

The gully sides to be rehabilitated are located on a 1st and 2nd order drainage depressions which combine to exit the downstream (western) property boundary, refer **Figure 5**. The drainage depression flows generally east to west to eventually join the Murrumbidgee River approximately 4.4 kms to the west, refer **Figure 4**. The catchment area for this gully sequence is moderate (62 hectares) and commences at the ridge which runs north south parallel to Southwell Road and crosses Brooklands Road refer **Figure 2**.

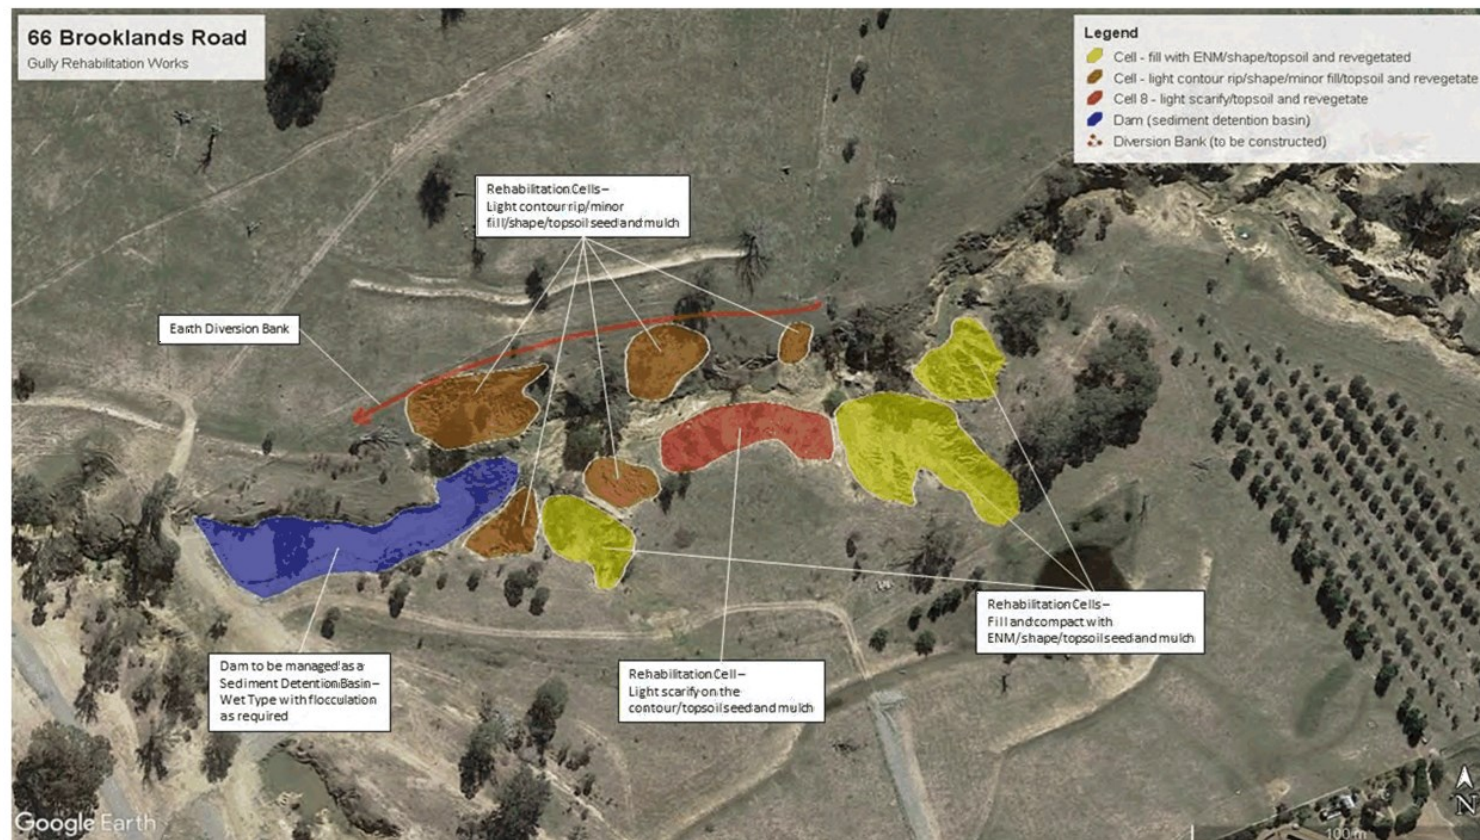
Figure 6: Gully Rehabilitation Plan

The gully reach to be rehabilitated consists of a deeply incised 2nd Order Stream with lateral incised 1st Order Streams which branch off to the south at three points. The reach starts at the upstream eastern boundary as an incised 2nd Order Stream and finishes in a large dam on the western boundary, refer **Figures 5 & 6**. The length of the reach is approximately 440 metres and depth of the gullies ranges between 2 and 6 metres and widths range from 5 metres to more than 20 metres.

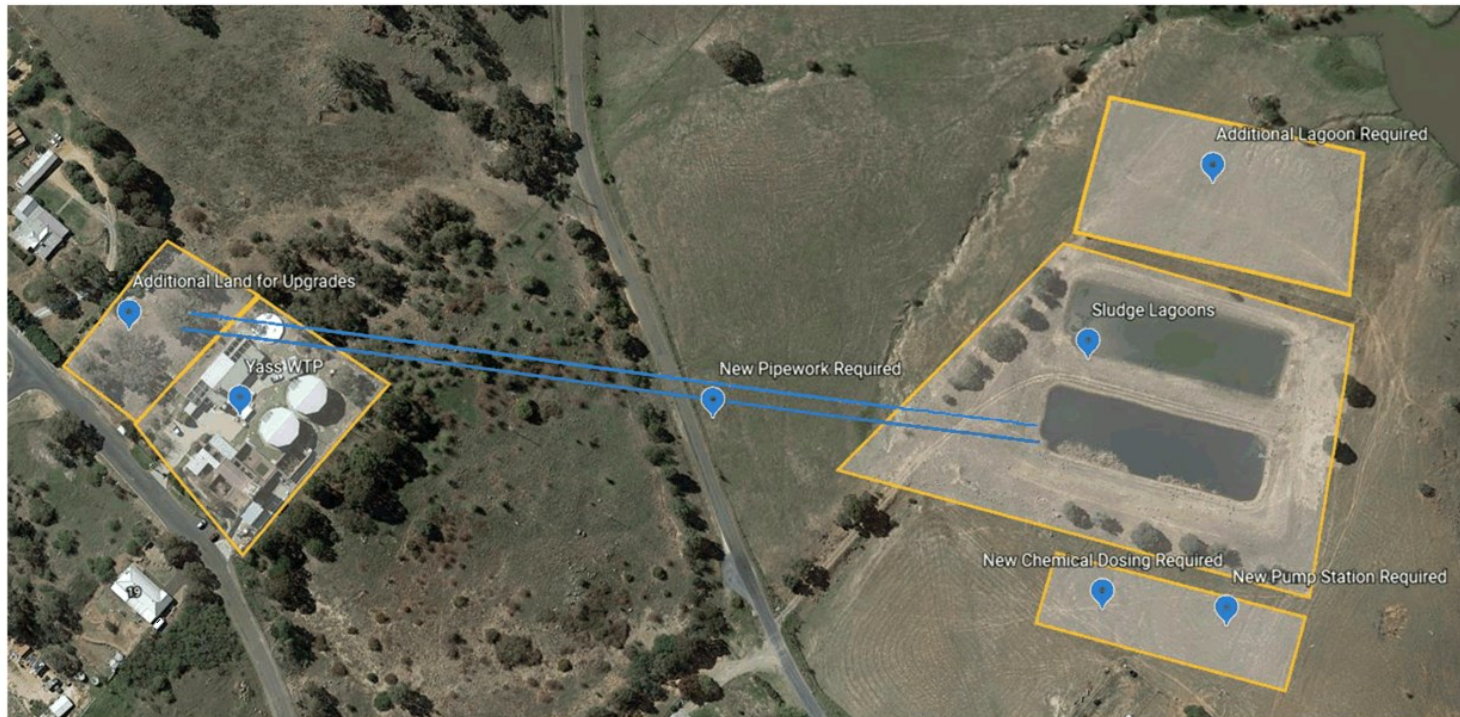
Figure 5-1 Additional equipment and space required for pre-treatment clarification

A visual representation of these upgrades is shown in Figure 5-1. The space required for additional pump stations, pipework, sludge lagoons, and chemical dosing systems is not available at the existing WTP site and would require procurement of additional land.

CWT does not recommend moving forward with consideration of this option as it has logistic, operational, and treated water quality issues.
