Yass Soldiers Memorial Hall Committee Meeting

5.1 Memorial Hall Dilapidation Report

SPECIAL PURPOSE INSPECTION DILAPIDATION REPORT

ADDRESS:	Yass Memorial Hall 82-94 Comur Street YASS NSW 2582
REPORT PREPARED FOR:	Yass Valley Council 209 Comur Street YASS NSW 2582
PHONE:	(02) 6226 1477
EMAIL:	Seamus.McGurk@yass.nsw.gov.au
DATE ATTENDED:	27 – 29 April 2021

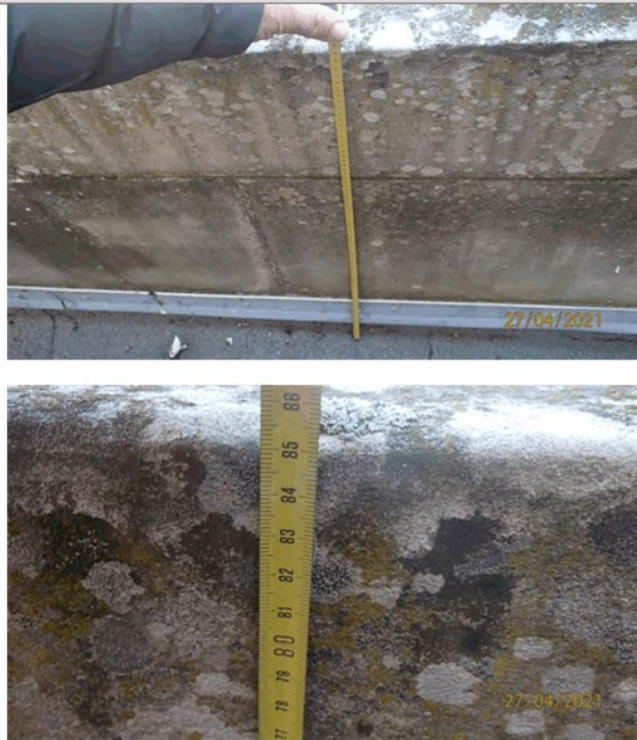
ITEM	LOCATION	DESCRIPTION / OVERVIEW / FINDINGS	IMAGE REFERENCE
2	First floor balcony above main entry to the Memorial Hall.	<p>The sandstone balustrade measures at 850mm in height from the finished balcony level.</p> <p><u>The minimum required balustrade height is 1000mm and consideration should be given to fitting a sympathetic value straight extension rail in order to achieve compliance with current building code requirements.</u></p>

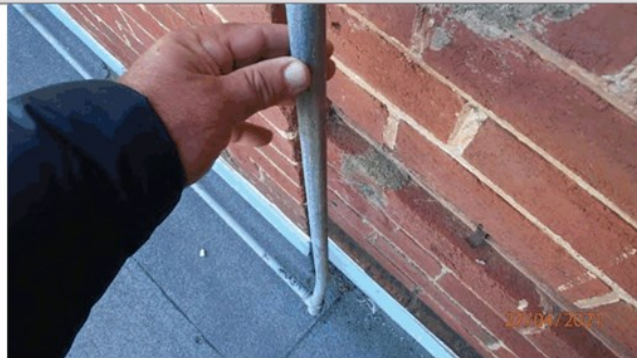
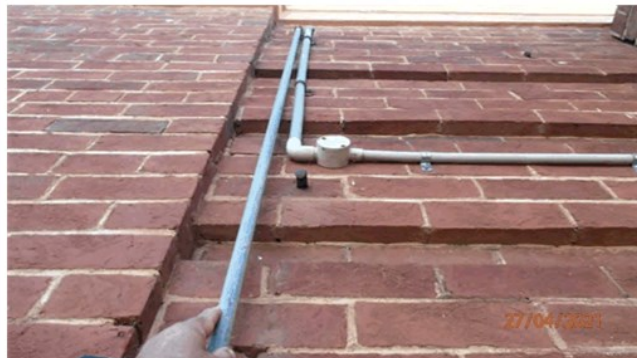
ITEM	LOCATION	DESCRIPTION / OVERVIEW / FINDINGS	IMAGE REFERENCE
4	Front façade, first floor balcony.	<p><u>Old, galvanised iron conduits/water pipes are surface mounted and not secured on the façade, and consideration should be given to removal.</u></p> <p><u>The electrical conduits that are surface mounted can also be seen which provide power for external power points and floodlights and consideration should be given to rerouting these, so they are not visible on the front elevation.</u></p>

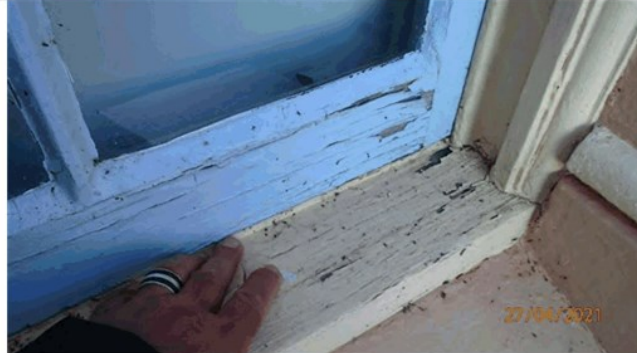
ITEM	LOCATION	DESCRIPTION / OVERVIEW / FINDINGS	IMAGE REFERENCE
6	Windows and doors facing first floor balcony.	<p><u>The external timber windows and doors facing the first-floor balcony present with weathering and deterioration to the paint finish and glazing party.</u></p> <p><u>These external timber elements could be treated holistically by stripping back old paint, conducting repairs and/or replacement of damaged timber elements and repainting for long-term protection.</u></p>

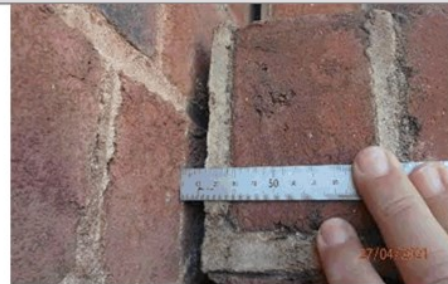
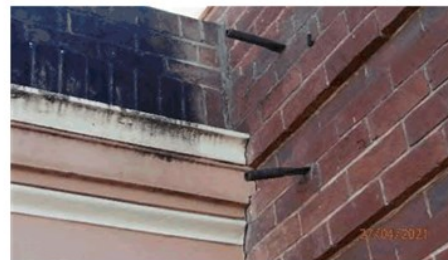
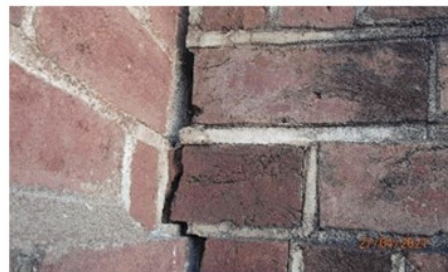
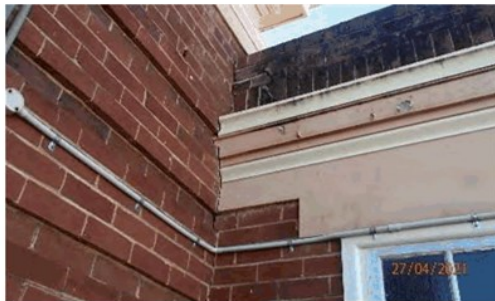
ITEM	LOCATION	DESCRIPTION / OVERVIEW / FINDINGS	IMAGE REFERENCE
7	Right side wall at balcony level.	<p>The right-side wall projection at balcony level presents with movement cracks between perpendicular walls, which was measured at approximately 12mm at the top of the wall (parapet level).</p> <p>The left side wall projection also displays some movement and cracking, along with previous patching, although it is not as significant as that observed on the right side.</p> <p>The crack width indicates the cracking is classified as Category 3. The NSW Guide to Standards and Tolerances, Part 3.2 Damage to masonry walls (Refer to Table 3.02 On Page 24) states the following:</p> <p><i>"Category 3 or greater damage to walls is defective and requires investigation, stabilisation, monitoring and rectification work, which may include breaking out and replacing sections of the wall."</i></p> <p>Smaller cracks can be sealed with a colour matched polyurethane to prevent moisture entry and accommodate future movement.</p>

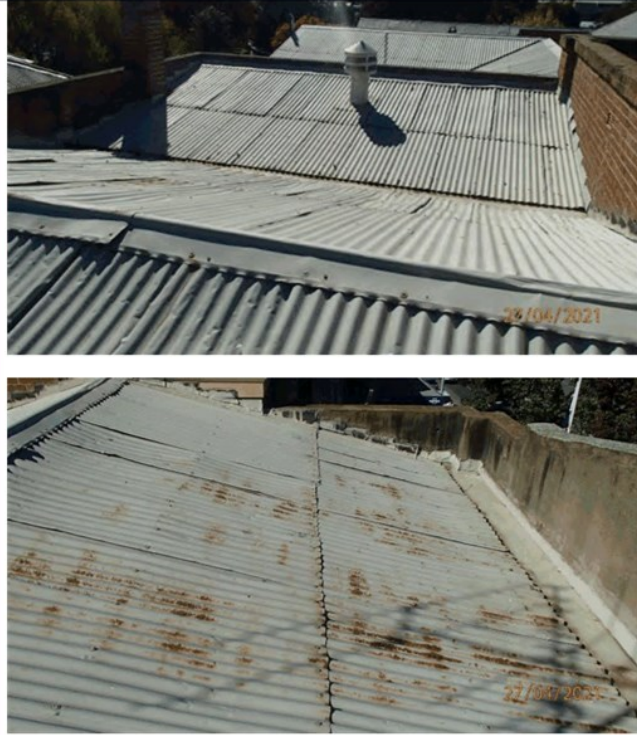
ITEM	LOCATION	DESCRIPTION / OVERVIEW / FINDINGS	IMAGE REFERENCE
ROOF			
8	Roof, front left corner over the meeting room on the first-floor level of the archive area.	<p>These images are an overview of the roof over the meeting room on the first-floor level of the archive area at the front left corner of the building.</p> <p><u>The corrugated roof sheet, capping and flashing presents with gaps in multiple areas and the shallow gutters lack depth and overflow provisions.</u></p>

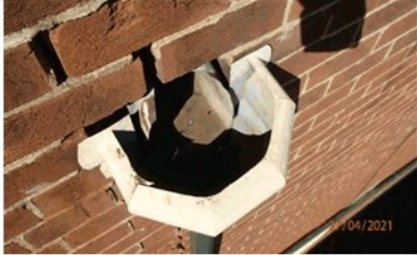
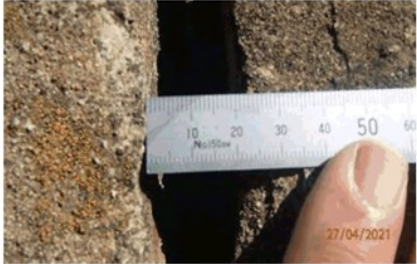
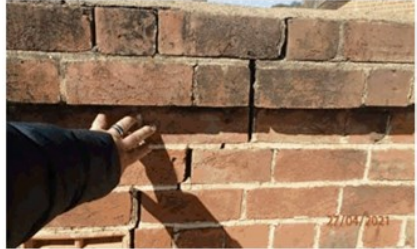
ITEM	LOCATION	DESCRIPTION / OVERVIEW / FINDINGS	IMAGE REFERENCE
10	Masonry parapet walls either side of valley gutter of the corrugated roofs at the front left corner of the building .	<p><u>There is evidence of cracking to the masonry parapet walls at either end of the valley gutter.</u></p> <p><u>This cracking extends the full height of the wall on the left side elevation and consideration should be given to providing an articulation joint in these areas.</u></p> <p>The crack width indicates the cracking is classified as Category 3. The NSW Guide to Standards and Tolerances, Part 3.2 Damage to masonry walls (Refer to Table 3.02 On Page 24) states the following;</p> <p><i>"Category 3 or greater damage to walls is defective and requires investigation, stabilisation, monitoring and rectification work, which may include breaking out and replacing sections of the wall."</i></p>

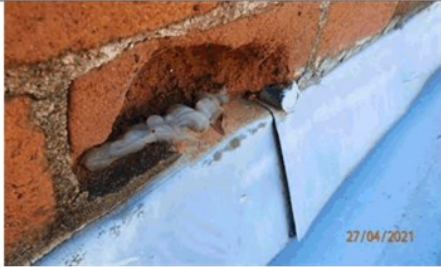
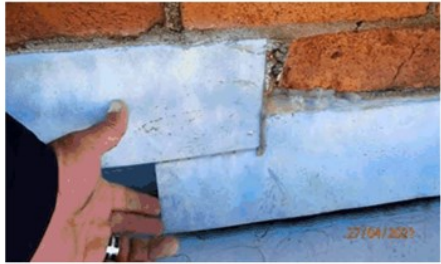
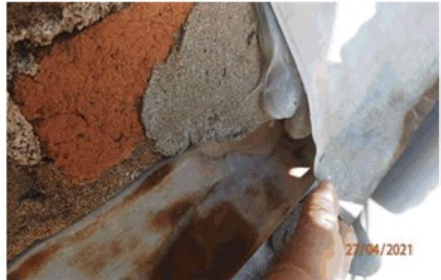
ITEM	LOCATION	DESCRIPTION / OVERVIEW / FINDINGS	IMAGE REFERENCE
14	Box guttering, corrugated roof over the archives and Memorial Hall mezzanine seating level.	<p>The box gutter servicing this roof has been replaced in the past, although there are still visible defects, gaps and fixing issues with the adjoining parapet flashing near the box gutter and around the perimeter of the roof.</p>

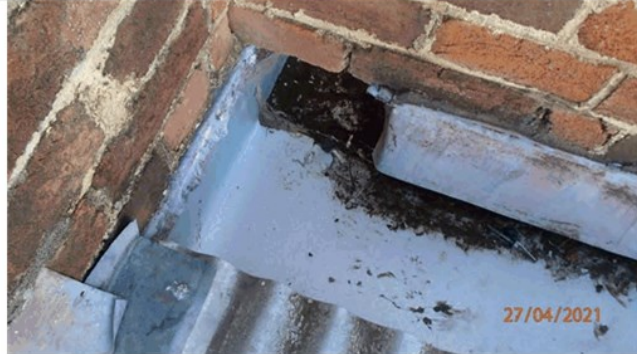
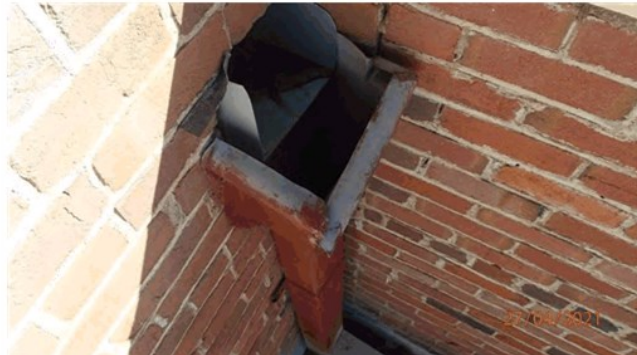
ITEM	LOCATION	DESCRIPTION / OVERVIEW / FINDINGS	IMAGE REFERENCE
16	Box gutter, corrugated roof over the archives and Memorial Hall mezzanine seating level.	<p>The box gutter is serviced by two main drainage points at either end of the roof which flow into rainwater heads on the other side of the parapet which then discharge onto roof valleys and roofs below.</p> <p>Every downstream overflow, rainwater head and downpipe is accepting more and more capacity from a larger roof area. Accordingly, these items need to increase in size in order to accept more consolidated roof areas, gutters and overall total water catchment.</p>

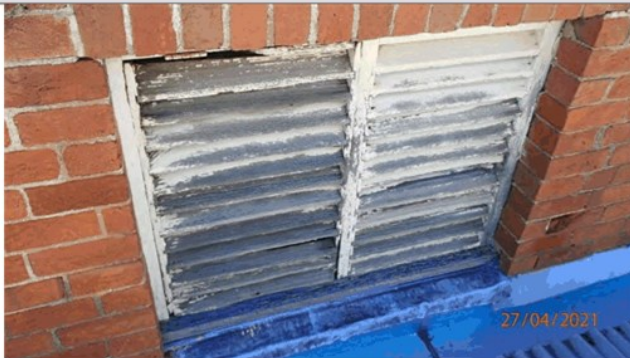
ITEM	LOCATION	DESCRIPTION / OVERVIEW / FINDINGS	IMAGE REFERENCE
17	Adjoining roof parapet over the main Memorial Hall.	<p>This image illustrates timber louvres built into the adjoining roof parapet which provides roof ventilation over the main Memorial Hall.</p> <p><u>The timber louvres presents with weathering and deterioration which requires maintenance, repairs and repainting for long-term protection.</u></p>

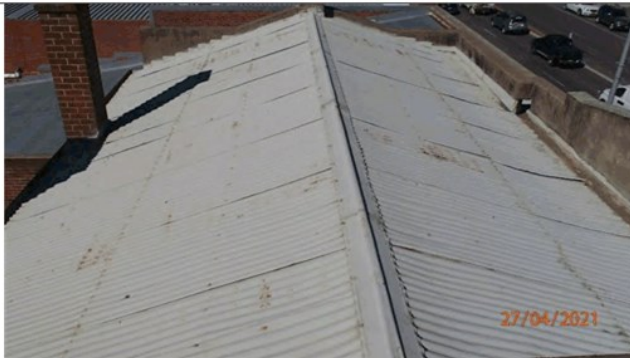
18	Pitched corrugated roof over the archive offices below, front right corner of the building.	<p>This image is an overview of the pitched corrugated roof over the archive offices below, front right corner of the building.</p> <p><u>This roof area suffers from significant leakage into the offices below and replacement of the roof sheeting, capping, flashing and guttering should be considered.</u></p>

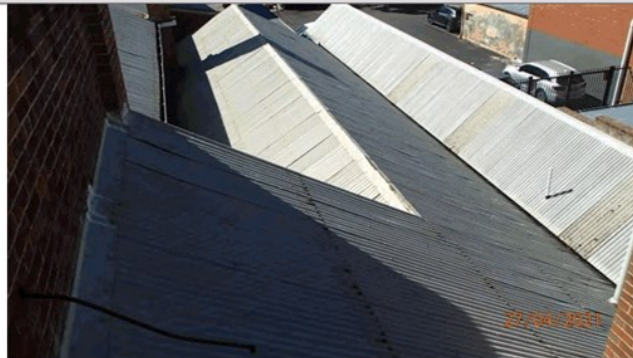
ITEM	LOCATION	DESCRIPTION / OVERVIEW / FINDINGS	IMAGE REFERENCE
19	Pitched corrugated roof, covered link, right-hand side of Memorial Hall building.	<p>This image is an overview of the pitched corrugated roof and covered link roof on the right-hand side of the building.</p> <p><u>This section of roof also presents with loose roof sheets fixing, indentation to roof sheeting, gaps between roof sheets, joints, visible gaps and defects to the apron flashing.</u></p>

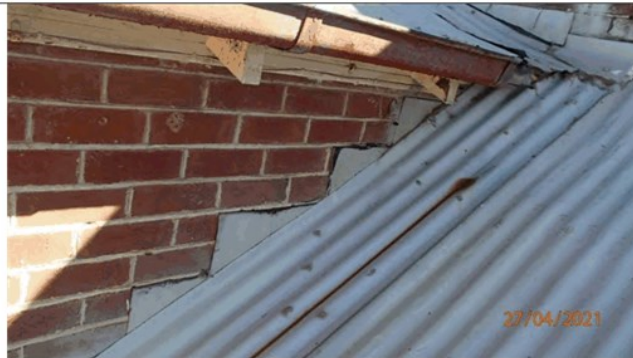
20	Pitched corrugated roof, covered link, right-hand side of building, Memorial Hall under discharge joint for the roof gutter.	<p><u>This image illustrates a makeshift patch of roof sheeting adjoining the original stepped apron flashing which has not been installed correctly and secured with screws, which are not proper roofing screws and have been sealed with sealant. It is located underneath the discharge point for the roof gutter above which corresponds with previous leakage below.</u></p>

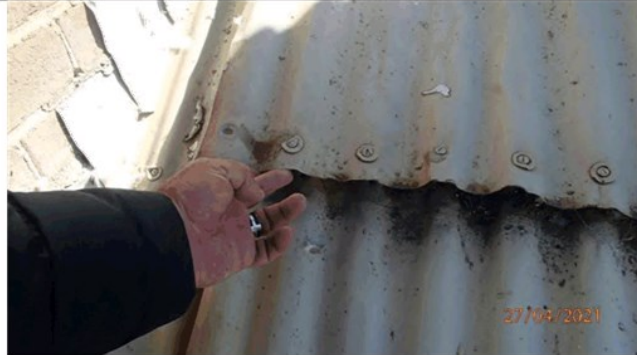
ITEM	LOCATION	DESCRIPTION / OVERVIEW / FINDINGS	IMAGE REFERENCE
21	Pitched corrugated roof, covered link, right-hand side of Memorial Hall building.	<u>This image illustrates loose roof sheeting over the same section of roof as shown in the images above.</u>

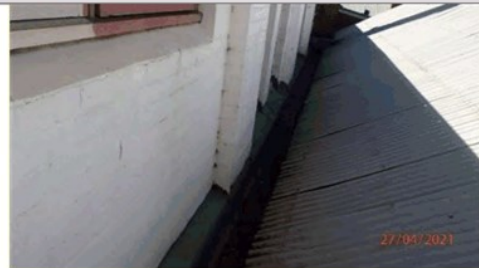
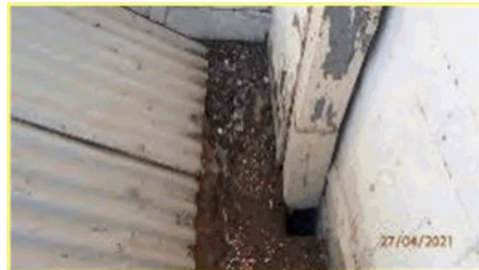
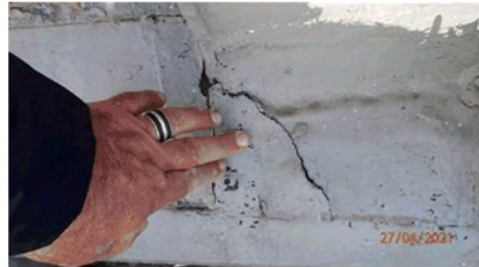
ITEM	LOCATION	DESCRIPTION / OVERVIEW / FINDINGS	IMAGE REFERENCE
22	Annex 1 - Pitched roofs right side of the main Memorial Hall.	<u>The pitched roofs on the right side of the main Memorial Hall are serviced by a box gutter which presents with areas of inadequate fall, significant cracking and deterioration to adjoining windows sill flashing and numerous potential bypass leakage points at the junction of the roof sheeting and gutter itself, where significant gaps between sheets are visible.</u>

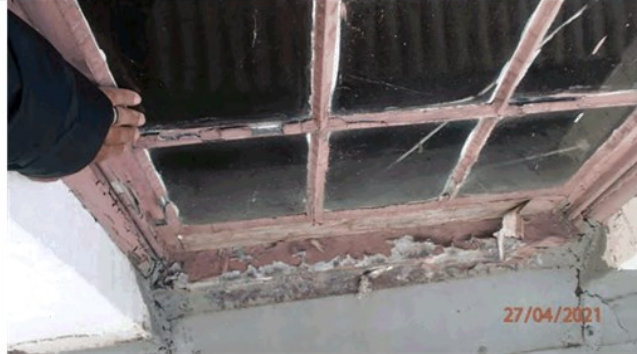
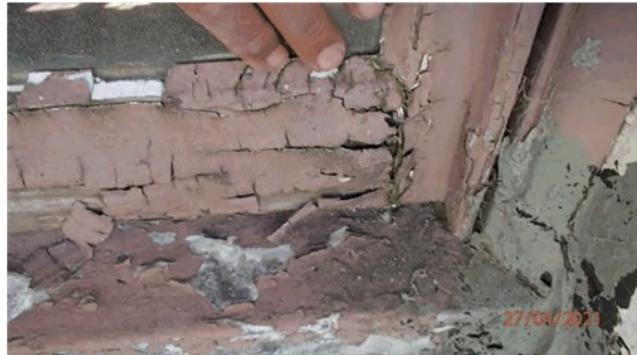
ITEM	LOCATION	DESCRIPTION / OVERVIEW / FINDINGS	IMAGE REFERENCE
23	Upper level windows, main Memorial Hall.	<u>The upper level windows of the main Memorial Hall present with significant weathering and deterioration which requires significant maintenance and repairs, and painting for long-term protection.</u>

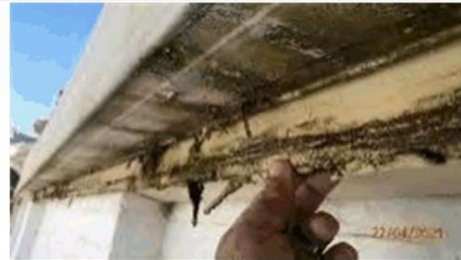
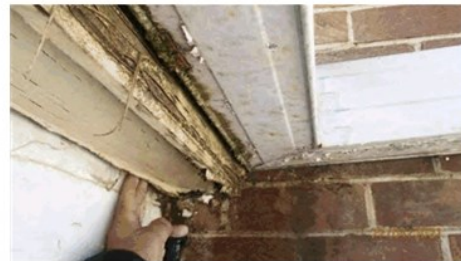
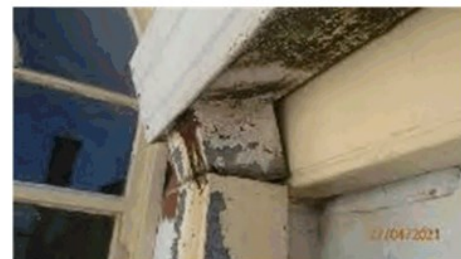
ITEM	LOCATION	DESCRIPTION / OVERVIEW / FINDINGS	IMAGE REFERENCE
24	Timber fascia and gutters, main Memorial Hall.	<p><u>The timber fascia on the edge of the main Memorial Hall roof presents with significant weathering and deterioration from numerous gutter leakage points.</u></p> <p><u>Consideration should be given to replacement of this section of fascia with a more durable colorbond fascia trim.</u></p> <p><u>The roof gutters themselves present with leakage sagging and consideration should be given to replacement.</u></p>

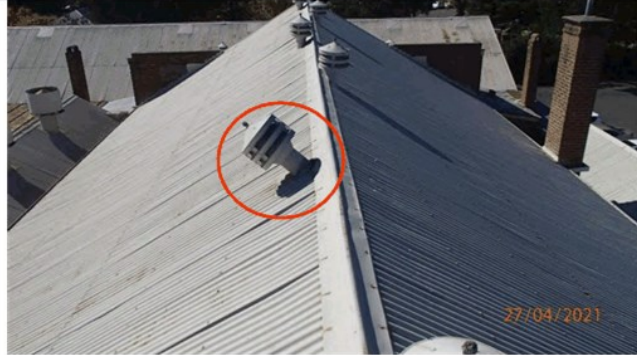
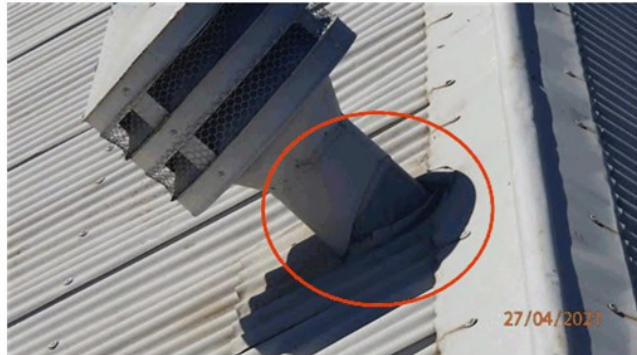
ITEM	LOCATION	DESCRIPTION / OVERVIEW / FINDINGS	IMAGE REFERENCE
26	Main Memorial Hall, pitched roof.	<p><u>These are overview images of the main Memorial Hall pitched roof, which presents with the same defects as other corrugated pitched roofs.</u></p> <p><u>One of the roof vents is not secured properly and tends to lean over creating gaps around the surrounding flashing, creating potential bypass leakage points.</u></p> <p><u>The area below this exhaust shows water marks to the ceiling lining and staining to the floorboards within the Memorial hall.</u></p>

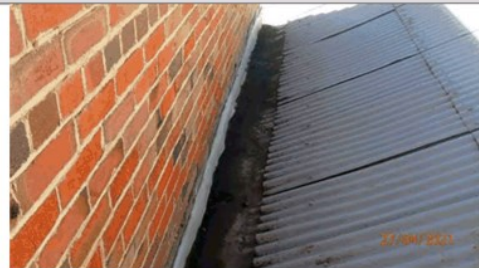
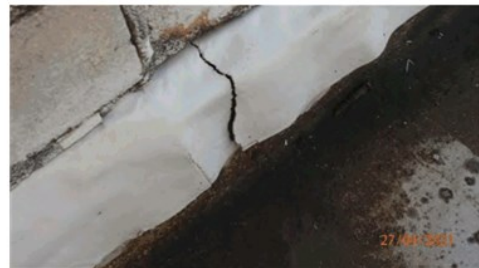
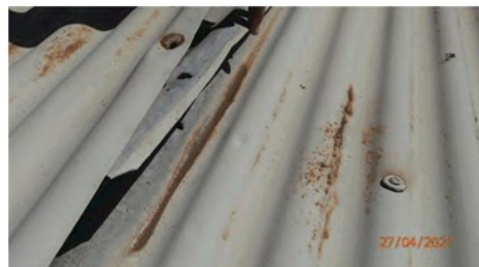
ITEM	LOCATION	DESCRIPTION / OVERVIEW / FINDINGS	IMAGE REFERENCE
28	Main Memorial Hall roof.	<u>The main Memorial Hall roof is pitched towards an adjoining brick wall, which is serviced by a box gutter that presents with cracking to the joining apron flashing, along with gaps to the adjoining sheeting which corresponds with the leakage evidenced to the ceiling below.</u>

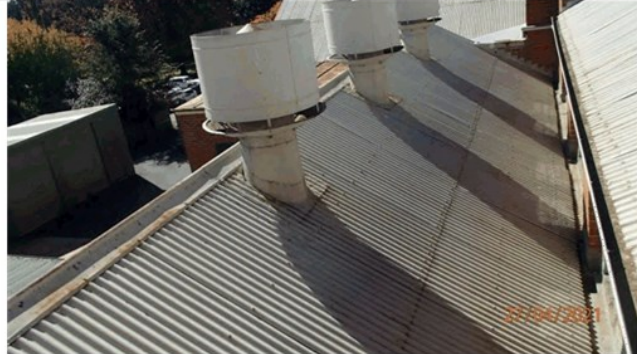
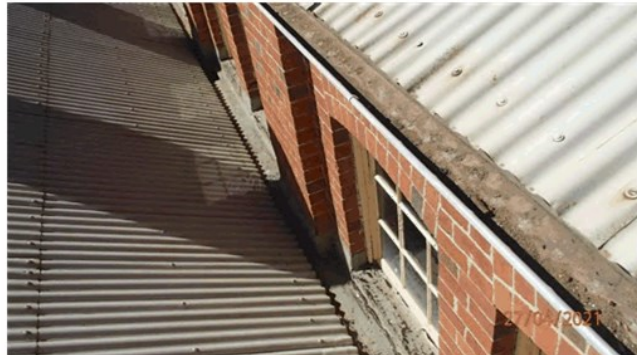
ITEM	LOCATION	DESCRIPTION / OVERVIEW / FINDINGS	IMAGE REFERENCE
29	Annex 2 - Pitched corrugated roof, left-hand side of main Memorial Hall roof.	<u>The pitched corrugated roof on the left-hand side of the Memorial Hall main roof (marked as Annex 2 on the floor plans) presents with the same gutter, flashing, fascia and window deterioration issues.</u>

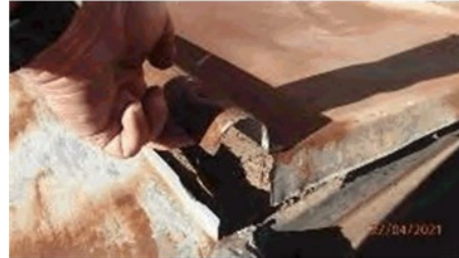
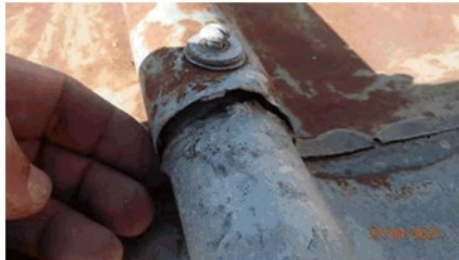
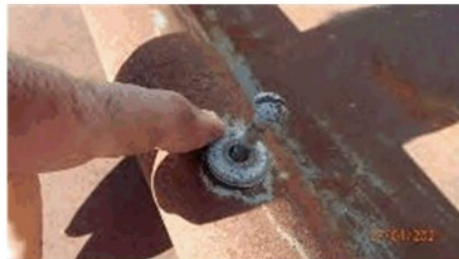
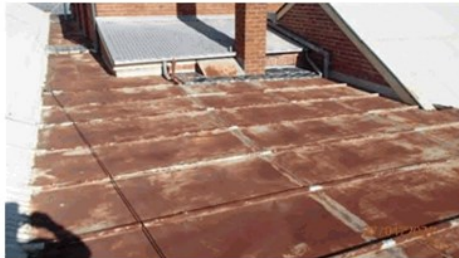
ITEM	LOCATION	DESCRIPTION / OVERVIEW / FINDINGS	IMAGE REFERENCE
30	Flat metal deck roof over storage facility left rear of memorial hall.	<u>The flat metal deck roof over the storage facility at the rear of the library presents with surface corrosion, loose screw fixings with roofing sheets and gaps between sheet joints which are all potential bypass leakage points which require additional maintenance and repairs.</u>

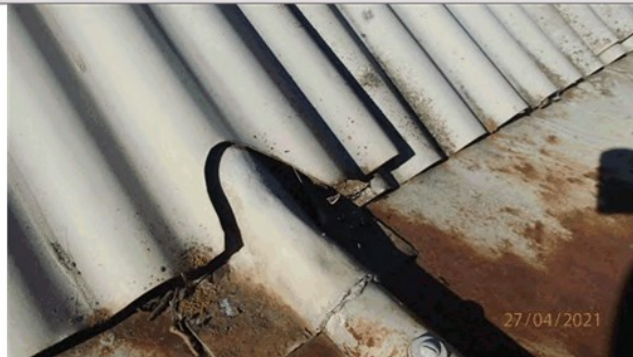
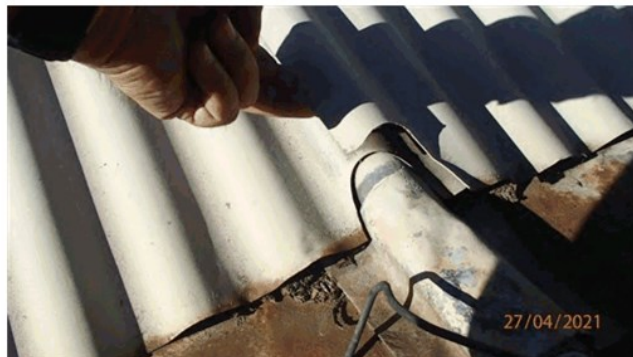
ITEM	LOCATION	DESCRIPTION / OVERVIEW / FINDINGS	IMAGE REFERENCE
31	Junction between flat metal deck roof and pitched corrugated roof over library. Left rear of memorial hall.	<p><u>The junction between the flat metal deck roof and the pitched corrugated roof over the library presents with loose roofing sheets and gaps that are potential bypass leakage points.</u></p> <p><u>Consideration should be given to introducing an additional apron flashing between the junction of the two roofs to eliminate any potential leakage points.</u></p>

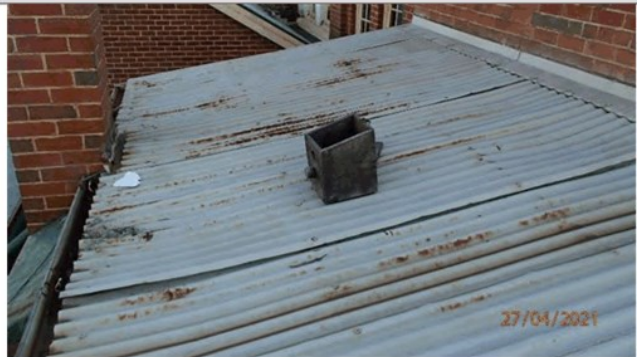
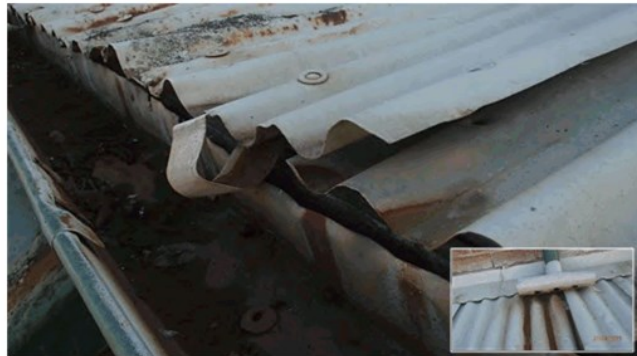
ITEM	LOCATION	DESCRIPTION / OVERVIEW / FINDINGS	IMAGE REFERENCE
32	Small skillion roof over the male toilets right of the hall stage .	<u>The small skillion roof over the male toilets to the right of the main stage presents with surface corrosion, gaps to the roof sheeting, loose roof sheeting fixings, and potential leakage issues around the sheeting below the small spreader servicing the roof above.</u>

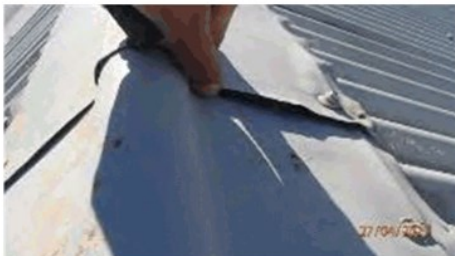
ITEM	LOCATION	DESCRIPTION / OVERVIEW / FINDINGS	IMAGE REFERENCE
35	Library roof, entry at rear of building.	<p>These images illustrate the condition of the library roof in the pitched and skillion areas over the library entry at the rear of the building. The roof itself is generally in reasonable condition, although there is evidence of loose screw fixings, gaps between roof sheets, gaps between joints in the ridge capping and a cowl is missing to one of the vent pipes as well as inadequate penetration flashing.</p> <p>The overall condition appears to be reasonable, although maintenance is required.</p> <p>If roof replacement is carried out to the Memorial Hall, I would also recommend replacement of the library roof sheeting and associated cappings and flashings as well.</p>

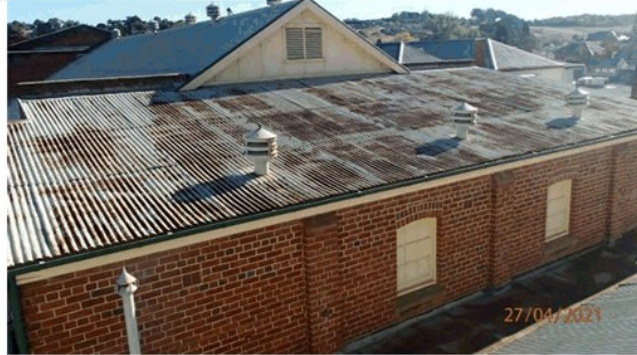
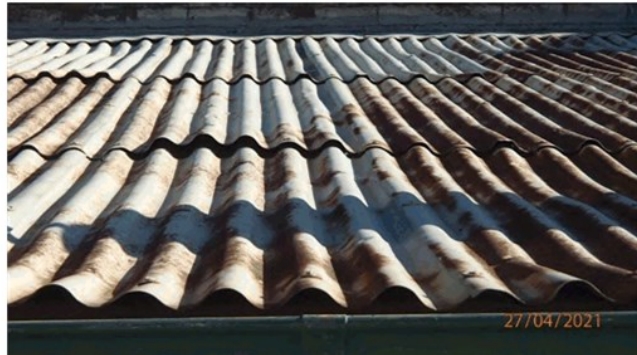
ITEM	LOCATION	DESCRIPTION / OVERVIEW / FINDINGS	IMAGE REFERENCE
36	Skillion roof, rear end of main Memorial Hall.	<u>The skillion roof at the rear end of the main Memorial Hall shows evidence of loose screw fixings, gaps between sheets and surface corrosion in some areas.</u>

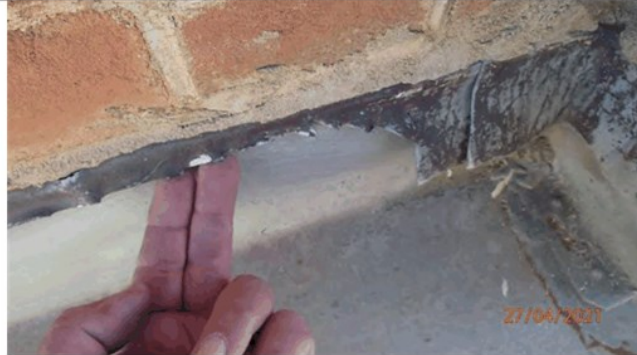
ITEM	LOCATION	DESCRIPTION / OVERVIEW / FINDINGS	IMAGE REFERENCE
37	Skillion roof, rear end of main Memorial Hall.	<p><u>The cut-in lead apron reglet has been deliberately cut in some areas, which reduces the effective overlap and coverage from the flashing to the upturn of the metal deck roof against the adjoining brick wall.</u></p> <p><u>Removal and replacement of the lead reglet flashing is recommended along the entire length of the building.</u></p>

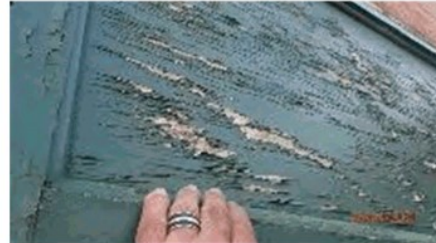
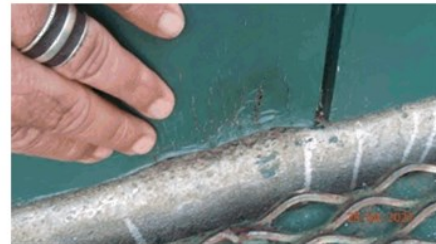
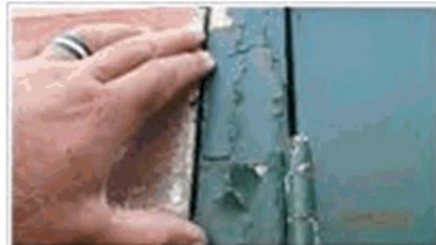
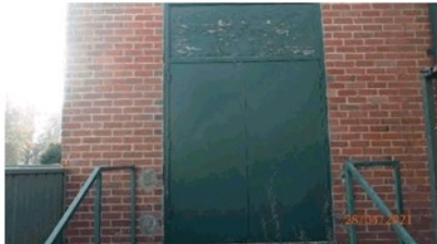
ITEM	LOCATION	DESCRIPTION / OVERVIEW / FINDINGS	IMAGE REFERENCE
EXTERIOR FAÇADE			
41	Double doors servicing storage room for library.	<p>The external double doors servicing the storage room for the library on the left rear corner of the building presents with weathering and deterioration of the overhead panel, doorjamb and bottom of the left-hand side door.</p> <p><u>Repairs and maintenance along with additional painting is required for long-term protection.</u></p>

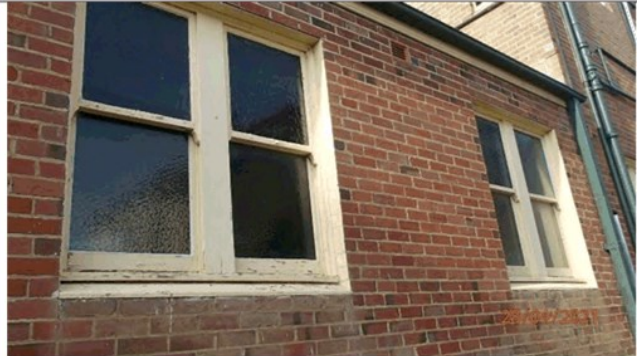
ITEM	LOCATION	DESCRIPTION / OVERVIEW / FINDINGS	IMAGE REFERENCE
44	Timber windows servicing Annex 2, left-hand side of building Memorial Hall.	<p>The timber windows servicing the Annex 2 to the left side of the building presents with weathering and deterioration and additional patching, repairs and painting are required for long-term protection.</p> <p>The same weathering deterioration can also be observed to the windows servicing the male toilet facilities adjacent to Annex 2.</p>

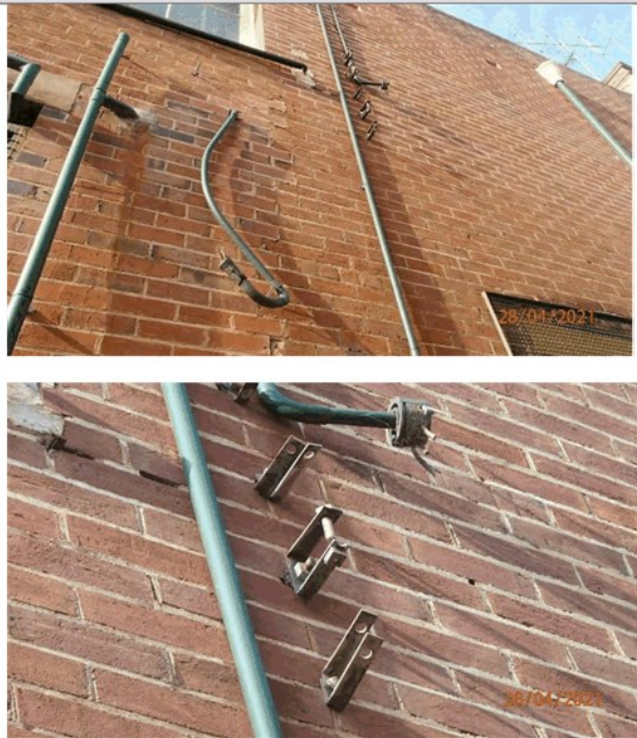
ITEM	LOCATION	DESCRIPTION / OVERVIEW / FINDINGS	IMAGE REFERENCE
45	External wall, Youth Centre office, left-hand side of building Memorial Hall.	<p>These images illustrate redundant electrical services conduits on the external wall of the Youth Centre office on the left-hand side of the building.</p> <p><u>Confirmation by the licensed electrician regarding any redundant services should be made and removal of the services should be executed along with any external wall patching and painting required.</u></p>

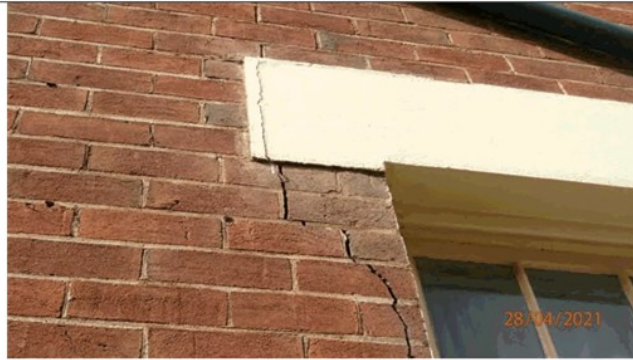
A photograph showing a vertical crack in a red brick masonry wall. A green downpipe runs vertically along the crack. The crack extends from the parapet down to the first floor level. A date stamp '28/04/2021' is visible in the bottom right corner.
47	Masonry wall, top left corner window servicing the Youth Centre offices.	Cracking to the masonry wall at the top left corner of the windows servicing the Youth Centre offices extends from the concrete lintel through six courses of brickwork below. The crack appears to be approximately 8mm or less and is as a result of differential movement between the masonry work and the concrete lintel above. <u>This cracking should be sealed with colour matched caulking.</u>

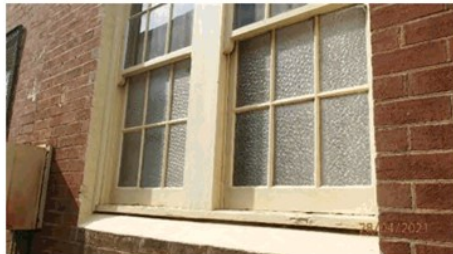
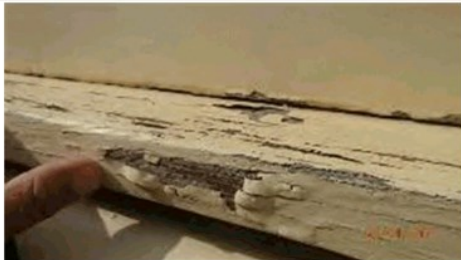
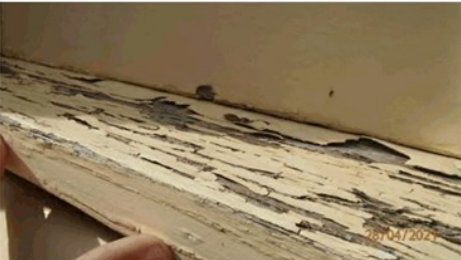
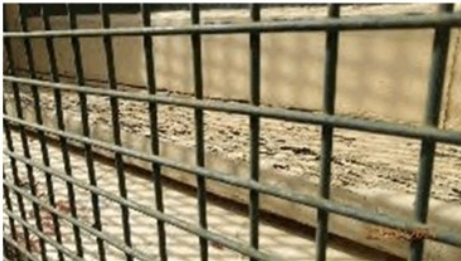
ITEM	LOCATION	DESCRIPTION / OVERVIEW / FINDINGS	IMAGE REFERENCE
49	Timber windows, left-hand side of Youth Centre offices.	<p><u>These images illustrate the weathering and deterioration to the timber windows on the left-hand side of the Youth Centre offices, which require patching and painting for long-term protection.</u></p>

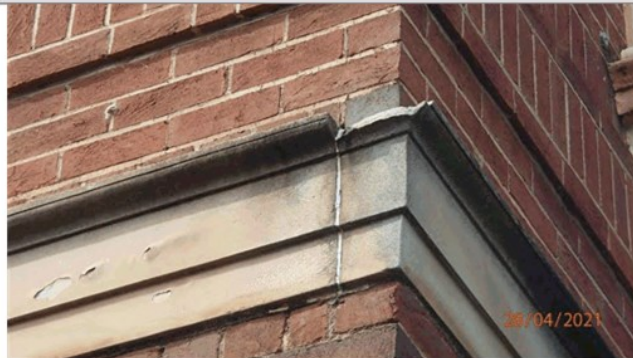
ITEM	LOCATION	DESCRIPTION / OVERVIEW / FINDINGS	IMAGE REFERENCE
50	Front left corner of building Memorial Hall.	<u>Cracking to the cement wall corbelling at the front left corner of the building, which requires patching and repair.</u>

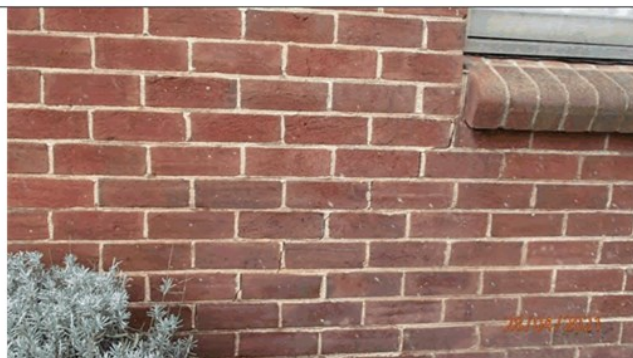
51	Front left corner of building Memorial Hall.	<p>Stepped cracking along mortar joints in the masonry wall at the front left corner of the building emanating from the brick windowsill servicing the Youth Centre office and stepping down 10 courses of brickwork to DPC level.</p> <p><u>This is not considered serious or unusual, though patching to the cracking with colour matched mortar is recommended.</u></p>

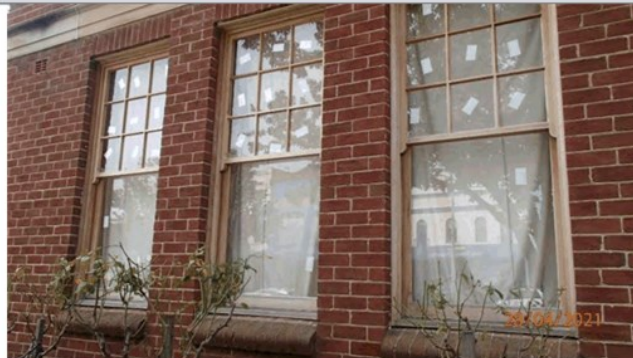
ITEM	LOCATION	DESCRIPTION / OVERVIEW / FINDINGS	IMAGE REFERENCE
54	Lower-level windows, left corner Memorial Hall.	<p>The lower-level windows at the front left corner of the building servicing the Youth Centre offices are in reasonably good condition, although weathering can be seen to the timber elements.</p> <p><u>Additional protective painting is required for long-term protection.</u></p>

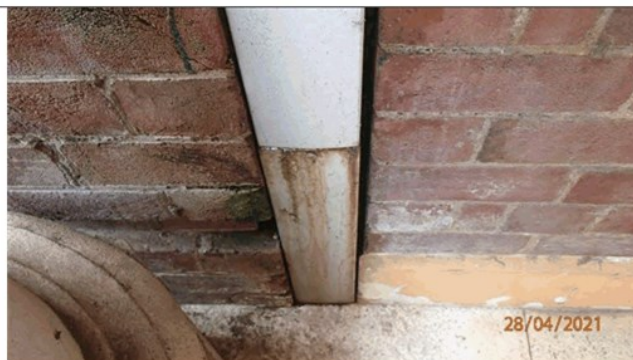
55	Left downpipe, first-floor balcony, Memorial Hall.	<p>The downpipe servicing the first-floor balcony on the left-hand side of the building displays evidence of leakage.</p> <p>The joint of the downpipe and tapping of the downpipe itself reveals potential blockage to the downpipe in this area.</p> <p><u>Additional clearing may be required.</u></p>

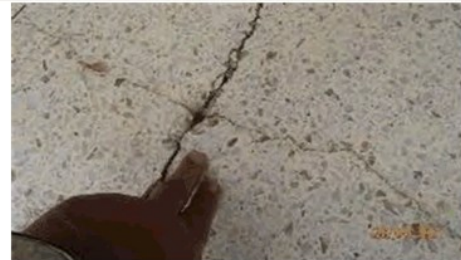
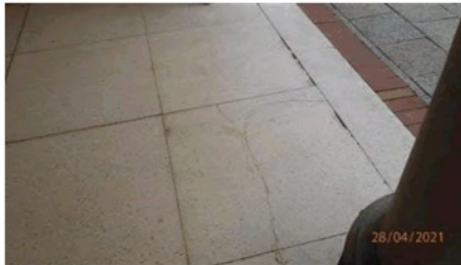
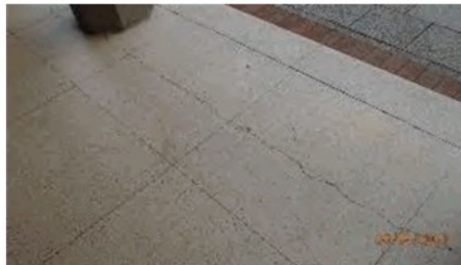
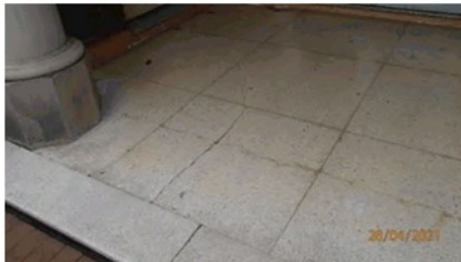
ITEM	LOCATION	DESCRIPTION / OVERVIEW / FINDINGS	IMAGE REFERENCE
60	Front entry, Memorial Hall.	<p>These images illustrate cracking to the Terrazzo pavement at the front entry to the Memorial Hall with cracks generally being 1mm or less.</p> <p><u>Replacement of the cracked Terrazzo panels is recommended.</u></p>

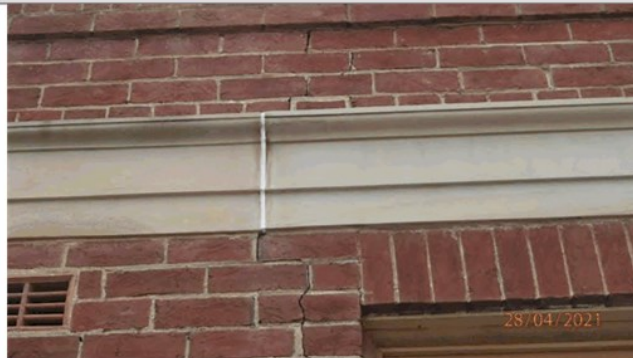
ITEM	LOCATION	DESCRIPTION / OVERVIEW / FINDINGS	IMAGE REFERENCE
65	Front right façade, masonry wall.	<p>This image illustrates cracking to the masonry walls between the upper and lower-level windows at the front right façade.</p> <p><u>Consideration should be given to patching and repair of the mortar along with sealing of cracked bricks with colour matched caulking to provide weathering protection.</u></p>

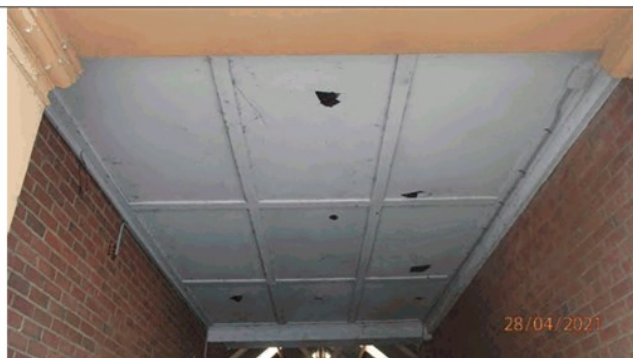
A photograph showing a close-up of a red brick masonry wall. A horizontal white pipe or downspout runs across the middle of the frame. There is visible vertical cracking in the mortar joints between the upper and lower levels of windows. A date stamp '28/04/2021' is visible in the bottom right corner.
66	Soffit, public walkway.	<p>The soffit lining of the public walkway link for at the front right side of the building, presents with damage and cracking. It should be understood this lining material is likely to be bonded asbestos.</p> <p><u>Consideration should be given to removal and replacement with fibre cement and matching timber trims, to be painted to match existing.</u></p>

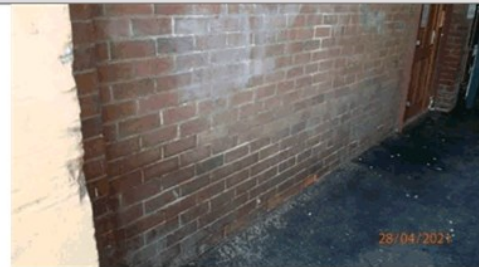
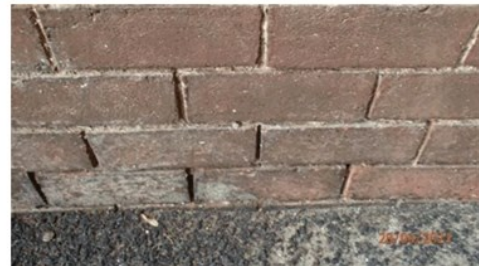
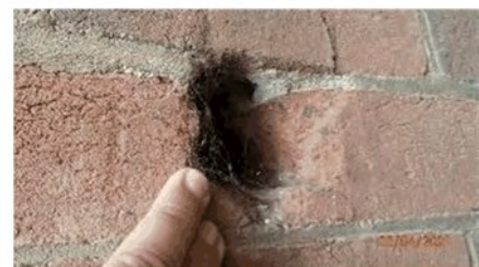
ITEM	LOCATION	DESCRIPTION / OVERVIEW / FINDINGS	IMAGE REFERENCE
67	Masonry wall, right of Memorial Hall.	<p>The masonry wall on the right-hand side of the building, adjoining the public walkway presents with deterioration to the mortar along with holes in the masonry.</p> <p><u>Repointing of the mortar and patching of the holes is recommended.</u></p>

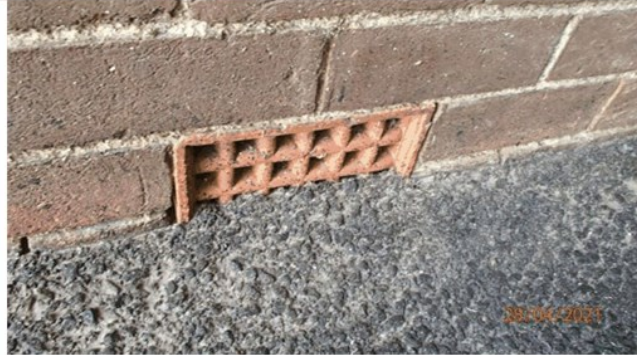
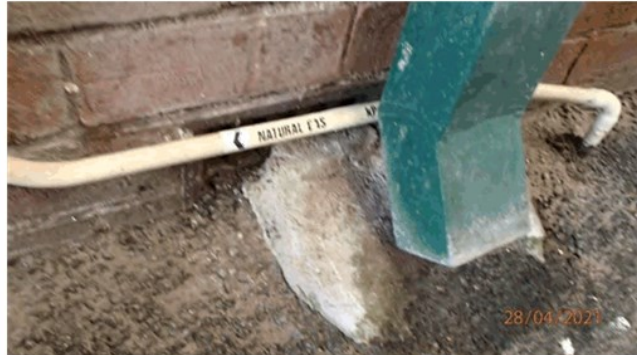
ITEM	LOCATION	DESCRIPTION / OVERVIEW / FINDINGS	IMAGE REFERENCE
70	Right of Memorial Hall, public walkways and library.	<p>There is partial encroachment of the subfloor vents on the right-hand side of the Memorial Hall building, along the public walkway towards the library, however, since this area is covered, it is unlikely this section will be exposed to any direct rain or surface water. There appeared to be adequate subfloor vents in other areas, and I do not consider this a significant issue.</p> <p><u>The downpipe vent servicing the pitched corrugated roof along the walkway discharges onto the ground, which may create slippery conditions and consideration should be given to forming a spoon drain along the length of the wall to control surface water and stormwater being discharged from the roof.</u></p>

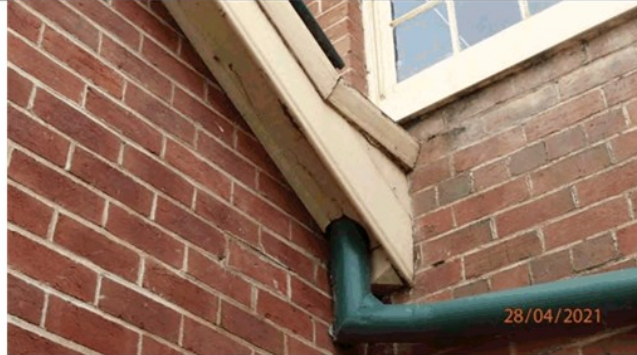
ITEM	LOCATION	DESCRIPTION / OVERVIEW / FINDINGS	IMAGE REFERENCE
74	Gable end fascia and soffit trim, kitchen annex.	<p>The gable end fascia and soffit trims to the kitchen annex, adjoining the Memorial Hall on the right-hand side show evidence of weathering and water damage.</p> <p><u>Maintenance, repairs and repainting for long-term protection is required.</u></p>

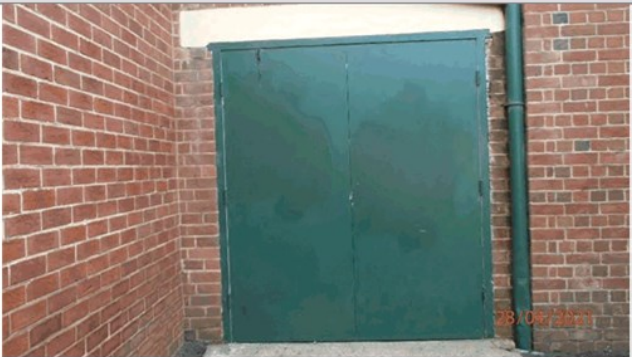
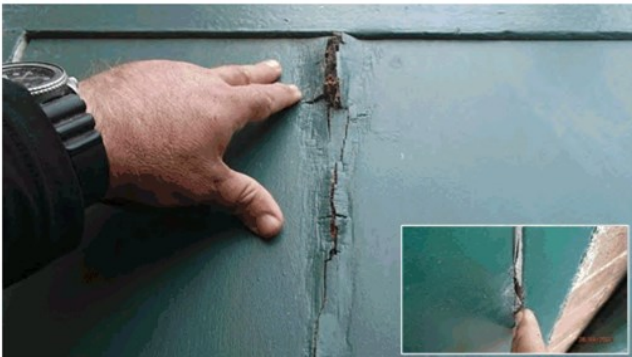
ITEM	LOCATION	DESCRIPTION / OVERVIEW / FINDINGS	IMAGE REFERENCE
75	Service doors, right Memorial Hall.	<p>The service doors on the right-hand side of the Memorial Hall presents with water damage to the left-hand side door along with deterioration to the paint finish on the doorjamb.</p> <p>Replacement of the damaged door, along with additional maintenance, repairs and painting to the doorjamb's is recommended.</p> <p><u>Consideration should also be given to fitting a protective cover flashing trim at the head of the door and a weather strip at the base of the doors.</u></p>

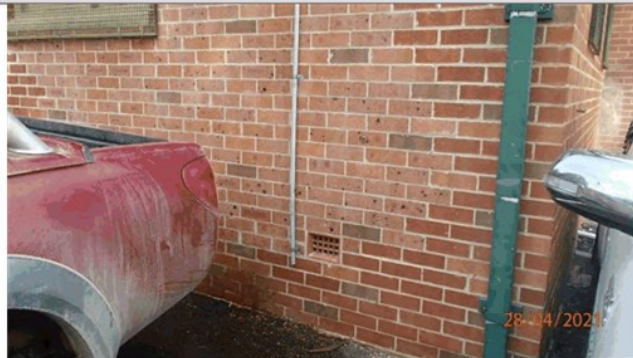
ITEM	LOCATION	DESCRIPTION / OVERVIEW / FINDINGS	IMAGE REFERENCE
81	Masonry wall of office area adjoining Library.	<p>This image illustrates previous patching to the masonry wall of the office area adjoining the public library, which appears to be a result of previous vehicle impact damage.</p> <p><u>Consideration should be given to additional protective metal bollards and guard rail against the wall to prevent re-occurrence of vehicle impact.</u></p>

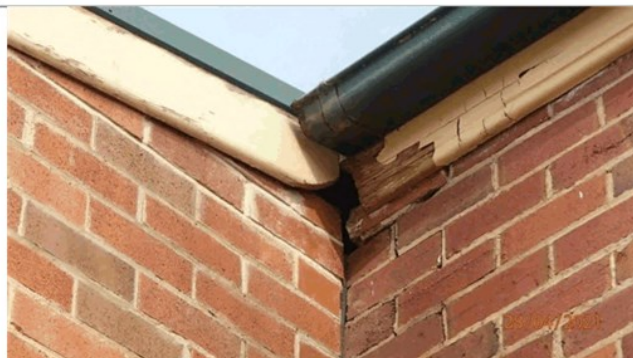
82	Timber fascia, junction Library office and wall junction.	<p>The timber fascia at the junction of the public library office and public library wall junction presents with damage.</p> <p><u>Consideration should be given to replacement of a section of the fascia to conceal the existing hole along with securing any loose bricks in that area to prevent water and pest entry.</u></p>

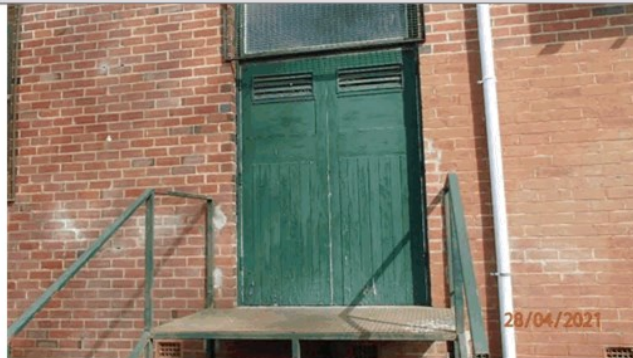
ITEM	LOCATION	DESCRIPTION / OVERVIEW / FINDINGS	IMAGE REFERENCE
83	Service doors, rear of Library.	<u>The service doors at the rear of the public library present with weathering and deterioration and additional patching, and painting is required for long-term protection.</u>

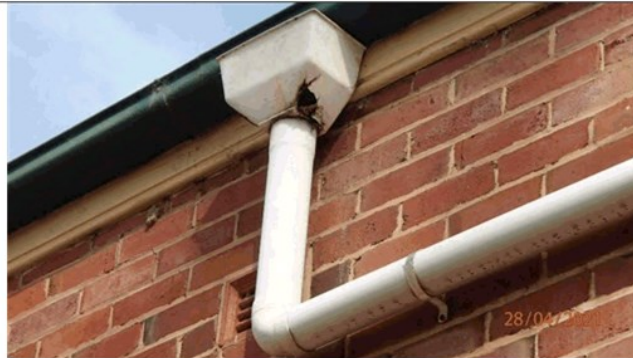
84	PVC rainwater head, rear of Library.	<u>The PVC rainwater head at the rear of the public library presents with damage and consideration should be given to replacement of the rainwater head.</u>

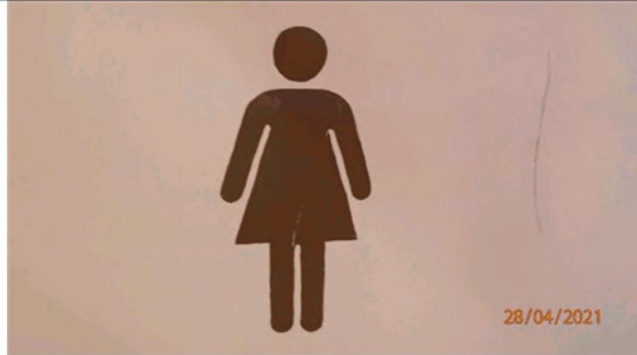
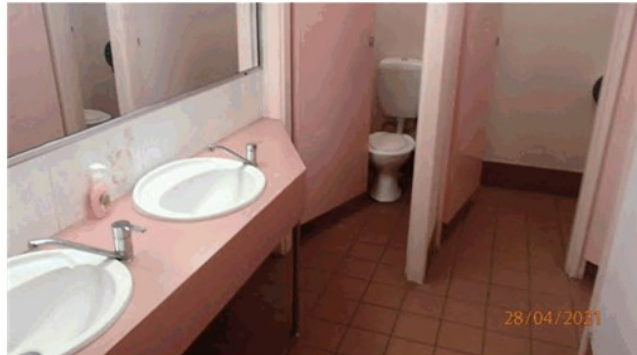
ITEM	LOCATION	DESCRIPTION / OVERVIEW / FINDINGS	IMAGE REFERENCE
INTERIOR – MEMORIAL HALL			
93	Female toilet facilities.	<p>The interior fixtures and finishes of the female toilet facilities on the left-hand side of the entry foyer to the Memorial Hall showed no obvious significant defects to the fixtures or finishes and no obvious leakage from the plumbing and drainage fixtures.</p> <p>The floor tiling showed no evidence of excessive cracking or lifting at the time of inspection.</p> <p>The small storeroom on the right-hand side of the main staircase was locked and not accessible at time of inspection.</p>

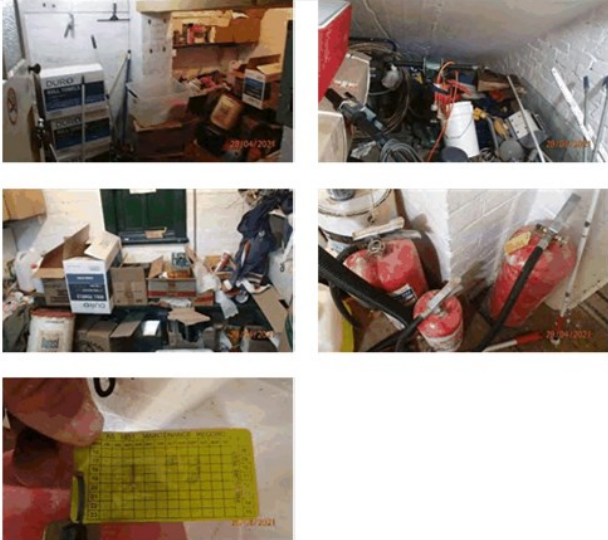
ITEM	LOCATION	DESCRIPTION / OVERVIEW / FINDINGS	IMAGE REFERENCE
94	Cleaner's storage room, beneath main foyer stairs.	<p>The cleaner's storage room beneath the main foyer stairs had no obvious structural faults, although not all areas could be inspected due to restricted access and vision from stored materials.</p> <p>There are three fire extinguishers stored in this room, one of which has a service tag which indicated it was last inspected in March 2020.</p> <p>An electrical distribution board DB 6 is located within the cleaner's room, which showed no obvious faults. The switches were tested and found to be active.</p>
