Yass Soldiers Memorial Hall Committee Meeting

5.1 Memorial Hall Dilapidation Report

SPECIAL PURPOSE INSPECTION DILAPIDATION REPORT

ADDRESS:	Yass Memorial Hall 82-94 Comur Street YASS NSW 2582
REPORT PREPARED FOR:	Yass Valley Council 209 Comur Street YASS NSW 2582
PHONE:	(02) 6226 1477
EMAIL:	Seamus.McGurk@yass.nsw.gov.au
DATE ATTENDED:	27 – 29 April 2021

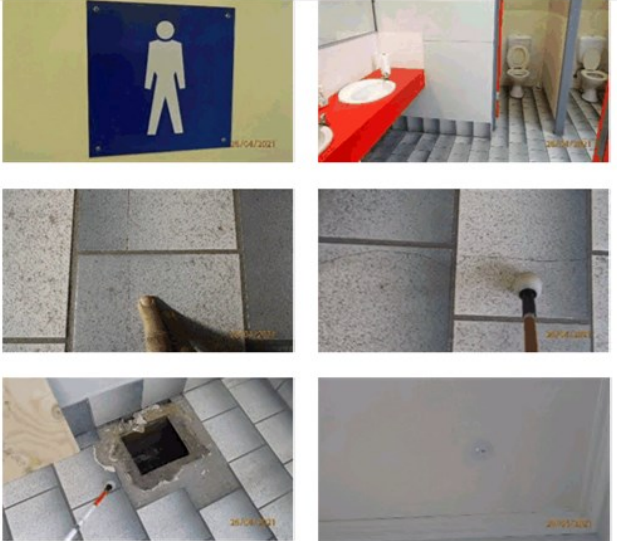
ITEM	LOCATION	DESCRIPTION / OVERVIEW / FINDINGS	IMAGE REFERENCE
95	Male toilet facilities.	<p>The interior fixtures and finishes of the male toilet facilities on the left-hand side of the entry foyer to the Memorial Hall showed no obvious significant defects to the fixtures or finishes and no obvious leakage from the plumbing and drainage fixtures, and also the electrical items were functioning at the time of inspection.</p> <p>There was evidence of cracked tiling, with the cracking being in line which corresponds with the location of masonry walls adjacent, although the tiles did not appear to be loose or drummy at the time of inspection.</p> <p>A section of tiles adjacent to the urinal has been removed and the floor has been cut to provide a small access panel, although it is unclear why this was done. However, it does reveal that the tiling has been laid over the original timber floor, with fibro sheeting placed over the timber and then full notched trowel spread of adhesive, which is visible below the 150mm x 150mm tiles.</p> <p>There are minor cracking and peeling of the paint finish to the ceiling as well as minor cracking between the cornice trim and the ceiling lining, which require additional minor patching and painting.</p> <p><u>Repairs to the toilet floor are required and consideration should be given to replacement of the floor tiles throughout, along with new waterproofing.</u></p>

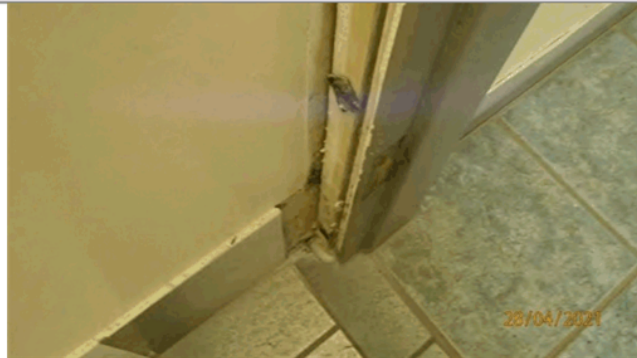
ITEM	LOCATION	DESCRIPTION / OVERVIEW / FINDINGS	IMAGE REFERENCE
96	Male toilet facilities.	<p>The timber architrave trim has been removed around the doorframe which was intended as an airlock entry to the male toilet.</p> <p><u>A small section of skirting tile has also been removed and it is unclear why this was done, although patching and repair and replacement of architrave is required.</u></p>

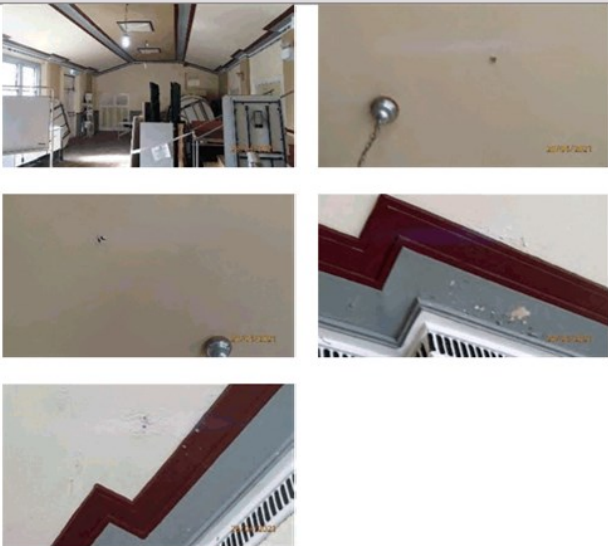
ITEM	LOCATION	DESCRIPTION / OVERVIEW / FINDINGS	IMAGE REFERENCE
98	Storage room, left-hand side of Memorial Hall.	<p>The storage annex for tables and chairs on the left-hand side of the main Memorial Hall showed evidence of minor water damage and staining to plasterboard ceilings below the ridgeline and along the right-hand side, which runs underneath the valley box gutter.</p> <p><u>Repairs to roof and gutter areas are required prior to patching and painting of the ceilings.</u></p> <p><u>The storage room area at the left rear corner of the annex was not accessible at the time of inspection.</u></p>

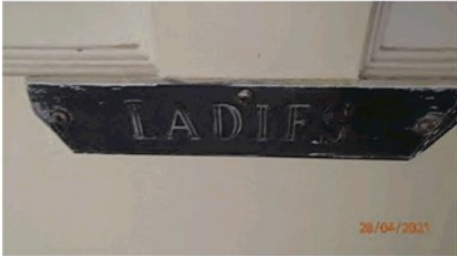
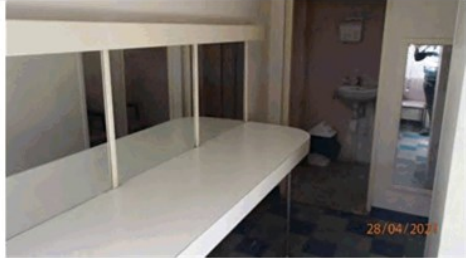
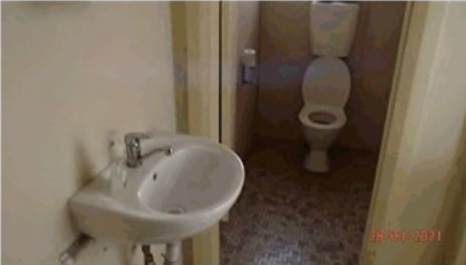
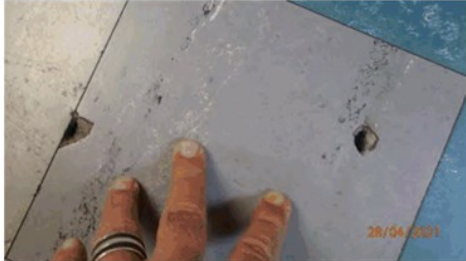
ITEM	LOCATION	DESCRIPTION / OVERVIEW / FINDINGS	IMAGE REFERENCE
99	Female dressing room and toilet facilities on the left-hand side of the Memorial Hall stage.	<p>The female dressing room and toilet facilities on the left-hand side of the Memorial Hall stage showed no significant faults to the fixtures, or finishes.</p> <p>The mosaic floor tiling did not present with any lifting or cracking at the time of inspection.</p> <p>The plumbing and drainage fixtures were tested and found to be operable.</p> <p>The lights were tested and found to be operable.</p> <p>The exit signage above exit doors was operable.</p> <p>The vinyl floor tiles in the dressing room area showed minor defects to isolated tiles but were generally in reasonable condition. <u>These damaged tiles should be replaced.</u></p>

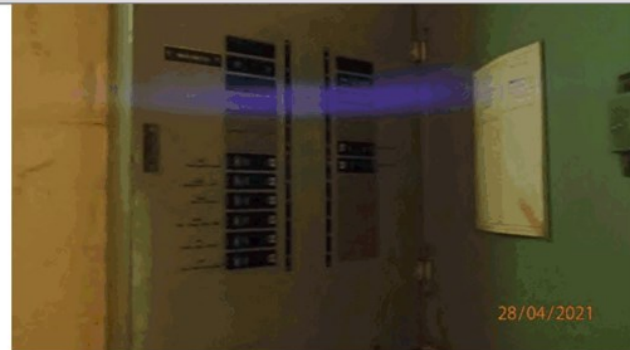
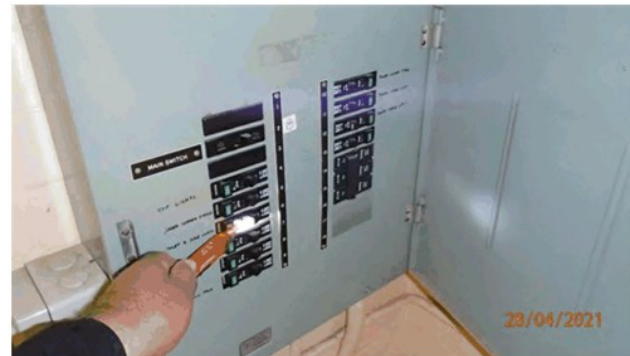
ITEM	LOCATION	DESCRIPTION / OVERVIEW / FINDINGS	IMAGE REFERENCE
101	Main stage, left side and adjacent to female dressing room and toilet facilities.	The electrical distribution board's numbered 4 and 5 are located adjacent to the female dressing room and toilet facilities at the left-hand side of the main stage. These were checked and found to be active.

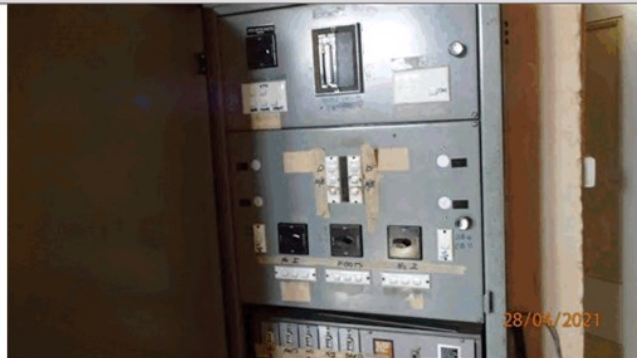
ITEM	LOCATION	DESCRIPTION / OVERVIEW / FINDINGS	IMAGE REFERENCE
102	Main stage left side adjacent to exit stairs.	<p>The house lighting and stage lighting is located on the main distribution board located on the left-hand side of the stage, adjacent to the left-hand side exit stairs.</p> <p>The switches and lights were tested and found to be active.</p>

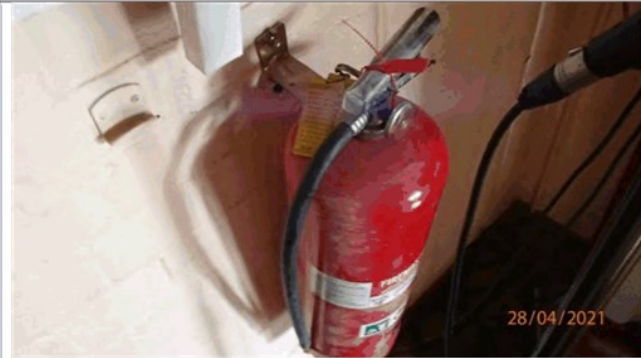
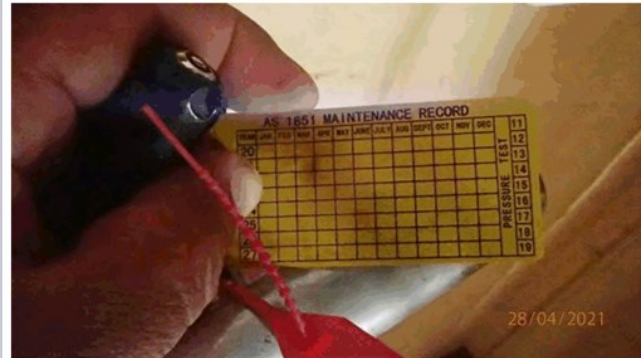
ITEM	LOCATION	DESCRIPTION / OVERVIEW / FINDINGS	IMAGE REFERENCE
104	Adjacent to right-hand side stage door exit.	The water-based fire extinguisher located adjacent to the right-hand side stage exit door has service tags which indicate it was last inspected in March 2021.

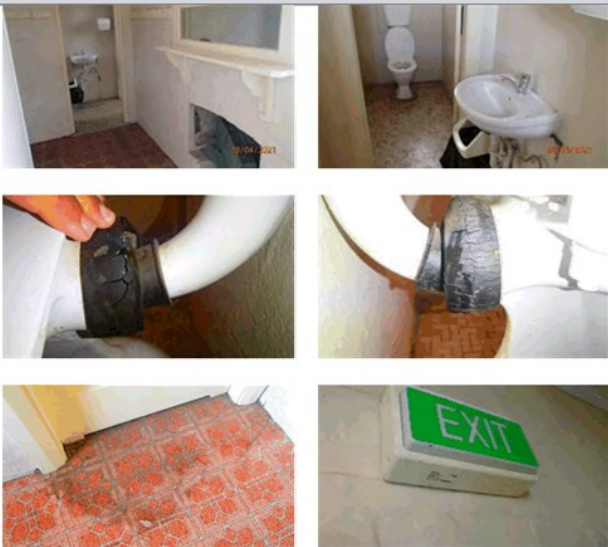
ITEM	LOCATION	DESCRIPTION / OVERVIEW / FINDINGS	IMAGE REFERENCE
105	Male change room and toilet facilities, right-hand side of main stage.	<p>The male change room and toilet facilities on the right-hand side of the main stage showed <u>evidence of deteriorated carpet floor finish in the change room area with watermarks adjacent to the fixed external door.</u></p> <p>The toilet facilities were tested and found to be operable, <u>although both toilets have cracked rubber seals at the rear of the toilet suites which require replacement.</u></p> <p>The mosaic tiled floor finish showed no evidence of cracking or lifting at the time of inspection.</p> <p><u>The exit sign above the entry door to the change room was flickering at the time of inspection and requires a new lightbulb.</u></p>

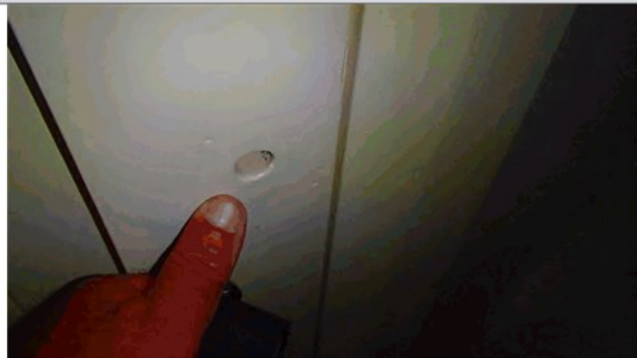
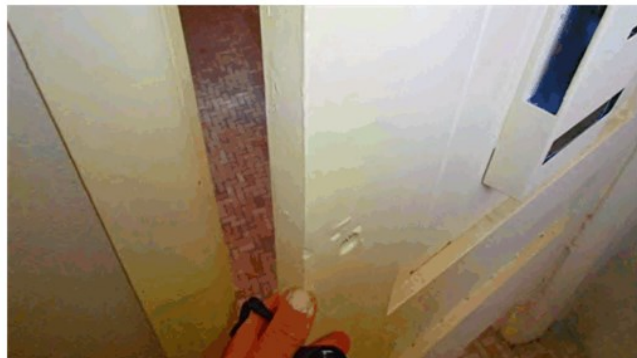
ITEM	LOCATION	DESCRIPTION / OVERVIEW / FINDINGS	IMAGE REFERENCE
106	Male toilet facilities, right-hand side of main stage.	<p><u>The toilet doors are not fitted with privacy locks and new privacy locks should be supplied and fitted.</u></p> <p><u>The toilet facilities are not fitted with exhaust fans.</u></p> <p><u>The original louvre windows have been covered with small sliding aluminium windows.</u></p>

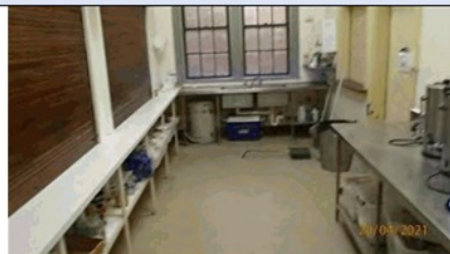
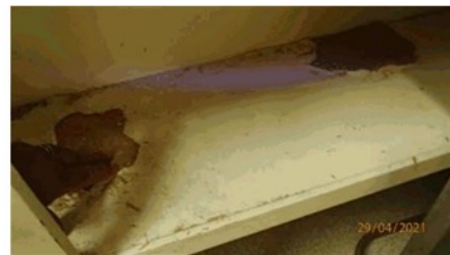
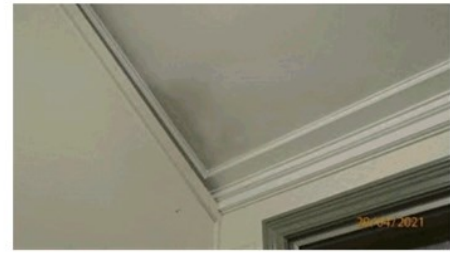
ITEM	LOCATION	DESCRIPTION / OVERVIEW / FINDINGS	IMAGE REFERENCE
INTERIOR - KITCHEN			
108	Kitchen, Servery.	<p>The servery area of the kitchen facilities, <u>presents with minor deterioration to the fixed joinery</u>, although there was no obvious leakage from the plumbing or drainage fixtures or the electric hot water unit.</p> <p><u>The ceiling lining above the kitchen sink area showed evidence of watermarks and staining, which correspond with gaps in roof sheeting along the gutter line.</u></p>

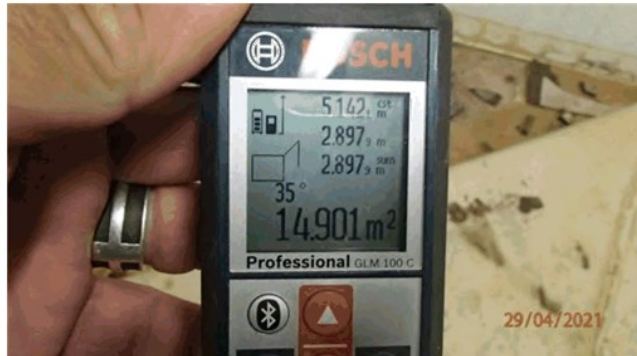
ITEM	LOCATION	DESCRIPTION / OVERVIEW / FINDINGS	IMAGE REFERENCE
109	Kitchen, preparation and cooking area.	Images illustrating kitchen preparation and cooking area with dimensions and area of the kitchen cooking and servery area.

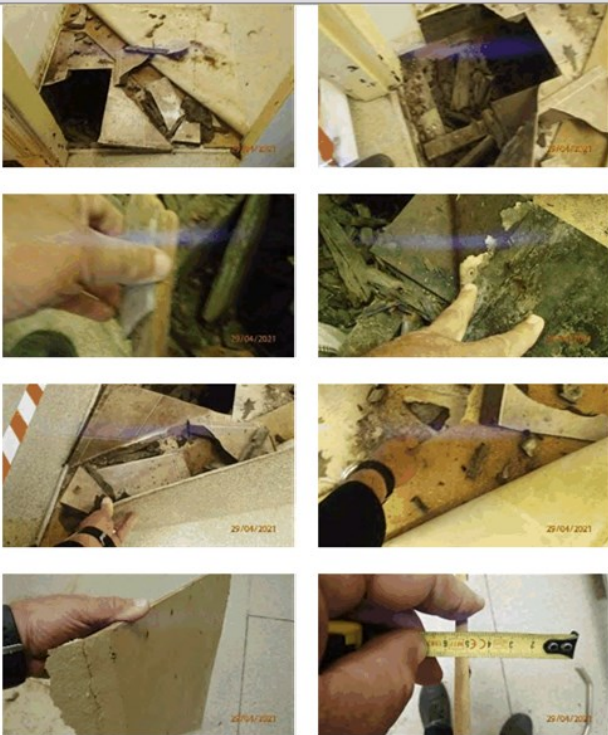
ITEM	LOCATION	DESCRIPTION / OVERVIEW / FINDINGS	IMAGE REFERENCE
110	Kitchen, preparation and cooking area.	<p>The kitchen cooking and preparation area displays significant deterioration to the timber flooring which has suffered dry rot and wood decay.</p> <p>The kitchen floor appears to have two layers of vinyl flooring, with the original floor placed over Masonite sheeting and directly fixed to the hardwood timber flooring. The second layer of flooring has been placed over the original vinyl floor with 8 x 6mm sheets of medium density fibreboard covered with a sheet vinyl membrane. The deterioration to the floor seems to be as a result of years of mopping and cleaning where water has bypassed the vinyl floor and seeped into the timber flooring for an extended period of time. The covering of the original vinyl floor with new sheeting did not address the original damage caused to the solid timber flooring.</p> <p>Most of the observed damage seems to have occurred in the entry door to the kitchen preparation area, while other parts of the floor seem to be relatively stable and displayed no excessive movement.</p> <p><u>Recommend removal of all the vinyl flooring to allow for an inspection, and replacement and repair of the timber floor as needed.</u></p>

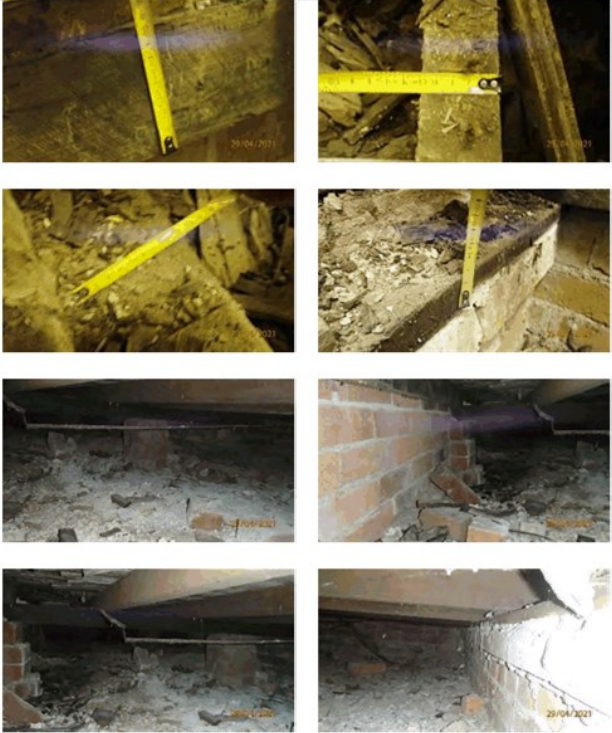
ITEM	LOCATION	DESCRIPTION / OVERVIEW / FINDINGS	IMAGE REFERENCE
111	Kitchen, floor framing and subfloor.	<p>These images illustrate the sizes of the existing floor framing, being 100 x 50mm hardwood joists spaced at approximately 450mm centres, sitting on a perimeter whaling plate of 100 x 25mm hardwood plate, with intermediate supports on timber bearers and brick piers, with bearers being approximately 100 x 75mm.</p> <p>Other images illustrate the appearance of the subfloor below the kitchen cooking and servery area.</p>

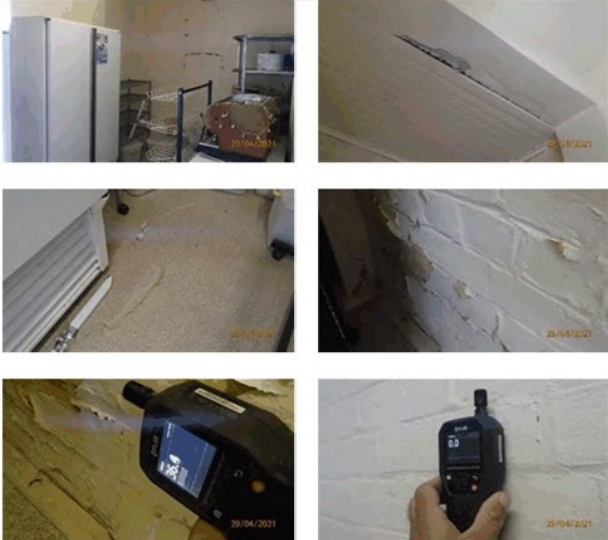
ITEM	LOCATION	DESCRIPTION / OVERVIEW / FINDINGS	IMAGE REFERENCE
112	Kitchen, cool room facilities.	<p>These images illustrate the cool room facilities adjacent to the kitchen facilities which show evidence of deterioration to the render finish on the concrete beam adjoining the timber ceiling, watermarks to the vinyl floor, along with deterioration to the paint finish on the base brickwork, which indicated elevated moisture levels of approximately 37% compared to brickwork higher on the wall which was 0%.</p> <p>There is no evidence of similar moisture on the outside of the cool room.</p>

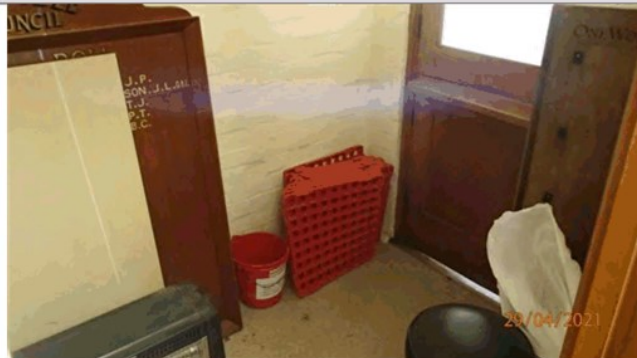
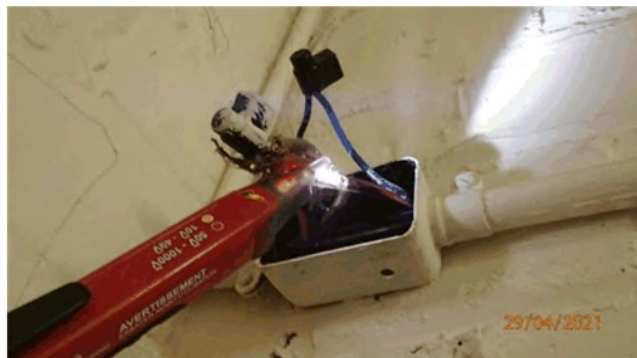
ITEM	LOCATION	DESCRIPTION / OVERVIEW / FINDINGS	IMAGE REFERENCE
113	Storeroom, adjacent to the cool room.	<p>These images illustrate the storeroom adjacent to the cool room.</p> <p>This storage area displayed no significant faults to the walls and floor or timber lined ceiling, although not all areas could be inspected due to restricted access and vision from stored materials.</p> <p><u>There was evidence of exposed live wiring at a junction box for the light switch conduit which needs to be addressed and concealed by a licenced electrician.</u></p>

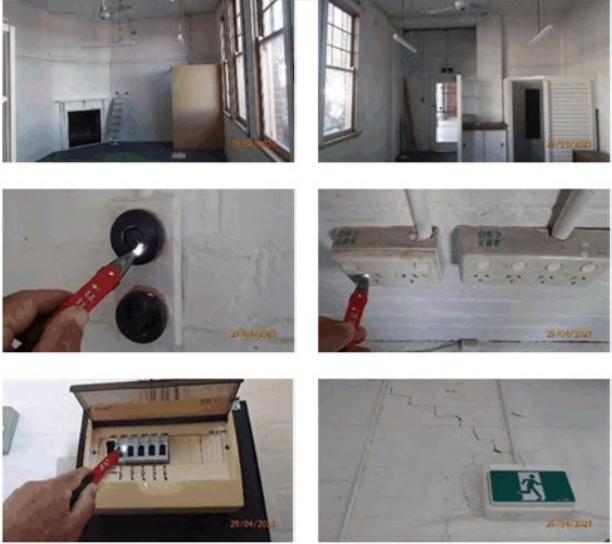
ITEM	LOCATION	DESCRIPTION / OVERVIEW / FINDINGS	IMAGE REFERENCE
114	Community meeting room. (The office suite at the front right corner of the building is labelled as the community meeting room on the plans).	These images illustrate the condition of the front office suite at the front right corner of the building, where the power was turned off at the time of inspection, with no power to light switches, power points or the exit sign at the time of inspection.

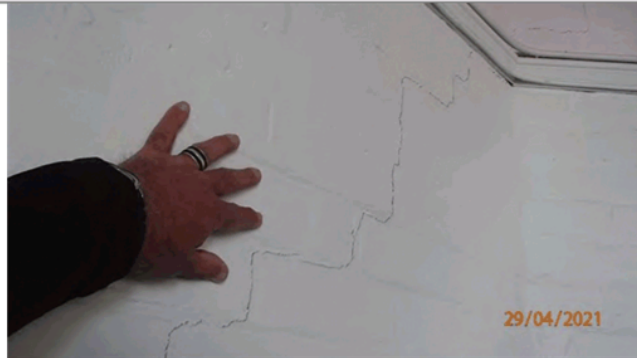
ITEM	LOCATION	DESCRIPTION / OVERVIEW / FINDINGS	IMAGE REFERENCE
116	Front right office space.	The front office space at the front right corner of the building also presented with minor stepped cracking to the internal masonry walls above the fireplace and the wall separating the right side corridor. These cracks presented as 1mm or less and did not appear to be of significant structural concern.

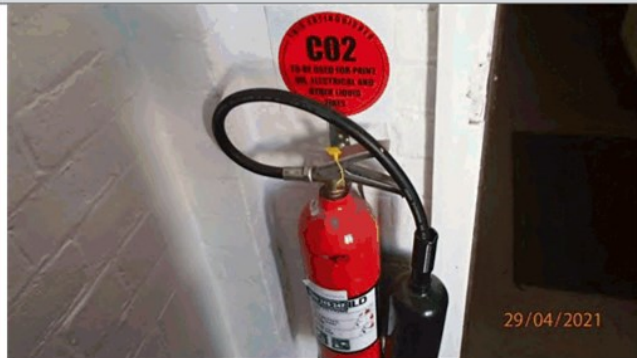
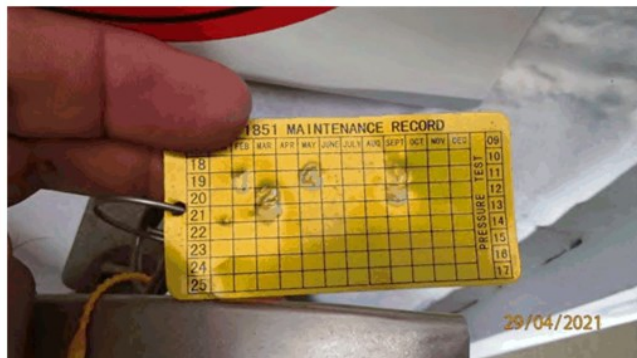
ITEM	LOCATION	DESCRIPTION / OVERVIEW / FINDINGS	IMAGE REFERENCE
117	Front right office space.	The CO2 fire extinguisher located within this office space has a service tag which indicates it was last checked in March 2021.

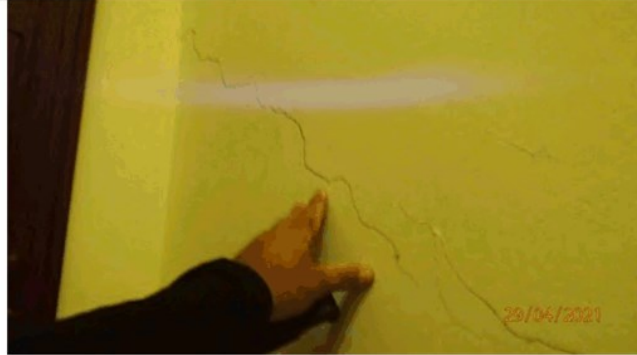
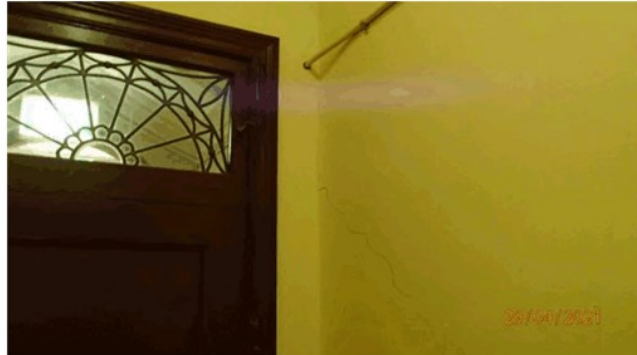
ITEM	LOCATION	DESCRIPTION / OVERVIEW / FINDINGS	IMAGE REFERENCE
118	Corridor leading to right side stairs and exit.	<p>The corridor leading to the right-side stairs and exit also presents with hairline cracking, which corresponds with the cracking previously mentioned in the front right office interior wall. These cracks are also approximately 1mm or less and radiate from the top right corner of the adjoining perpendicular wall and door.</p> <p><u>These are related to external cracking and movement and would be addressed as part of any external remediation.</u></p>

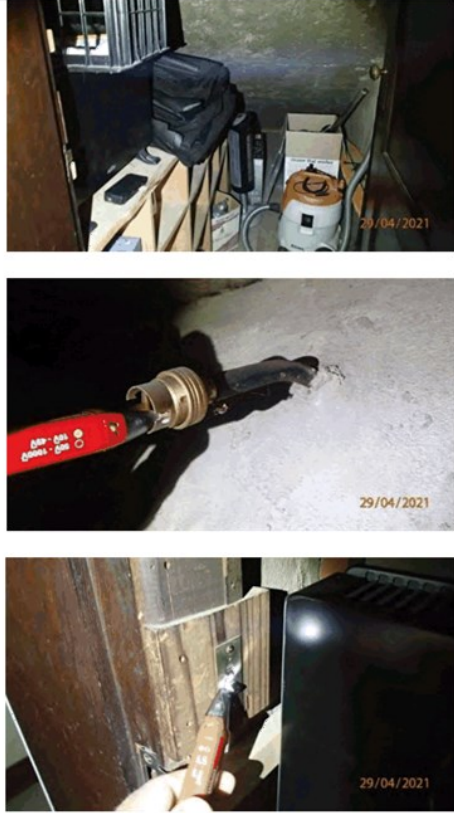
ITEM	LOCATION	DESCRIPTION / OVERVIEW / FINDINGS	IMAGE REFERENCE
119	Storage area under right side internal stairs.	<p>The storage space under the right-side internal stairs showed no significant faults to the general structure or floor, <u>although there was power to this space and the light switch was active; no lightbulb was fitted.</u></p> <p><u>The door to the storage space sticks at the threshold and requires adjustment for proper closure.</u></p>

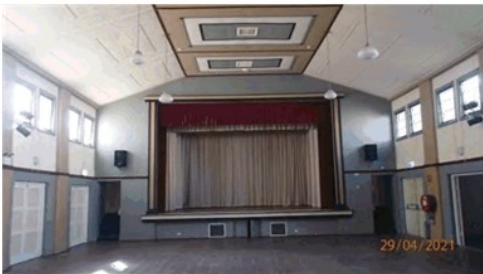
ITEM	LOCATION	DESCRIPTION / OVERVIEW / FINDINGS	IMAGE REFERENCE
120	Main hall, Memorial Hall.	<p><u>These images illustrate the main Memorial Hall, which displays sagging to the ceiling lining, along with water damage where previous repairs have occurred. Repairs to the roof above this area are required prior to any repair or replacement of ceiling linings.</u></p> <p><u>The timber flooring (80mm wide) in the Memorial Hall shows evidence of previous extensive patching and repairs, along with areas where additional patching and repairs are currently required. There is a section of bleached timber flooring below the area of previous leakage.</u></p>

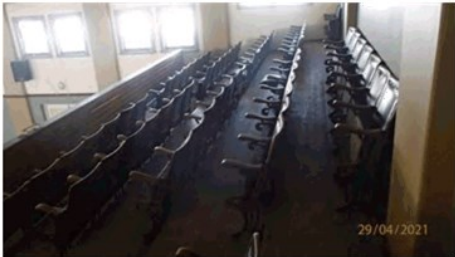
ITEM	LOCATION	DESCRIPTION / OVERVIEW / FINDINGS	IMAGE REFERENCE
121	Mezzanine level, Memorial Hall.	<p>These images illustrate the mezzanine seating level, <u>where water damage and sagging can be seen to the ceiling lining, as well as defects and damage to the timber flooring in this area.</u></p>

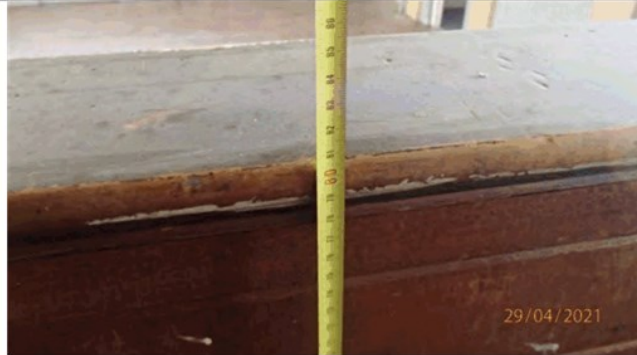
ITEM	LOCATION	DESCRIPTION / OVERVIEW / FINDINGS	IMAGE REFERENCE
122	Mezzanine level, Memorial Hall.	<p>The front balustrade to the mezzanine seating area measures at 810mm high, which is not considered adequate today in relation to safety standards in the Building Code of Australia.</p> <p>Consideration should be given to modifying the balustrade to achieve compliance with current requirements and eliminate public liability.</p>

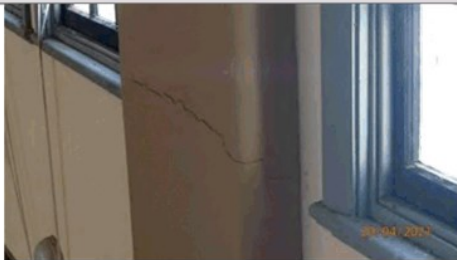
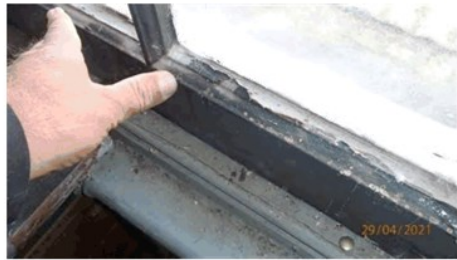
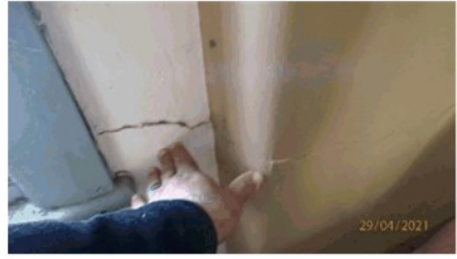
ITEM	LOCATION	DESCRIPTION / OVERVIEW / FINDINGS	IMAGE REFERENCE
123	Right of main hall, Memorial Hall, mezzanine level.	<p>There is evidence of cracking to the render on the masonry engaged peers between the windows on the right side of the hall, which presents as cracks of 2mm or less, which are horizontal in nature and in line with the windowsill.</p> <p><u>The windows themselves at upper-level show evidence of significant weathering deterioration and require patching, repair repainting for long-term protection.</u></p>

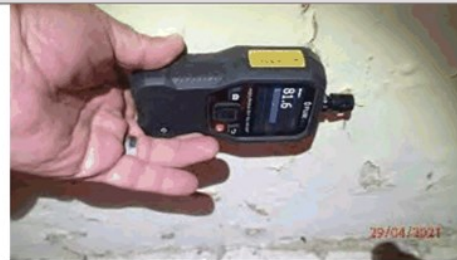
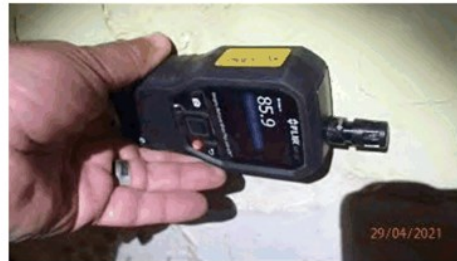
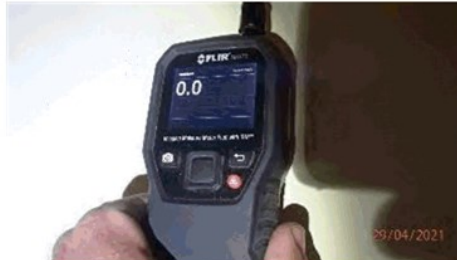
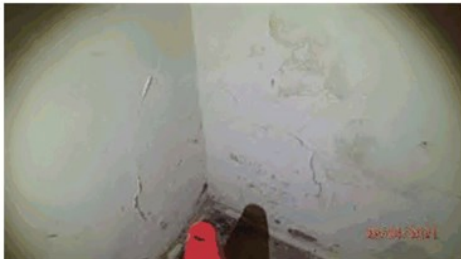
ITEM	LOCATION	DESCRIPTION / OVERVIEW / FINDINGS	IMAGE REFERENCE
125	Internal front left facade, Youth centre, Memorial Hall.	<p>The exterior walls, adjacent to the external entry door present with excessive moisture readings and deterioration to the render. Readings of between 81 and 87% were recorded at lower levels, with upper levels of the wall showing 0 percent.</p> <p>The areas of dampness to the wall corresponds with the external downpipe position which services the balcony above which was previously reported as showing evidence of leakage and blockage.</p> <p>Further investigation by a licenced plumber is required to alleviate the downpipe issues before patching and repairs to the walls can be carried out.</p>

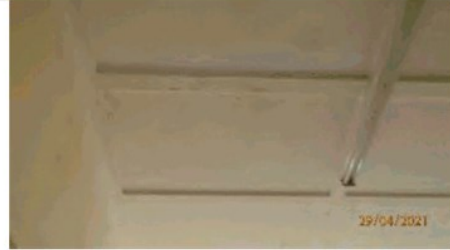
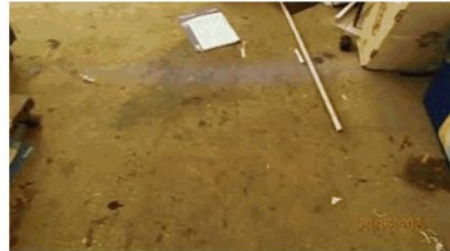
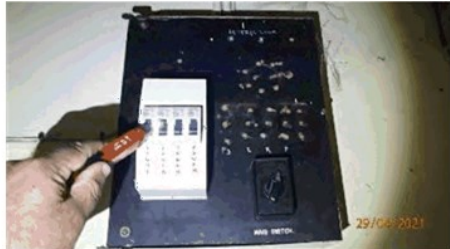
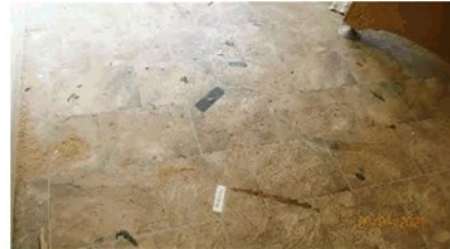
ITEM	LOCATION	DESCRIPTION / OVERVIEW / FINDINGS	IMAGE REFERENCE
126	Youth Centre.	<p><u>There was no power to the Youth Centre at the time of inspection.</u></p> <p><u>The ceiling linings showed evidence of watermarks in isolated areas, which corresponds with roof sheeting defects above.</u></p> <p><u>The condition of the carpets and vinyl flooring in the Youth Centre is in poor condition and requires replacement.</u></p>

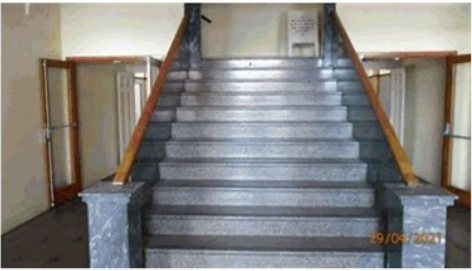
ITEM	LOCATION	DESCRIPTION / OVERVIEW / FINDINGS	IMAGE REFERENCE
127	Main internal stairs, Memorial Hall central lobby.	<p><u>These images illustrate the condition of the main internal stairs located centrally within the entry lobby.</u></p> <p><u>There is evidence of cracking to the marble capping on the right side baluster pillar, although the sections do not appear to be loose. The stair balustrade measures approximately 700mm from the nosing to the top of the timber railing, which is not considered adequate under today's Building Code requirements. The timber handrail on the flight of stairs leading from the landing to the first-floor level measures approximately 750mm from the stair nosing to the top of the handrail which is also considered not adequate under today's standards.</u></p> <p><u>The first-floor ceiling above the entry stair and top landing presents with significant damage to the ceiling lining, which is located below the box gutter at roof level. While some improvements have been made to the box gutter, there are still defects in this area which need to be addressed before any internal ceiling repairs can be carried out.</u></p>

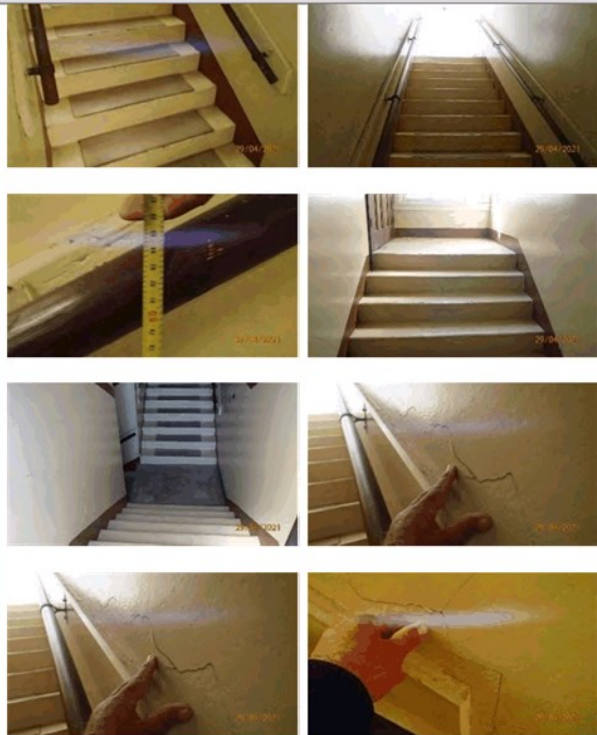
ITEM	LOCATION	DESCRIPTION / OVERVIEW / FINDINGS	IMAGE REFERENCE
128	Internal access stairs, right side Memorial Hall servicing the Archive room on the first-floor level and the Mezzanine viewing gallery.	<p><u>These images illustrate the internal access stairs on the right-hand side of the building providing access to the archive rooms at first floor level and the mezzanine viewing gallery.</u></p> <p><u>The stair risers and goings appear to be compliant and within Building Code tolerances, while the timber handrails on the first flight of stairs measures 850mm from nosing to top of handrail, while the second flight of stairs leading to the archive area measures approximately 780mm from nosing to top of handrail.</u></p> <p><u>The second flight of stairs leading to the mezzanine viewing gallery above the main hall does not have any handrails. (A handrail on one side at least is required).</u></p> <p><u>The door between the stair landing and the gallery areas overlooking the main Hall swings the wrong way (inwards) and this should be corrected as it is an emergency exit point.</u></p>

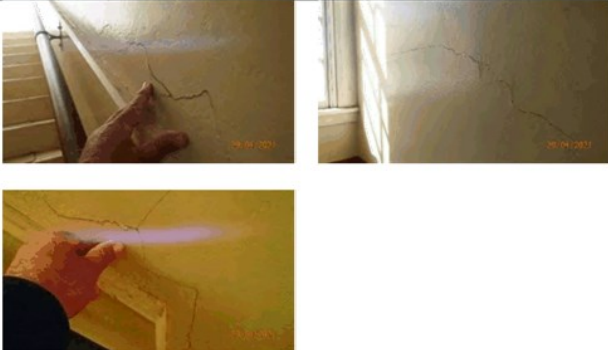
ITEM	LOCATION	DESCRIPTION / OVERVIEW / FINDINGS	IMAGE REFERENCE
129	Internal access stairs, right side Memorial Hall servicing the Archive room on the first floor level and the Mezzanine viewing gallery.	<p>Cracking was also observed to the rendered masonry walls of the stairwell, with cracks located above the handrail level on the first flight of stairs and radiating around the corner and up to the second flight of stairs towards the window adjacent to the mezzanine viewing gallery doors.</p> <p>These cracks present as approximately 1mm or less and follow the direction of handrails in a stepped fashion until they reached the top of the second landing to the mezzanine level where a horizontal crack extends along the length of the top landing to the window itself.</p>

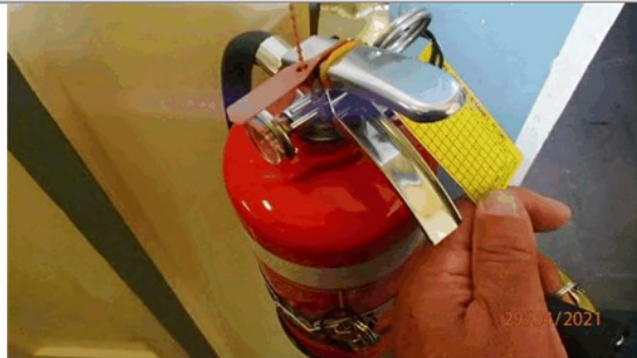
ITEM	LOCATION	DESCRIPTION / OVERVIEW / FINDINGS	IMAGE REFERENCE
131	First floor - Common corridor outside of main office and archive room.	The powder based fire extinguisher in the common corridor outside the main office area and the archive rooms indicates on the service tag that it was inspected in March 2021.

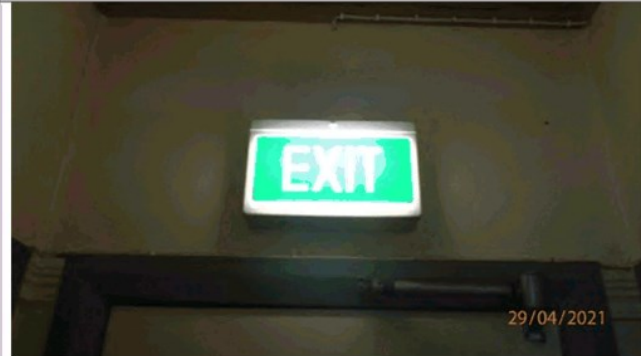
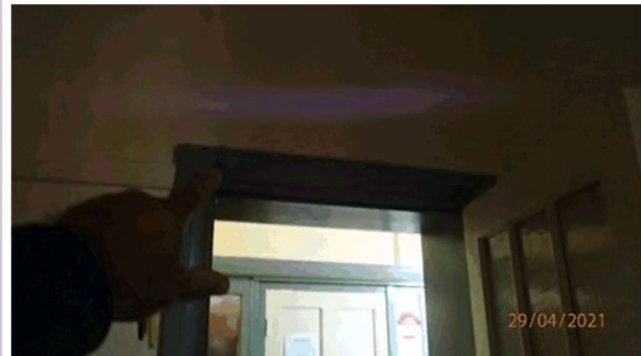
ITEM	LOCATION	DESCRIPTION / OVERVIEW / FINDINGS	IMAGE REFERENCE
132	First floor - Main entry door, top of internal stair.	<p>The exit signage above the main entry door at the top of the internal stair flight was functioning. This exit sign also acts as the exist sign for the adjoining archive room (room 3) as viewed from within the archive room.</p> <p><u>Additional directional signage is required.</u></p>

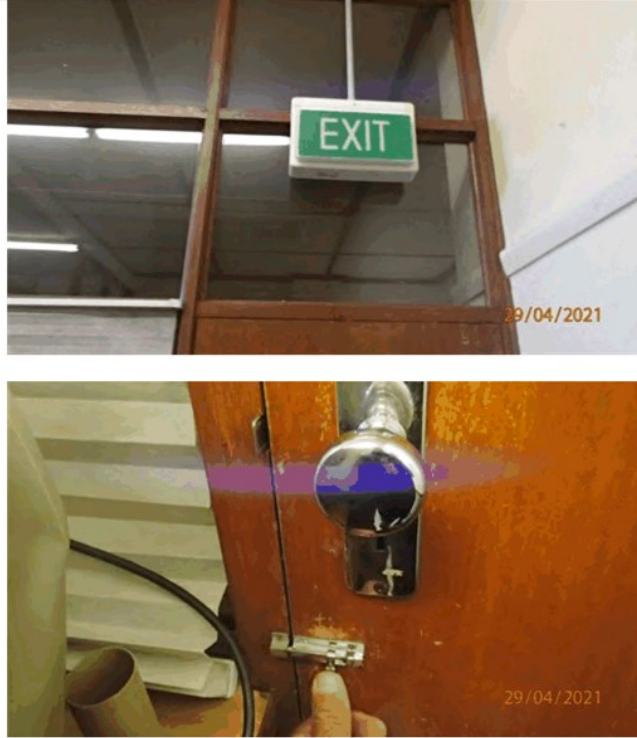
ITEM	LOCATION	DESCRIPTION / OVERVIEW / FINDINGS	IMAGE REFERENCE
133	First floor - Alternative exit within the archive room.	<p>The alternative exit in the archive room leads to an adjoining office space that is <u>fitted with a privacy latch and cannot be used as an emergency exit.</u></p> <p><u>This exit sign was not illuminated at the time of inspection.</u></p>

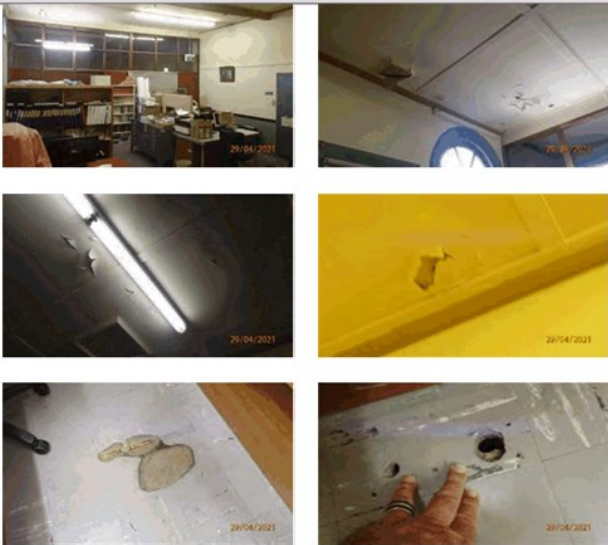
ITEM	LOCATION	DESCRIPTION / OVERVIEW / FINDINGS	IMAGE REFERENCE
134	First floor - Main Archive Room (Room 3).	<p>These images illustrate the Main Archive Room (Room 3), which shows numerous points of water damage and leakage at ceiling level, which correspond with noted roof defects.</p> <p>There is also evidence of damage to the vinyl floor where exposed timber flooring can be seen.</p>

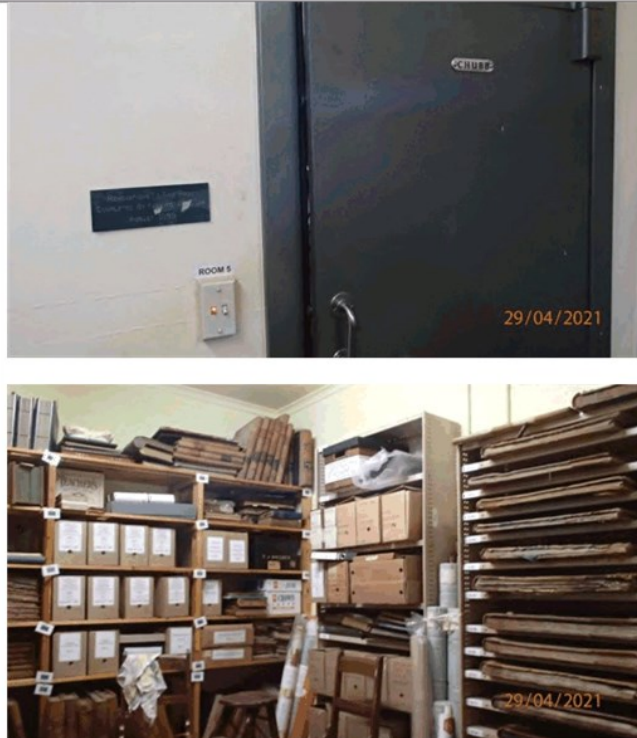
ITEM	LOCATION	DESCRIPTION / OVERVIEW / FINDINGS	IMAGE REFERENCE
135	First floor - Safe Room (Room 5).	These images illustrate the Safe Room (Room 5), which showed no significant faults to the ceiling or walls at the time of inspection. There was evidence of minor cracking to the concrete floor in this area, although this did not appear to be a significant structural concern.

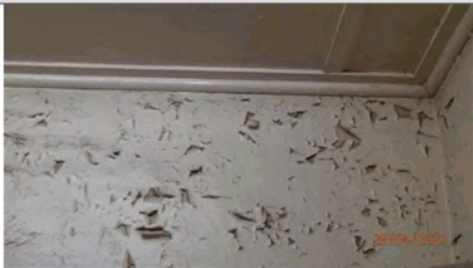
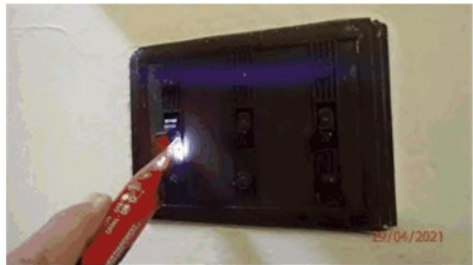
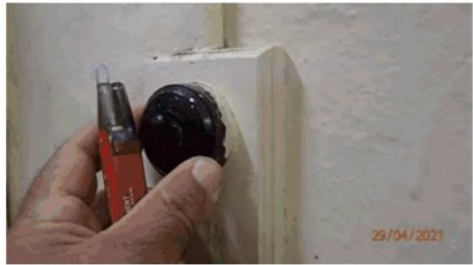
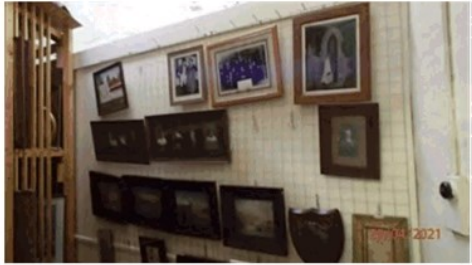
ITEM	LOCATION	DESCRIPTION / OVERVIEW / FINDINGS	IMAGE REFERENCE
136	First floor - Archive Room (Room 6).	<p>These images illustrate the interior of Archive Room (Room 6), which houses works of art, portraits and other images and maps.</p> <p><u>The ceiling within this area shows no significant damage, although the wall finish which adjoins the mezzanine viewing gallery shows evidence of significant deterioration to the paint finish, which is consistent with excessive moisture. These areas are located below sections of roof which showed evidence of gaps to roof sheeting and other defects.</u></p> <p><u>The electrical light switches and power points were tested and found to be active, although there are isolated old switches which did not seem to have power.</u></p> <p><u>Any renovations to the building should include rationalization of the electrical system with removal of all redundant electrical wiring.</u></p>

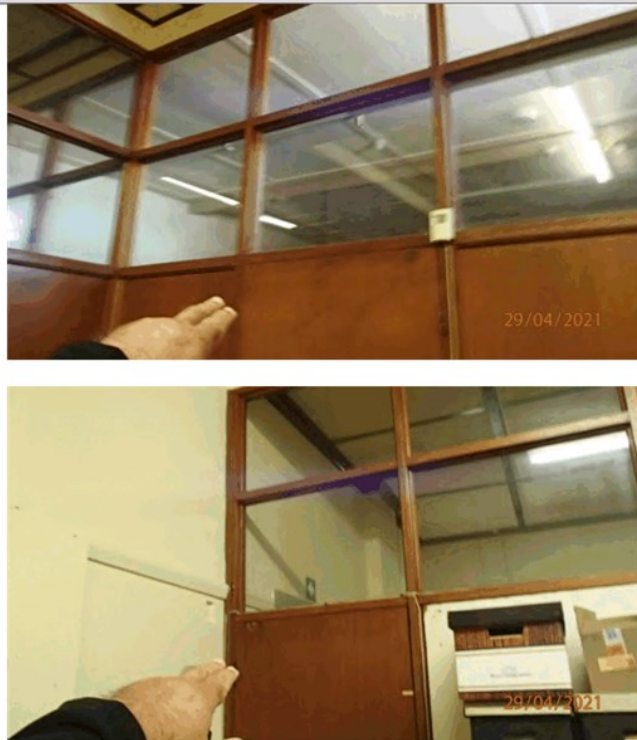
ITEM	LOCATION	DESCRIPTION / OVERVIEW / FINDINGS	IMAGE REFERENCE
138	First floor - Archive Storage Room (Room 4).	<u>Archive Storage Room (Room 4) also lacks any exit signage above the two main doors within the space.</u>

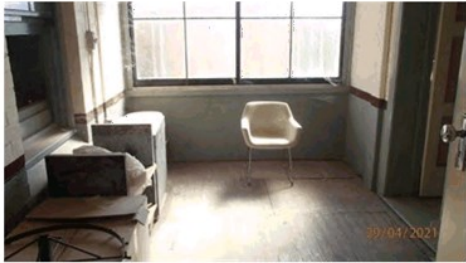
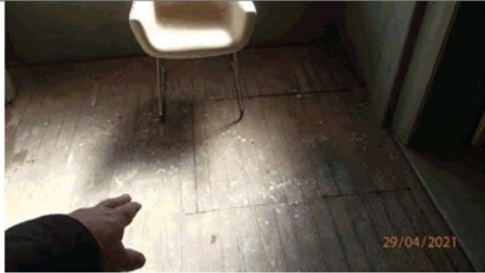
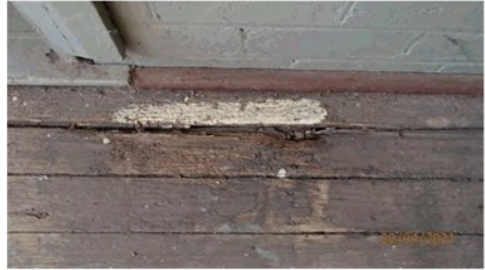
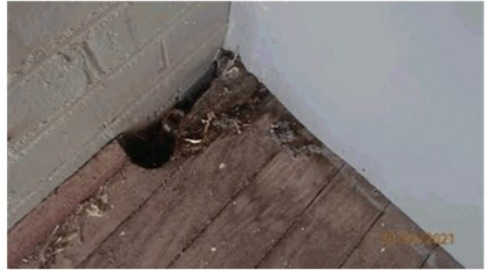
ITEM	LOCATION	DESCRIPTION / OVERVIEW / FINDINGS	IMAGE REFERENCE
141	First floor - Room leading to male toilet facilities.	<p>The room leading to the male toilet facilities on the first-floor level appears to have been an outdoor deck previously which was subsequently enclosed.</p> <p><u>The floorboards in this area are weathered and creaky with some unevenness in the floor around what appears to previously have been a hatch or opening in the floor.</u></p>

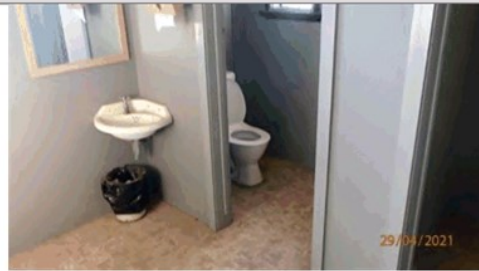
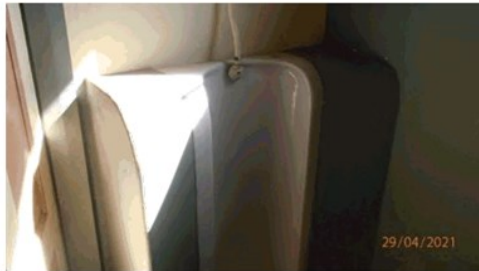
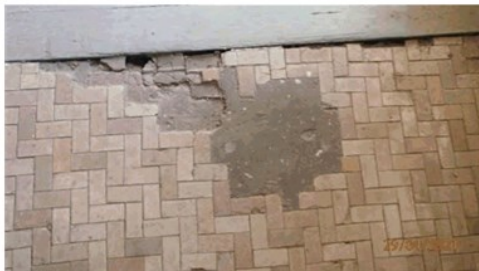
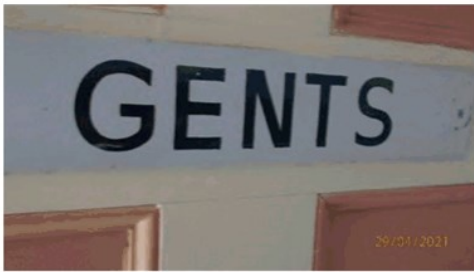
ITEM	LOCATION	DESCRIPTION / OVERVIEW / FINDINGS	IMAGE REFERENCE
142	First floor - Male toilet facilities.	<p>The male toilet facilities located on the first-floor level do not appear to have been used in some time.</p> <p><u>There is evidence of previous attempts to patch the mosaic floor tiles, and while the plumbing and drainage fixtures have not been used in some time, they were tested and found to be operable with no obvious leakage at the time of inspection.</u></p> <p>The ceiling lining shows evidence of deterioration although this is mostly to the paint finish, there does not appear to be any significant water damage.</p>

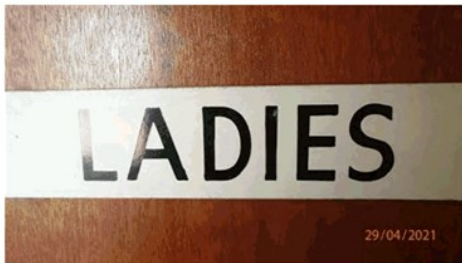
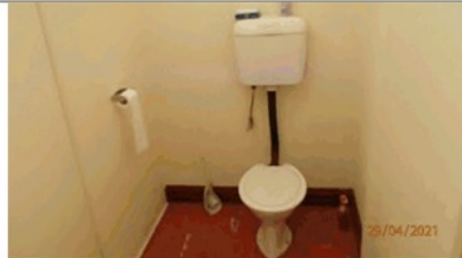
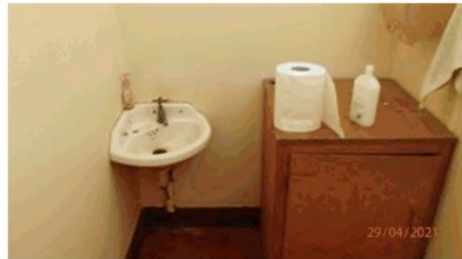
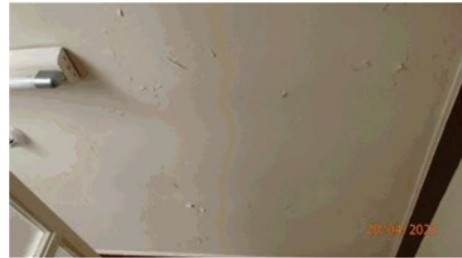
ITEM	LOCATION	DESCRIPTION / OVERVIEW / FINDINGS	IMAGE REFERENCE
143	First floor - Ladies toilet facilities.	<p>These images illustrate the condition of the ladies toilet facilities.</p> <p>The plumbing and drainage fixtures were tested and found to be operable, although the rubber seal at the rear of the toilet suite is cracked and should be replaced.</p> <p><u>The ceiling lining above the ladies toilet facilities and the adjoining room shows evidence of deterioration to the ceiling lining paint finish, along with some isolated evidence of water damage.</u></p>

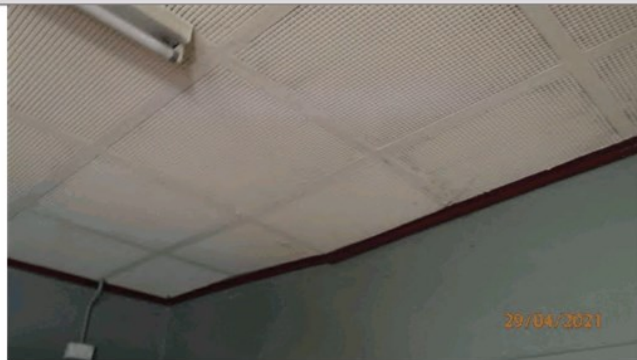
ITEM	LOCATION	DESCRIPTION / OVERVIEW / FINDINGS	IMAGE REFERENCE
144	First floor - Room adjoining kitchen facilities.	<p>The ceiling lining over the room adjoining the kitchen facilities has evidence of sagging and discolouration.</p> <p>This is consistent with potential water leakage from the roof sheeting above, and as with other areas of roof leakage, these areas require repair.</p>

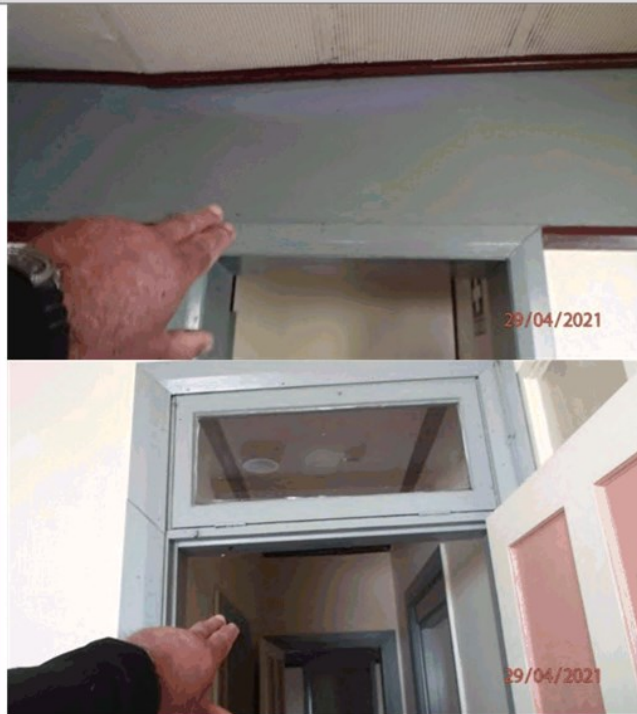
ITEM	LOCATION	DESCRIPTION / OVERVIEW / FINDINGS	IMAGE REFERENCE
145	First floor – Kitchen, male toilet facilities and adjoining room.	<u>All the rooms comprising the kitchen area, male and female toilet facilities, and adjoining storage area are not serviced by any emergency exit signage over the relevant doors. It should be addressed in order to achieve compliance with current code requirements.</u>

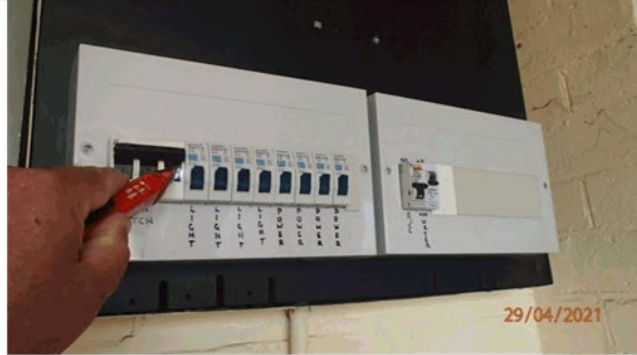
ITEM	LOCATION	DESCRIPTION / OVERVIEW / FINDINGS	IMAGE REFERENCE
146	First floor – Kitchen, male toilet facilities and adjoining room.	The electrical switches, fuses, lights and power points were tested and found to be active.

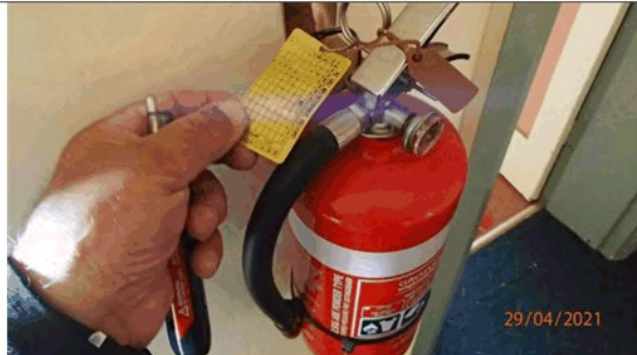
147	First floor - Kitchen.	The powder-based fire extinguisher located in the kitchen area has a service tag which indicate it was last inspected in March 2021.
