Yass Soldiers Memorial Hall Committee Meeting

5.1 Memorial Hall Dilapidation Report

SPECIAL PURPOSE INSPECTION DILAPIDATION REPORT

ADDRESS:	Yass Memorial Hall 82-94 Comur Street YASS NSW 2582
REPORT PREPARED FOR:	Yass Valley Council 209 Comur Street YASS NSW 2582
PHONE:	(02) 6226 1477
EMAIL:	Seamus.McGurk@yass.nsw.gov.au
DATE ATTENDED:	27 – 29 April 2021

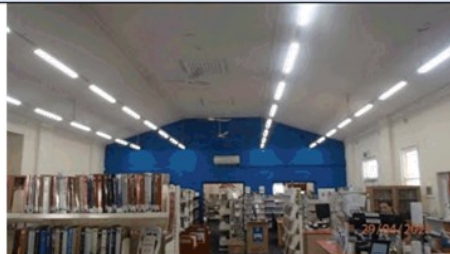
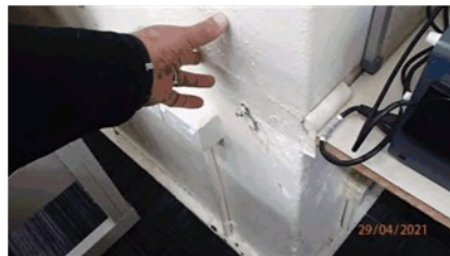
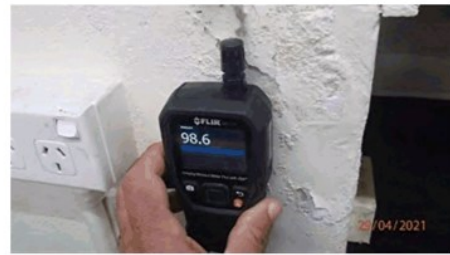
ITEM	LOCATION	DESCRIPTION / OVERVIEW / FINDINGS	IMAGE REFERENCE
INTERIOR - LIBRARY			
148	Library, interior.	<p>The interior of the main library building shows no significant faults to the ceiling lining.</p> <p><u>However, the exterior wall which adjoins Memorial Hall stage presents with excessive moisture readings to the lower level of the masonry wall behind this wall which adjoins the previously mentioned shafts that penetrate the flat roof.</u></p> <p><u>The guttering, flashing and drainage provisions within this void is allowing moisture to saturate into the brickwork.</u></p> <p><u>Improvements to the overall roof and ground drainage are required to eliminate excessive moisture in the masonry wall before any patching and repainting of the wall is done.</u></p>

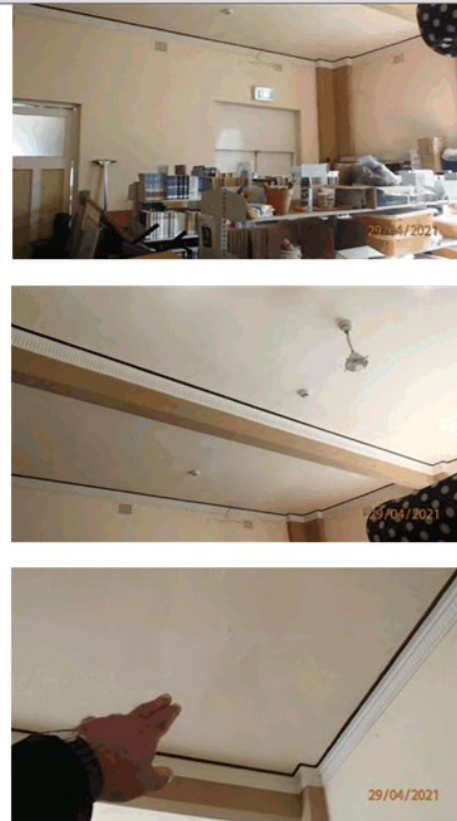
ITEM	LOCATION	DESCRIPTION / OVERVIEW / FINDINGS	IMAGE REFERENCE
149	Rear of Library, storage annex.	<p>These images illustrate the storage annex at the rear of the library which adjoins the storage annex on the left side of the Memorial Hall.</p> <p><u>This area is covered with the flat roof sheeting (metal deck roofing), and minor watermarks and damage can be seen to the ceiling, which corresponds with areas where there are loose roof sheets as identified previously in the roof section of this report.</u></p>

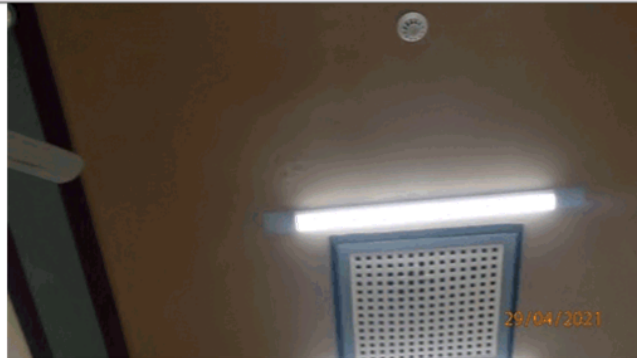
ITEM	LOCATION	DESCRIPTION / OVERVIEW / FINDINGS	IMAGE REFERENCE
150	Rear of Library	<u>The rear section of the library shows evidence of watermarks to the ceiling lining, which roughly corresponds with the ridgeline of the main roof and is consistent with the gaps observed in the ridge capping at roof level.</u>

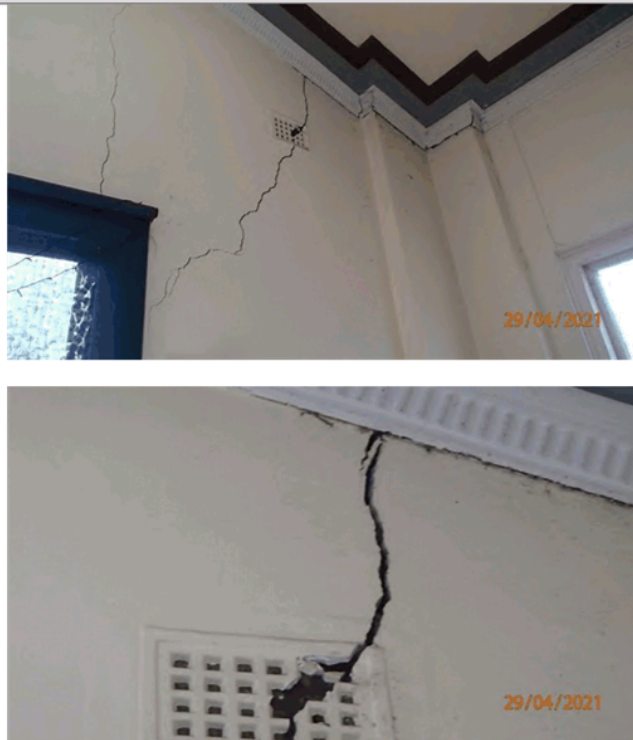
ITEM	LOCATION	DESCRIPTION / OVERVIEW / FINDINGS	IMAGE REFERENCE
151	Rear left corner of Library.	<p>The left rear corner of the library presents with significant cracking to the masonry walls, which was previously observed to the exterior building envelope inspection. The internal cracks present as being approximately 12mm or less and diminish as they radiate downward towards the top right corner of the adjoining window.</p> <p>Further engineering advice is recommended for the best method of repair, which may entail partial demolition and rebuilding.</p>

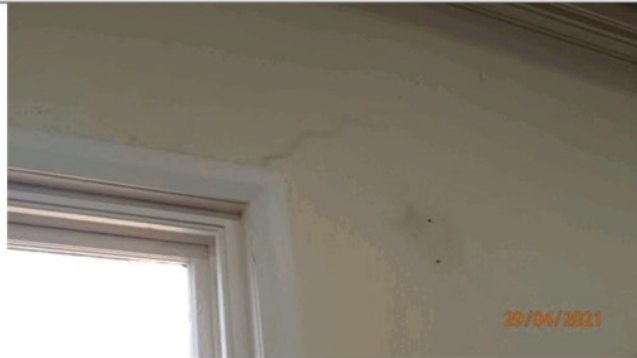
ITEM	LOCATION	DESCRIPTION / OVERVIEW / FINDINGS	IMAGE REFERENCE
152	Library.	Minor cracking to the rendered masonry wall can be seen radiating from the top right corner of the window adjacent to the library reception desk. This has been previously patched and does not appear to be of significant concern.

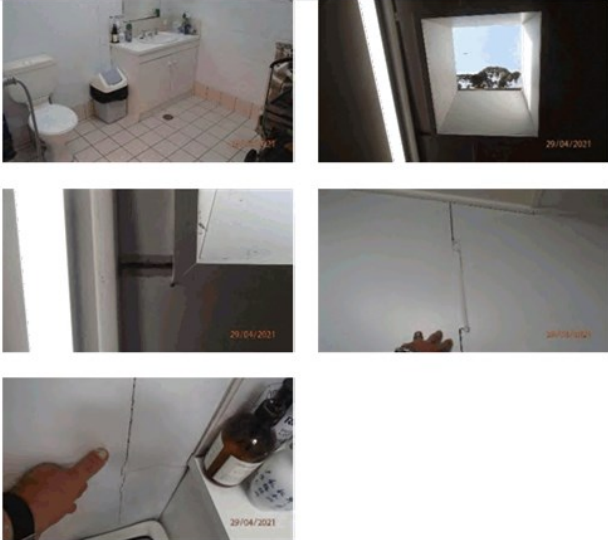
ITEM	LOCATION	DESCRIPTION / OVERVIEW / FINDINGS	IMAGE REFERENCE
154	Library, toilet facilities.	<p><u>These images illustrate the toilet facilities within the library, which show evidence of previous leakage around the skylight and some cracking to the wall lining adjacent to the vanity unit.</u></p> <p><u>Movement occurs along a sheet joint and while it is unclear what has caused the movement, it does not appear to be overly significant.</u></p>

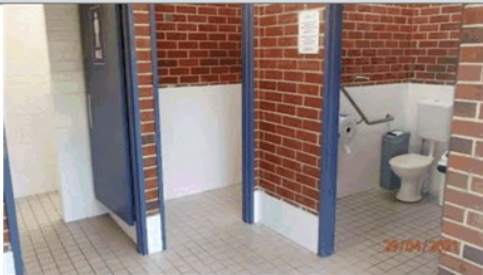
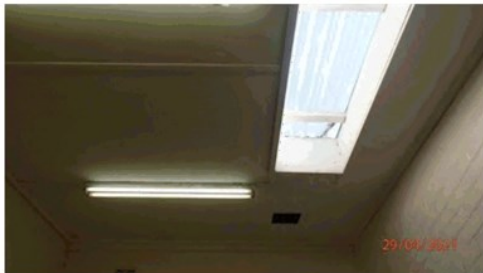
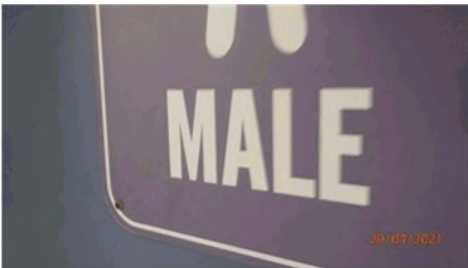
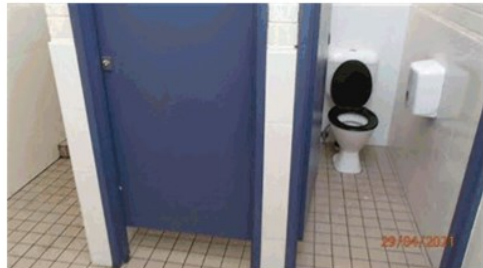
ITEM	LOCATION	DESCRIPTION / OVERVIEW / FINDINGS	IMAGE REFERENCE
155	Male public toilet facilities, side of Library.	<p>The male public toilet facilities to the side of the library showed no significant faults to the fixtures and finishes.</p> <p>The plumbing and drainage fixtures were tested and found to be operable.</p> <p>The electrical light switches were tested and found to be active.</p> <p>The ceiling lining and floor tiling showed no significant faults at the time of inspection.</p>

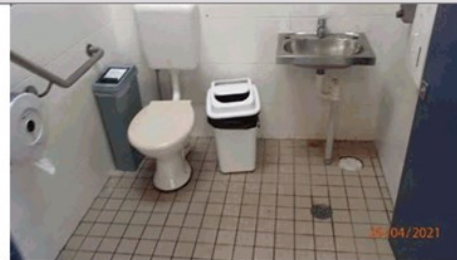
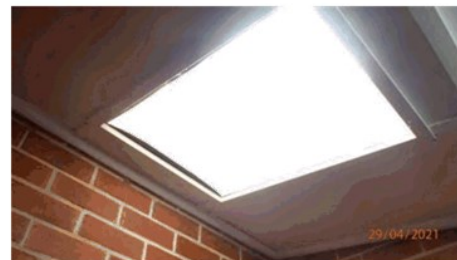
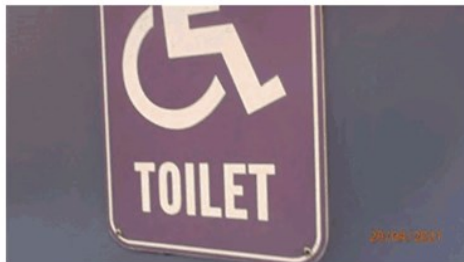
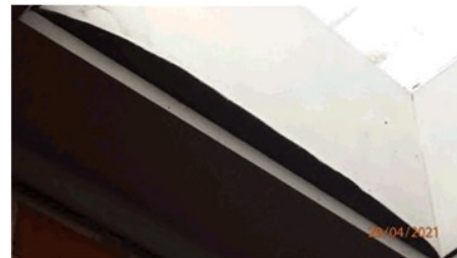
ITEM	LOCATION	DESCRIPTION / OVERVIEW / FINDINGS	IMAGE REFERENCE
156	Disabled public toilet facilities, side of Library.	<p>The disabled toilet facilities were inspected and showed no significant faults of the fixtures and finishes.</p> <p>The plumbing and drainage fixtures were tested and found to be operable.</p> <p>The electrical light switches were tested and found to be active.</p> <p>There was no significant faults to the ceiling lining or floor tiling at the time of inspection, however, a small section of shaft lining around the skylight over the disabled toilet requires additional re-fixing.</p>

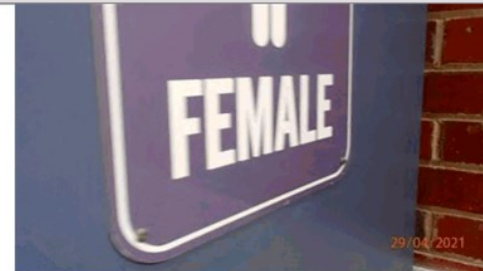
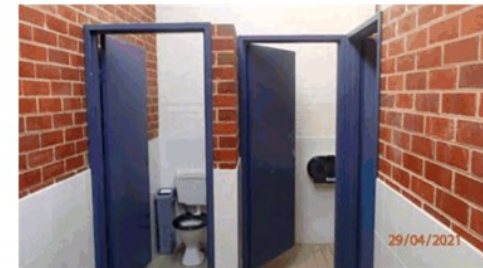
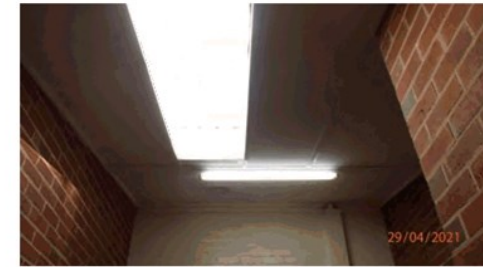
ITEM	LOCATION	DESCRIPTION / OVERVIEW / FINDINGS	IMAGE REFERENCE
157	Female public toilet facilities, side of Library.	The female public toilet facilities showed no significant faults to the fixtures and finishes and no obvious faults to the ceiling lining, floor and wall tiling.

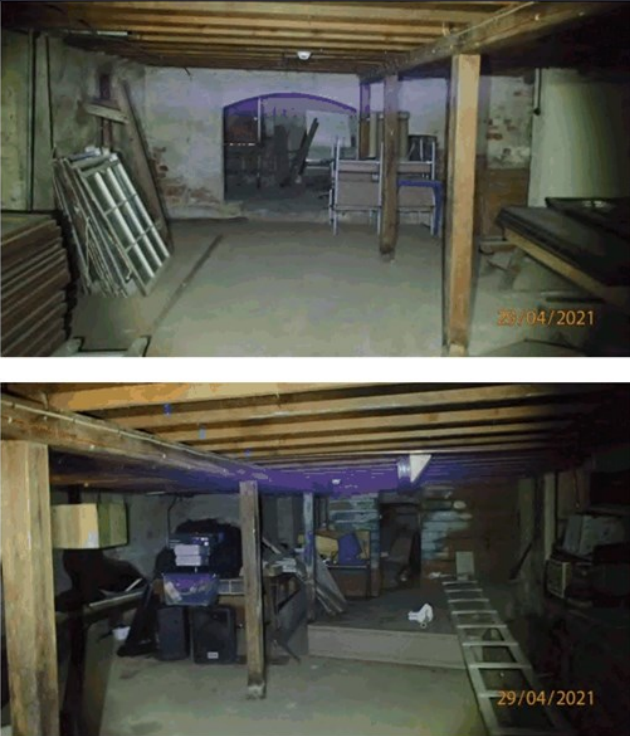
ITEM	LOCATION	DESCRIPTION / OVERVIEW / FINDINGS	IMAGE REFERENCE
SUBFLOOR			
158	Memorial Hall main stage, subfloor.	These images illustrate the subfloor void and storage area below the main stage in the Memorial Hall.

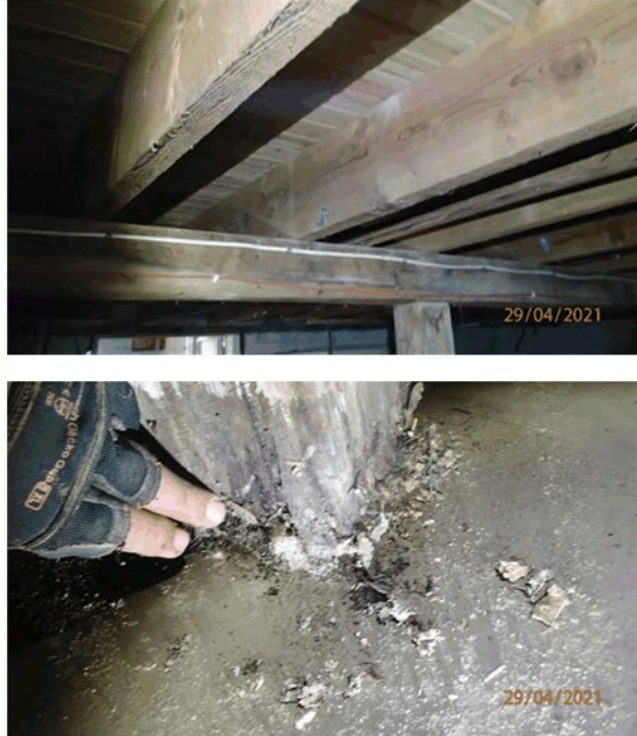
ITEM	LOCATION	DESCRIPTION / OVERVIEW / FINDINGS	IMAGE REFERENCE
159	Memorial Hall main stage, subfloor.	<p><u>The floor structure supporting the stage consists of deep joists supported on whaling plates resting on core brickwork at the perimeter, and a central 150 x 75 bearer mid span of the joists with 75 x 75 posts extending to the concrete floor.</u></p> <p><u>Water enters this subfloor void area from adjacent exposed voids and the bottom of the timber posts shows evidence of minor decay, although the majority of the post is still structurally stable.</u></p>

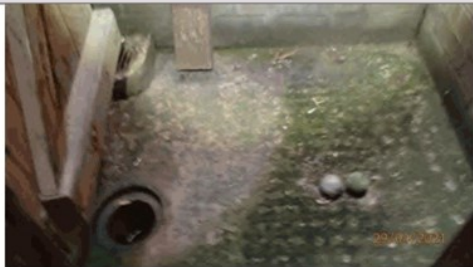
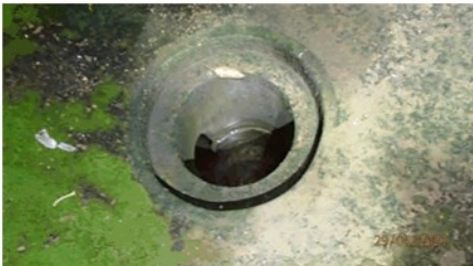
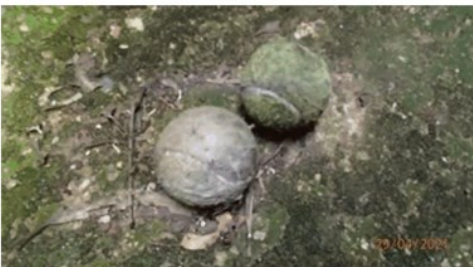
ITEM	LOCATION	DESCRIPTION / OVERVIEW / FINDINGS	IMAGE REFERENCE
161	External shaft void, between Memorial Hall and Library.	<p>The external shaft voids between the Memorial Hall and the library building are serviced by drains.</p> <p>Some of these voids appear to be draining adequately, although there is debris such as tennis balls within this area which could block the drainage since the grate is missing.</p> <p><u>Consideration should be given to supplying and fitting a new grate and removing any potential blockages from loose debris.</u></p>

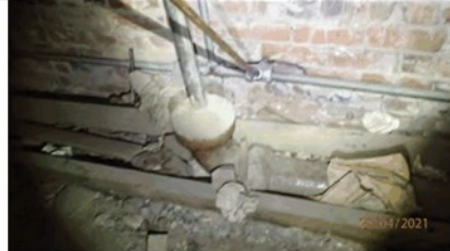
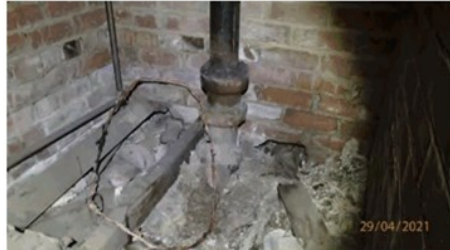
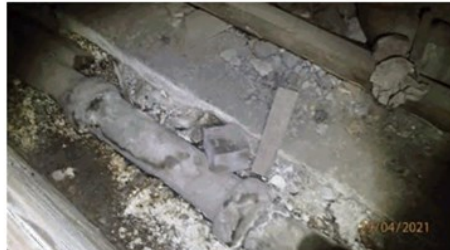
ITEM	LOCATION	DESCRIPTION / OVERVIEW / FINDINGS	IMAGE REFERENCE
162	Service voids behind storage area, between Memorial Hall and Library.	<p>There are service voids behind the storage area, between the library and Memorial Hall, which house the plumbing and drainage pipework.</p> <p><u>The old vitreous clay pipes show evidence of damp soil around them at the joints, which suggests all the joints are leaking. Some recent upgrades to water pipes can be seen where copper pipes join GAL iron pipes.</u></p>

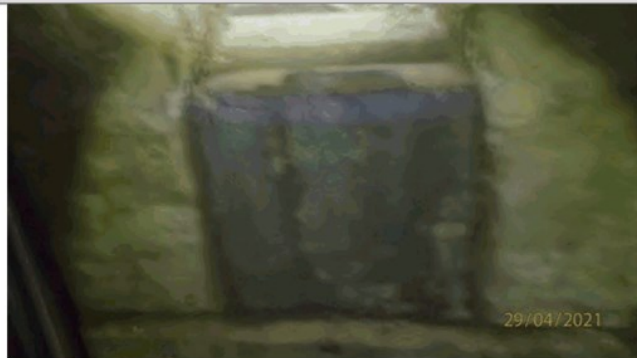
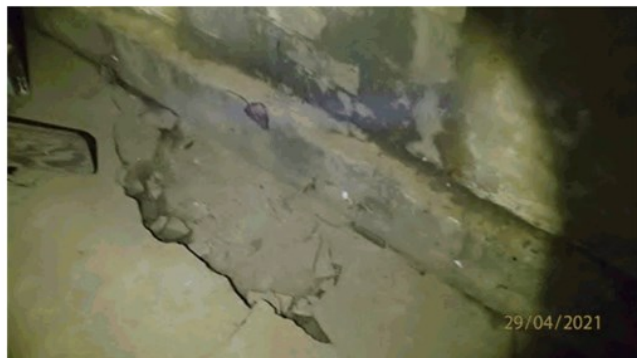
ITEM	LOCATION	DESCRIPTION / OVERVIEW / FINDINGS	IMAGE REFERENCE
164	Access hatch to service shaft void.	<u>The access hatch into the service void is missing a door, and it seems blockages occur regularly, resulting into water spilling into the subfloor area causing staining to the base brickwork and damage to the concrete floor finish within the subfloor void below the stage.</u>

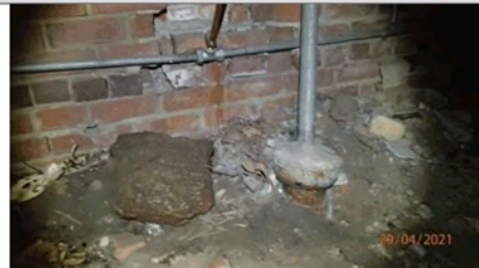
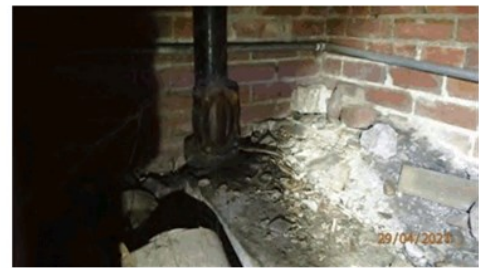
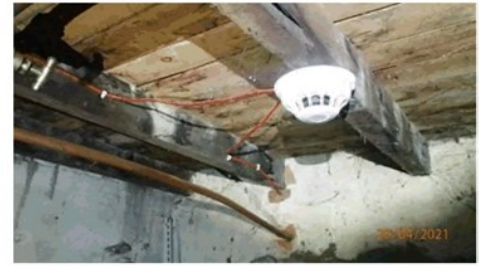
ITEM	LOCATION	DESCRIPTION / OVERVIEW / FINDINGS	IMAGE REFERENCE
165	Drainage and plumbing void.	<p>The drainage and plumbing void on the right-hand side shows no significant leakage to the plumbing and most drainage pipes, although dampness around the cast-iron drainage pipe servicing the male toilets may be leaking and some maintenance is required.</p> <p>Smoke detectors within the subfloor void appeared to be in good condition with no loose or damaged wiring.</p>

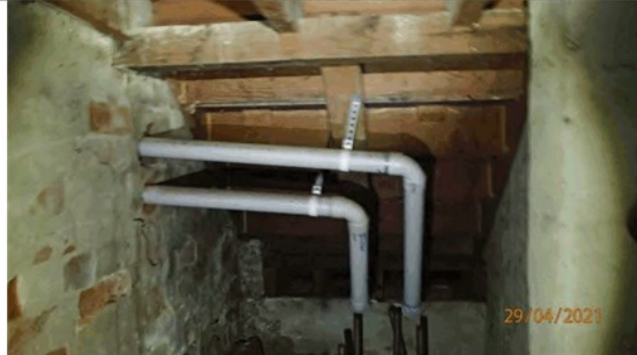
ITEM	LOCATION	DESCRIPTION / OVERVIEW / FINDINGS	IMAGE REFERENCE
166	Underside of staircase, stage right side of Memorial Hall.	The underside of the staircase on the right of the Memorial Hall stage showed no obvious faults to the stair structure.

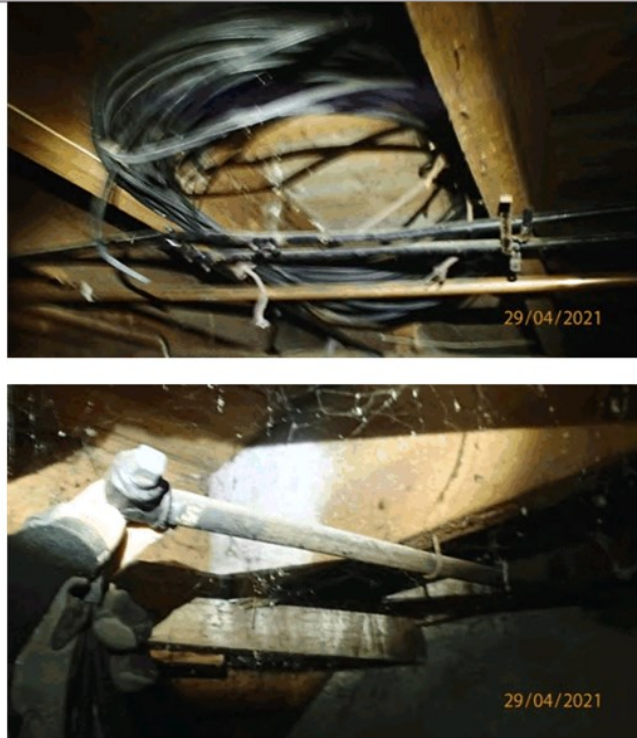
ITEM	LOCATION	DESCRIPTION / OVERVIEW / FINDINGS	IMAGE REFERENCE
167	Underside of staircase, stage left side Memorial Hall.	<p>There is what appears to be a significant amount of redundant electrical wiring and plumbing pipes which have been capped.</p> <p><u>Consideration should be given to rationalizing the plumbing and electrical services to eliminate any redundant services.</u></p>

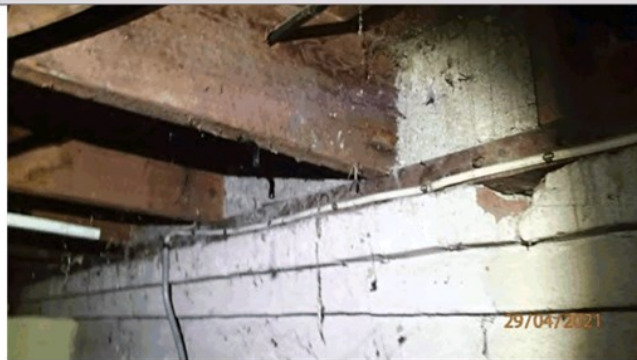
ITEM	LOCATION	DESCRIPTION / OVERVIEW / FINDINGS	IMAGE REFERENCE
168	Underside of stage.	Image showing the deep joists under the stage floor structure supported on whaling plate and corporate brickwork.

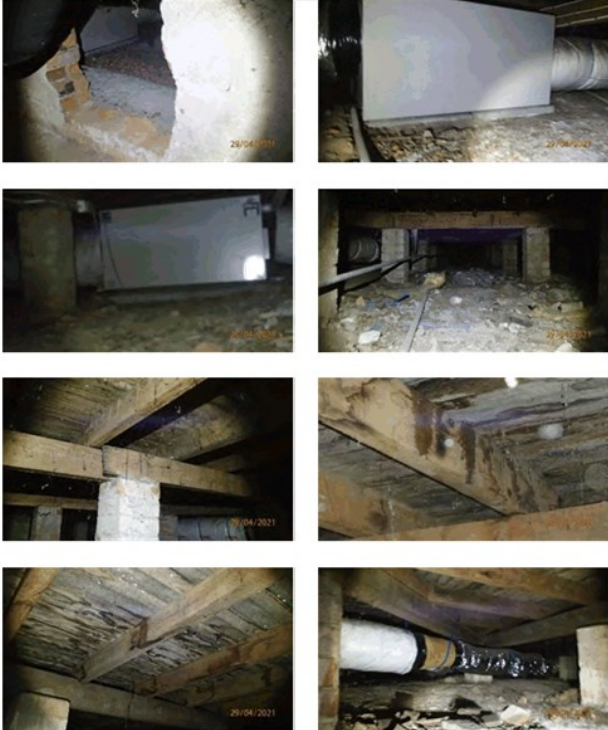
ITEM	LOCATION	DESCRIPTION / OVERVIEW / FINDINGS	IMAGE REFERENCE
169	Subfloor, below main Memorial Hall.	<p>These images illustrate the subfloor void below the main Memorial Hall.</p> <p>Access to this void is via penetrations in the base brickwork where the ducted heating units are located and appeared to be in good condition.</p>

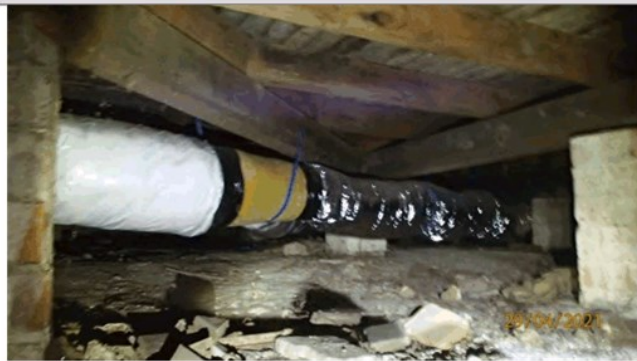
ITEM	LOCATION	DESCRIPTION / OVERVIEW / FINDINGS	IMAGE REFERENCE
171	Subfloor, below main Memorial Hall.	The ducted heating ducts appear to be well supported and suspended from the floor in all areas.

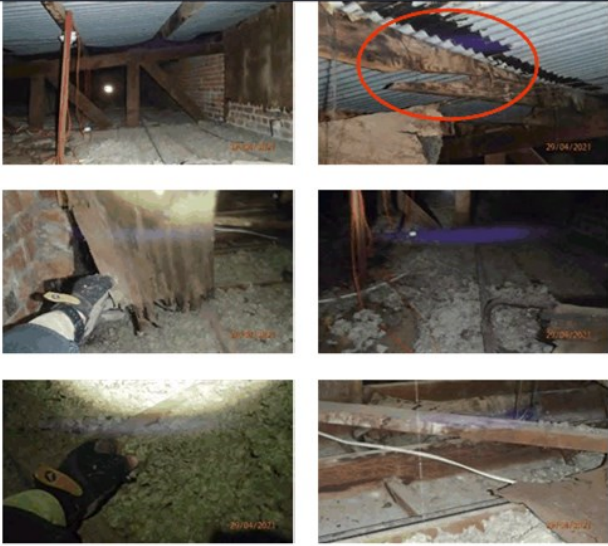
ITEM	LOCATION	DESCRIPTION / OVERVIEW / FINDINGS	IMAGE REFERENCE
ROOF VOIDS			
172	Void over first-floor archive offices.	<p>The roof void over the archive areas shows evidence of birds nesting, and deterioration to the sarking paper, which allows condensation and other moisture penetrating past the gaps in the roof sheeting to enter the roof void, thus creating water damage to ceilings below.</p> <p>There is a roof rafter, which has cracked, which corresponds with previous observations at roof level where the roof exhibited movement and sagging over the archive room.</p> <p>While there is loose insulation over some office areas, there are significant portions of the roof or ceiling that are not insulated.</p>

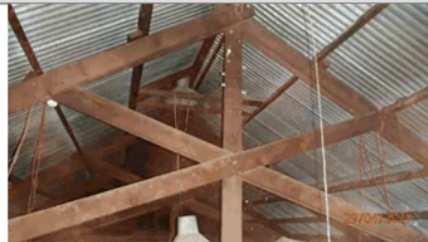
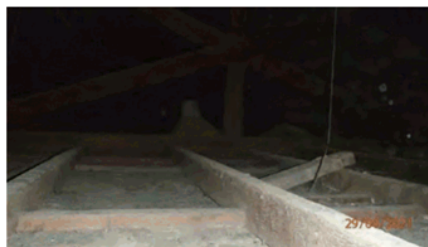
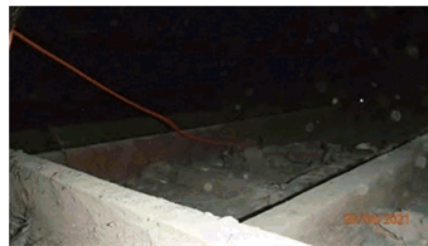
ITEM	LOCATION	DESCRIPTION / OVERVIEW / FINDINGS	IMAGE REFERENCE
173	Main roof void over Memorial Hall.	<p>This section of roof void has limited access, with only partial views available from the stage end of the roof and a gable end hatch at roof level, which had difficulty opened.</p> <p>The limited view of the roof truss structure and ceiling joists showed no obvious faults however, sagging ceiling lining, water damaged areas and areas with paint defects will require repair and replacement of linings along with extensive painting.</p> <p><u>In general, all ceiling areas that display water damage from leakage, will require replacement of roof sheeting, addition of new anticon insulation blankets, modification of gutters, overflow provisions, flashing, capping and roof safety anchor provisions.</u></p> <p><u>There may well be unanticipated roof structure repairs that will only be revealed once roof sheets are removed, but that will require a witness point inspection prior to fitting of new sheeting.</u></p>

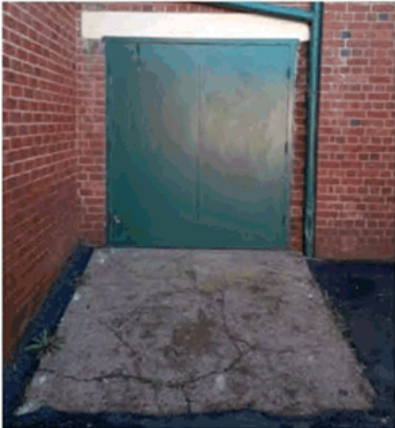
4.	Pedestrian ramps The pedestrian ramp serving exit 6 (see Appendix D.4) does not have slip-resistance measures.

Clause D2.10	DTS Install a tested slip-resistant coating of at least P4 or R11 (refer to NCC Volume One Table D2.14).

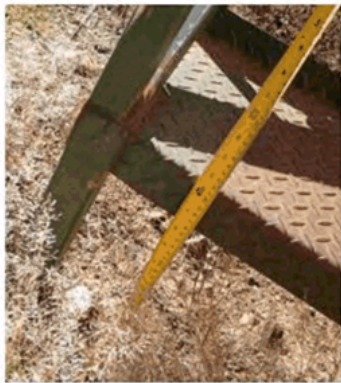
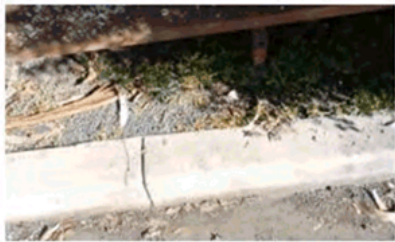
No	Description of issue	DTS provision	Proposed solution
5.	<p>Going and risers</p> <p>All of the stairs in the building do not have tested slip-resistant measures applied.</p> <p>Risers may be reduced when a stairway discharges on a sloping public walkway or public road. The final risers on exit 8, 9, 10 and 11 (see Appendix D.4) exceed the allowable riser heights.</p> <p>The discharge at exit 9 also discharges directly onto the road curb, which is unsafe.</p>

Clause D2.13	<p>DTS</p> <p>Install a tested slip-resistant coating or nosing strip to the treads of stairs. Rating to be at least P3 or R10 for internal and P4 or R11 for external stairs (refer to NCC Volume One Table D2.14).</p> <p>DTS</p> <p>The stairs would have to be rectified to achieve compliance. For consistent risers the last step would need to be approximately 180 mm high (different for each stairway). The last steps on exits 8, 9, 10 and 11 is on average more than 300 mm. See Appendix E.</p>

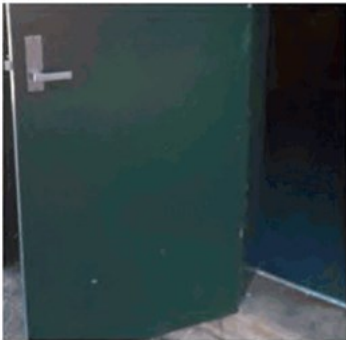
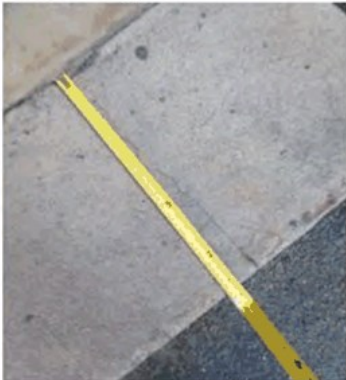
<p>Current landing of exit 5</p>

No	Description of issue	DTS provision	Proposed solution
6.	<p>Thresholds</p> <p>The threshold at exit 5 (see Appendix D.4) has two steps directly outside the door. For an entertainment venue the maximum height difference between the door sill and floor level in which the door opens is 50 mm. The current arrangement includes two risers – 170 mm and 180 mm, plus a landing of 470 mm.</p> <p>Exit 5</p>

Clause NSW D2.15	<p>DTS</p> <p>To comply with this specific NSW requirement. A larger landing (at least 750 mm long) would need to be installed. Subsequent stairs would be required to be located after the landing. Stairs must comply with the going and riser dimensions of table D2.13 of NCC Volume One.</p>

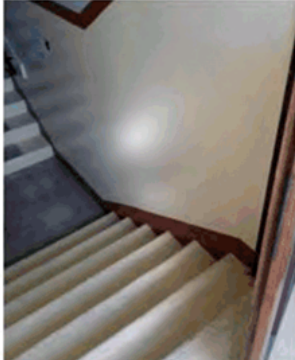
No	Description of issue	DTS provision	Proposed solution
8.	Handrails No handrail provided on the top flights of Stair 2 (see Appendix D.4). At least one handrail must be provided along the side of a flight of stairs.

Clause D2.17	DTS Install handrails to at least one side of the flight of stairs, at a minimum of 865 mm above the nosing line of the stairs.
9.	Swing of doors The main door entering into the library swings against the direction of egress. As this door forms part of the required exit, it must swing in the direction of egress.	Clause D2.20	DTS <ol style="list-style-type: none"> 1. Relocate the swing of the door to swing out instead of in; or 2. Compliance for exits can be achieved through the two other exits within the library. If the exit signage is removed the from main entrance door, DTS compliance will be achieved.

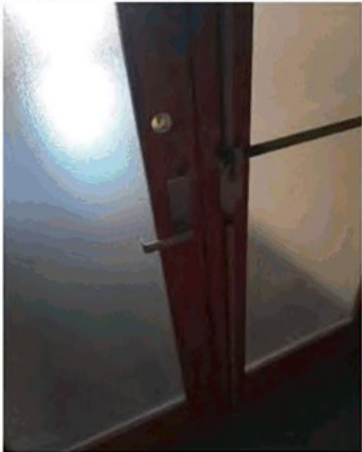
10.	<p>Operation of latch</p> <p>The panic bar on the second set of doors at exit 14 has been replaced with a standard latch set. This is a departure from the DTS provisions for this type of building.</p>

Clause D2.21	<p>DTS</p> <p>Reinstate a compliant panic bar to the door in exit 14.</p>
	<p>Three doors provide access to the first floor balcony. However, none of these doors have compliant latches to enable egress.</p>		<p>DTS</p> <p>Install compliant door sets, that allow for a single hand downward action to open.</p>
	<p>The entrance doors to the community meeting room and youth centre door sets are provided with dead bolts instead of compliant hardware.</p>  		<p>DTS</p> <p>If these rooms are deemed as separate sole-occupancy units these dead lock door sets are compliant. However if the rooms are not used as separate sole-occupancy units the door set need be replaced with compliant door hardware (single hand downward action).</p>

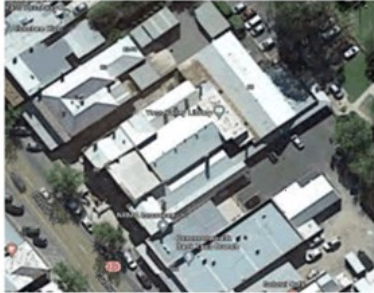
No	Description of issue	DTS provision	Proposed solution
11.	<p>Fire Hydrants</p> <p>There are no internal hydrants on site, however a street hydrant is located at the street near the south corner at Comur Street.</p>
